Australian Government
Department of Agriculture
and Water Resources

Machinery Cleaning Guide – Excavators

April 2016

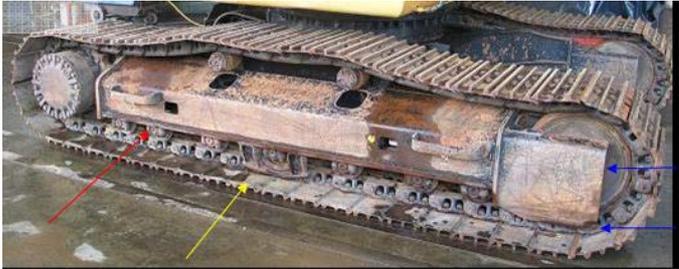
Description	Images
<p>All non-affixed panels, rock guards and motor covers must be dismantled. The yellow arrow indicates a small rock guard, which may not require dismantling. The red arrow indicates the rollers and the blue arrows the hollow channels on the idler wheel frame.</p>

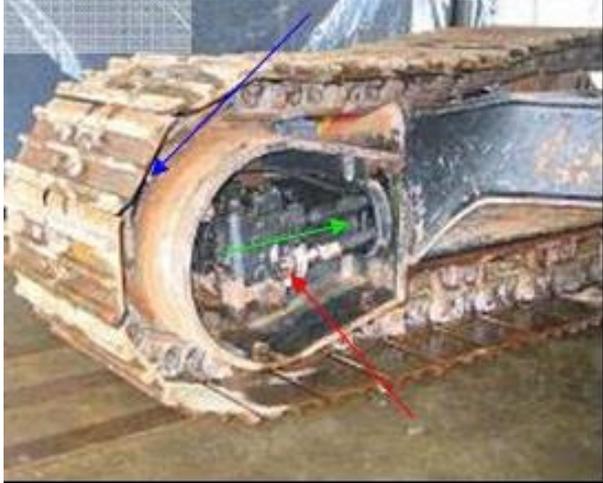
<p>Red arrow indicates that the motor cover has been removed, allowing access to the drive motor. The green arrow indicates the hollow channel, which extends up through the frame into the turret or slew ring. These hollow areas on each side need to be thoroughly flushed to ensure cleanliness. The blue arrow indicates the area at the rear of the motor cover, which can be easily overlooked.</p>

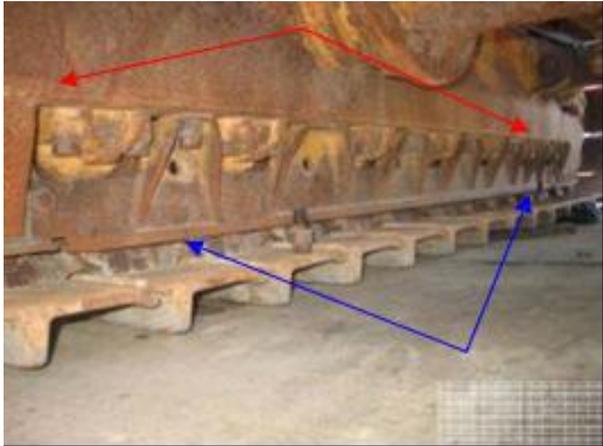
<p>Illustration of rock guards (red arrows) on a track frame. The frame to which these rock guards is attached (blue arrows), is hollow and must be verified clean. To verify this hollow area and around each roller, the rock guards must be dismantled.</p>

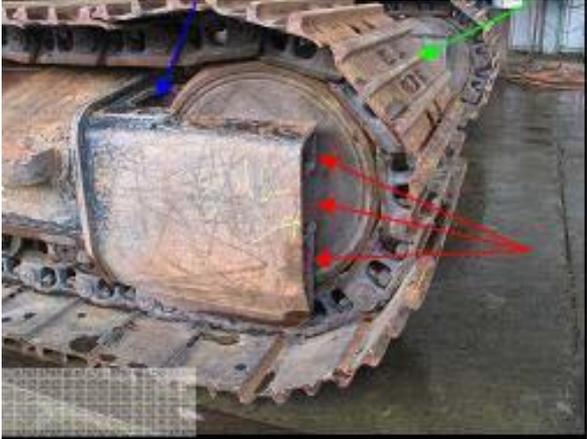
Description	Images
<p>This picture indicates the hollow sections that can be found supporting the idler wheel (red and blue arrows). All these hollow areas require thorough flushing to remove all contaminants. These hollow sections can also be found on the inside of the idler wheel (green arrow).</p>

A close-up photograph of an idler wheel assembly on a tracked vehicle. The image shows a large, cylindrical metal wheel with a central hub and several support arms. Red arrows point to hollow sections between the support arms and the wheel. Blue arrows point to the inner surface of the wheel. A green arrow points to a hollow section on the inside of the wheel.
<p>This picture indicates the outside of the drive motor. The red arrows highlights the rear of the motor cover and the blue arrows highlight each track nut.</p>

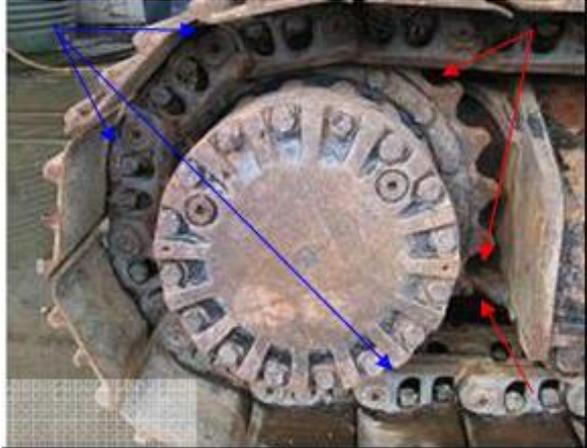
A close-up photograph of the drive motor of a tracked vehicle. The image shows a large, circular metal cover with several track nuts around its perimeter. Red arrows point to the rear of the motor cover. Blue arrows point to each track nut.

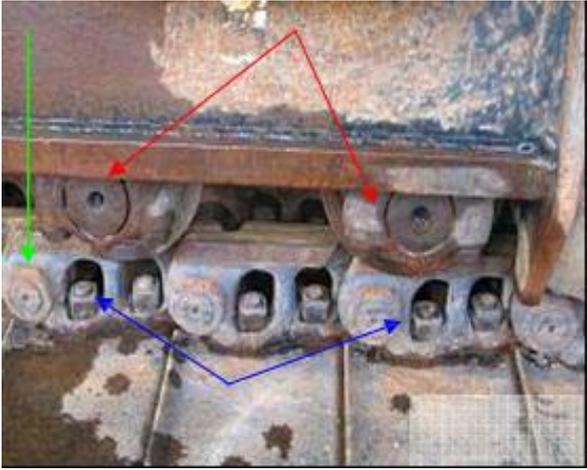
<p>The blue arrows highlights the small gaps either side of each nut where biosecurity risk material (BRM) is commonly found. The red and green arrows highlight small hollow areas where BRM can become compacted.</p>

A close-up photograph of the track nuts on a tracked vehicle. The image shows several track nuts arranged in a row. Blue arrows point to the small gaps between the nuts. Red and green arrows point to small hollow areas where biosecurity risk material (BRM) can become compacted.

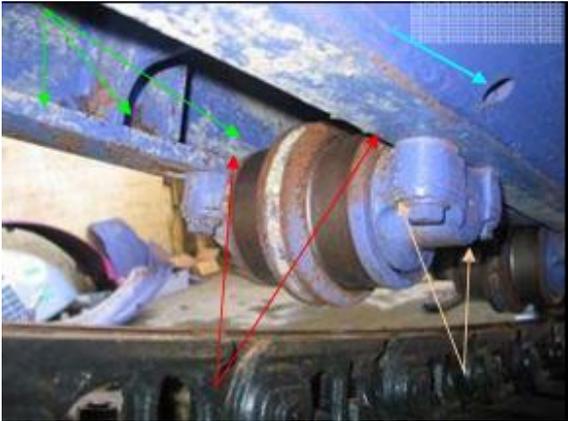
Description	Images
<p>This picture highlights the roller inside the track frame. Note the horizontal ledge inside the frame highlighted by the green arrows. The red arrows highlight the small gap either side of the roller while the aqua arrow shows a drainage hole, sometimes found on the turret of some excavators. The orange arrows highlight the area behind each nut.</p>

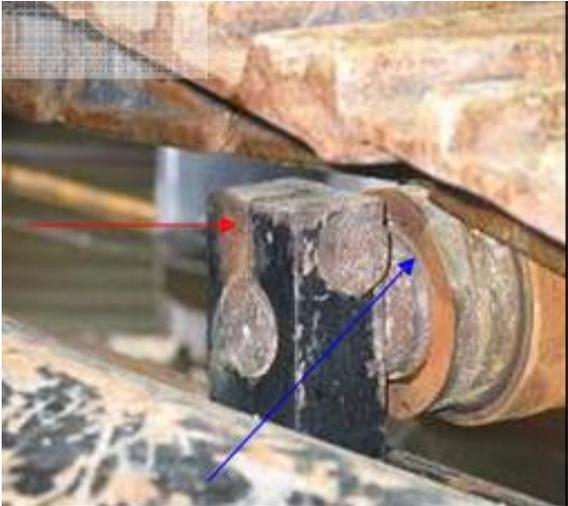
<p>Indicates the top roller above the track frame. The red arrow highlights the small gap at the rear, which must be flushed while the blue highlights the small gap at the rear of the roller.</p>

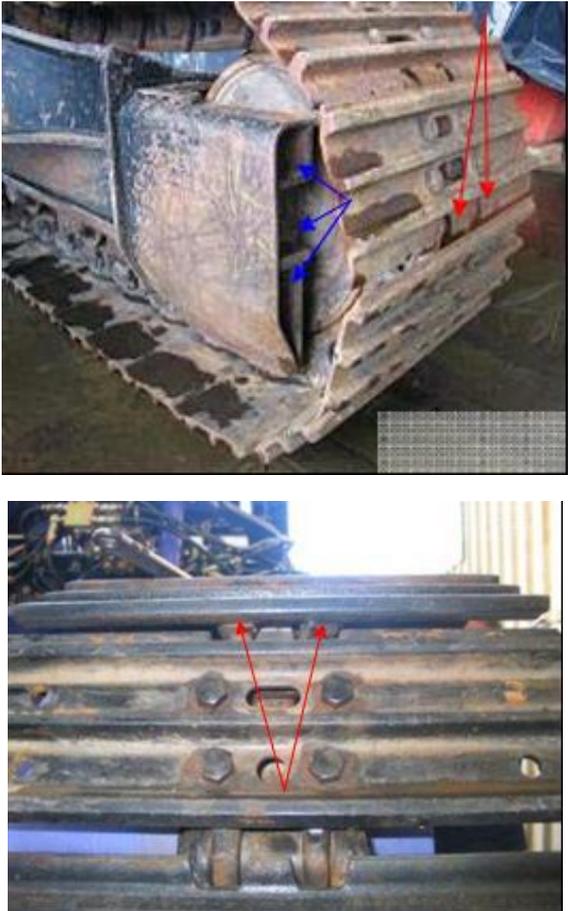
Description	Images
<p>Blue arrows again show the hollow framework that requires thorough cleaning and the red highlights where the track pads connect to the chain. All tracked machines undergo one full revolution to ensure cleanliness. The picture highlights the track pads opening slightly, this area is to be cleaned.</p>

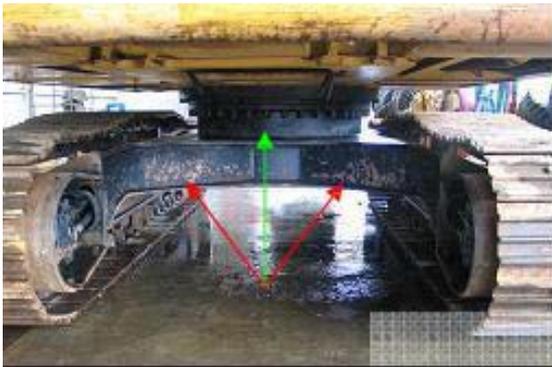
Description	Images
<p>The red arrows highlight the turret or slew ring, a hollow structure that can be accessed once the belly plate is removed (if present). The green arrow highlights the nuts/bolts that fix the body to the turret. All contaminated grease must be removed from each nut/bolt.</p>

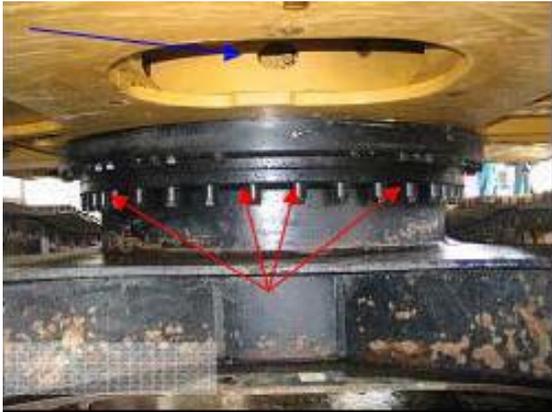
Description	Images
<p>A closer view of each nut/bolt that attaches the body to the turret (red arrows). The blue arrow highlights just one of the plates which has been removed, allowing access to the underside of the engine.</p>

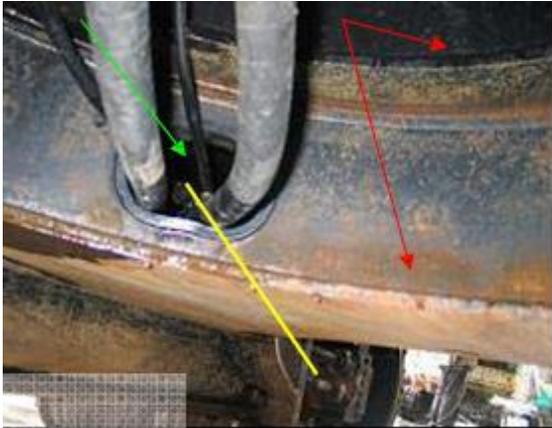
<p>The red arrows highlight the various ledges that can be found inside the turret/slew ring, each ledge requires thorough cleaning. The green arrow points to the hollow channel where the hydraulic hoses run down through the turret housing to the drive motors (yellow line demonstrates the path of the hydraulic hoses). This area must be flushed in the presence of the inspecting officer to verify cleanliness.</p>

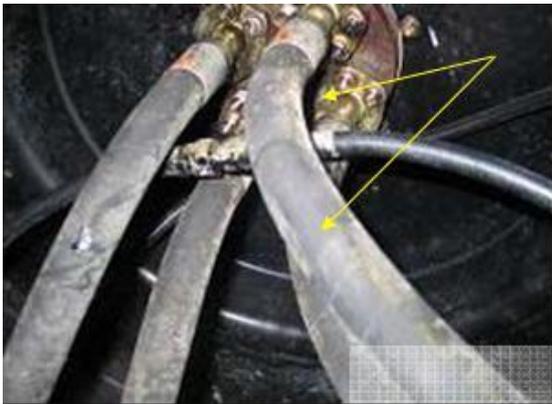
<p>The hydraulic hoses inside the turret/slew ring (yellow arrows). Each hose must be individually cleaned.</p>

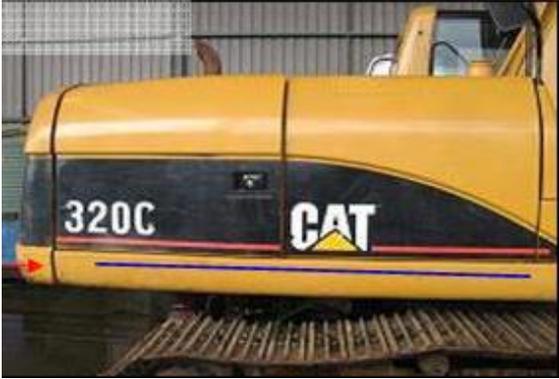
Description	Images
<p>The right hand side of the engine bay. On some models the horizontal blue line highlighted in this picture indicates a hollow channel while the red arrow on the left indicates the entrance to this area. On other models this area is completely sealed. If this channel is open ended, it will require flushing in the presence of the inspecting officer.</p>

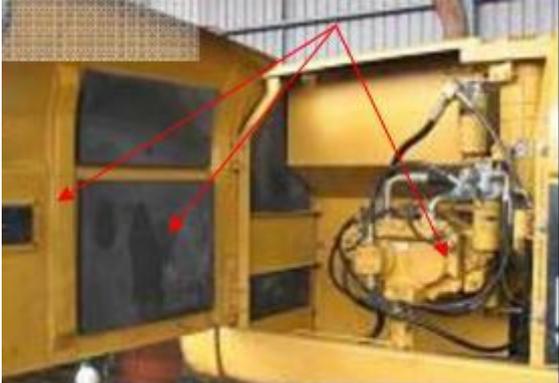
<p>Check all engine doors for hollow support channels. Check for drainage holes or if only spot-welded – will require flushing if not completely sealed. Check all foam insulation and hydraulic hoses (red arrows).</p>

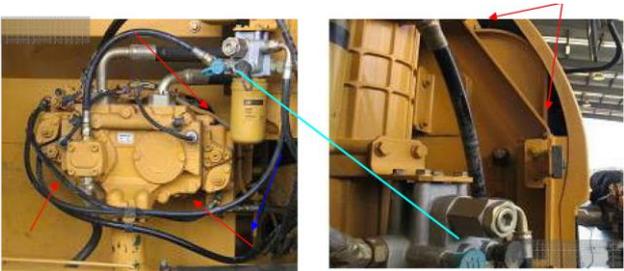
<p>Check all surfaces and hydraulic hoses for cleanliness as indicated by the red arrows. The blue arrow indicates an accumulation of hydraulic hoses, bound together by zip-ties. These hydraulic hoses need to be separated to allow cleaning and inspection.</p>

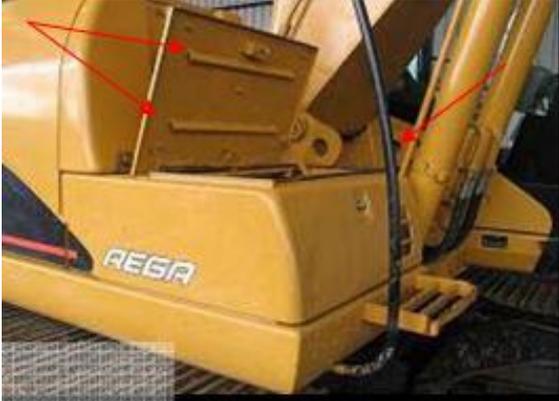
<p>The battery box located just in front of the fuel cell on the RH side of the excavator. Ensure the hollow, open-ended sections in the battery-box cover are flushed. Check handrail for openings at either end – flush if open-ended (red arrow).</p>

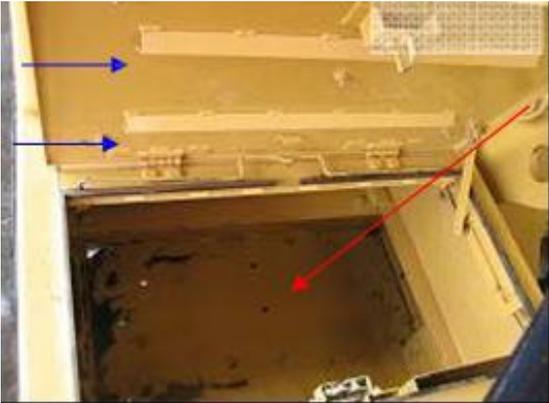
Description	Images
<p>The batteries have been removed (red arrows) allowing for easy cleaning and inspection. The blue arrows again highlight the open-ended channels on the inside of the battery box cover.</p>

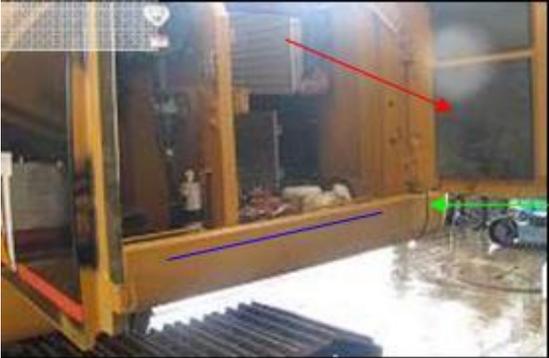
<p>A view of the LH side of the engine bay. Check all insulation foam (red arrow). The blue line again indicates that this section may be a hollow channel while the green arrow highlights the opening to this hollow section. This hollow section is not applicable on all models.</p>

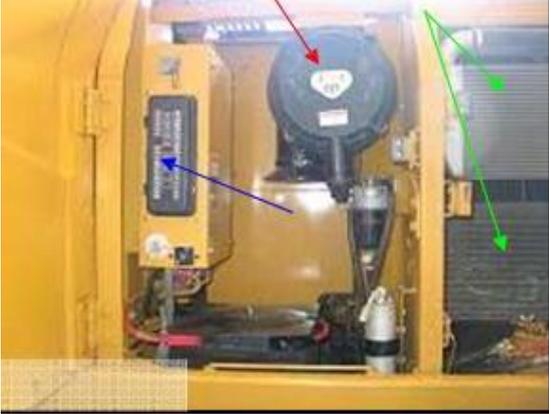
<p>The red arrow highlights the air-filter, which needs to be removed and checked for cleanliness. An air hose is the best way to verify cleanliness. The blue arrow highlights the fuse-box. This area is generally well sealed, however an internal cleanliness check is required. The green arrows highlight the oil coolers. Each must be flushed to ensure cleanliness.</p>

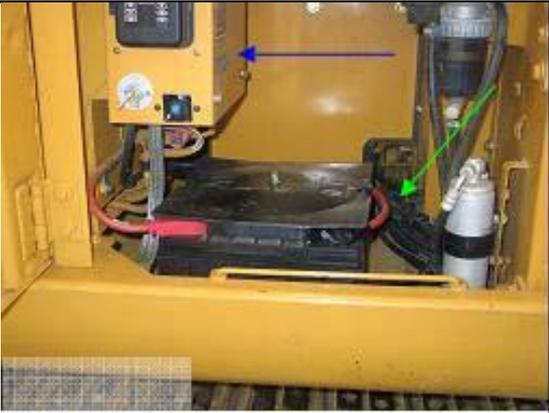
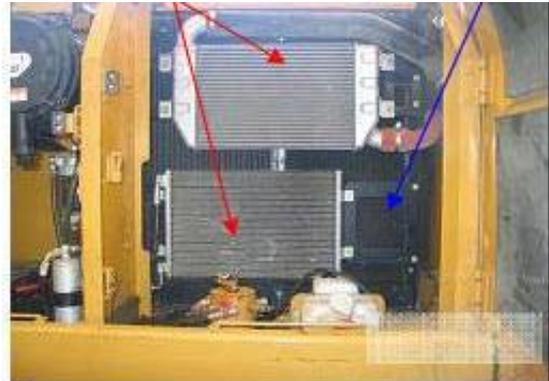
<p>Another view of the oil-coolers (red arrow) and radiator core (blue arrow). All require flushing to verify cleanliness. To allow access to the radiator at the rear, the oil cooling fins may have to be dismantled to allow thorough flushing.</p>

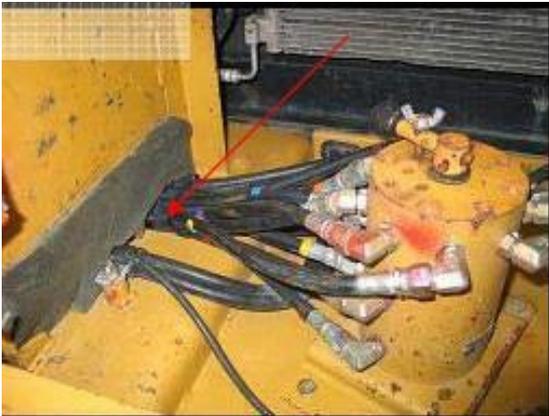
<p>An accumulation of hydraulic hoses bound together with zip-ties (red arrow).</p>

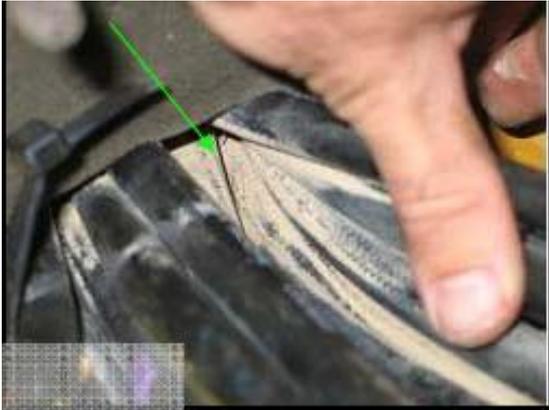
<p>The zip-tie removed, allowing the hoses to be moved and highlighting BRM between the hoses (green arrow).</p>

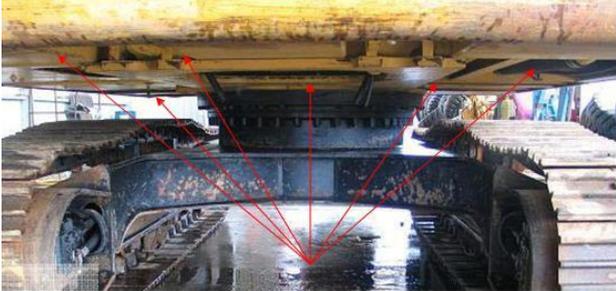
Description	Images
<p>All non-affixed panels on the underside of the car body have been removed allowing access for cleaning and inspection (red arrow).</p>

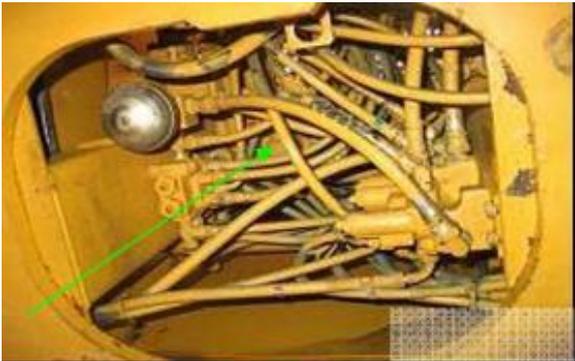
<p>When the non-affixed panels on the underside of the car body are dismantled, this allows access to cleaning and inspection staff. Areas like the one highlighted (green arrow) require careful attention and a mirror may assist the inspection process.</p>

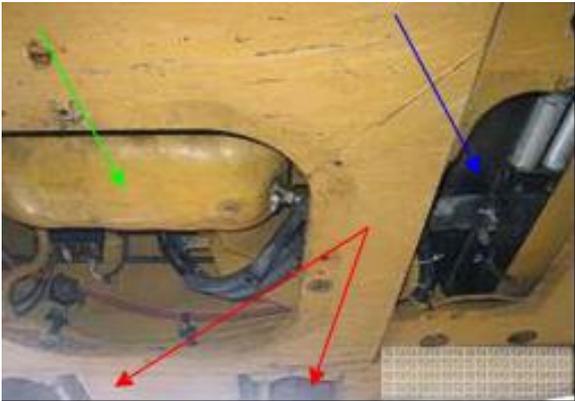
<p>The bottom of the sump (green arrow) is visible with the non-affixed panels removed. All contaminated grease and oil residues must be removed during cleaning. The blue arrow shows the bottom of the radiator, while the red arrows show where the counterweight attaches on some models.</p>

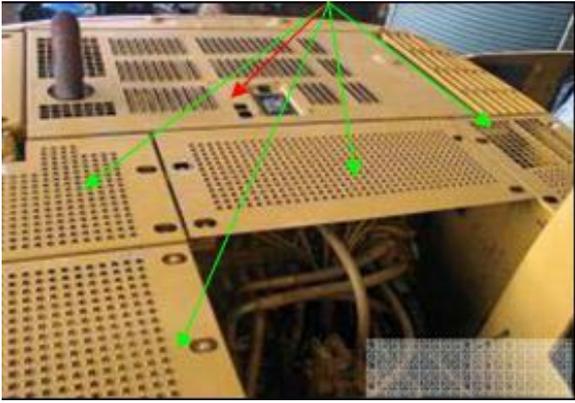
Description	Images
<p>The topside of the engine bay. The red arrow highlights the engine cover that opens, allowing access to the topside of the block. The green arrows highlight the remaining engine covers that are non-affixed and can be dismantled to allow for cleaning and inspection.</p>

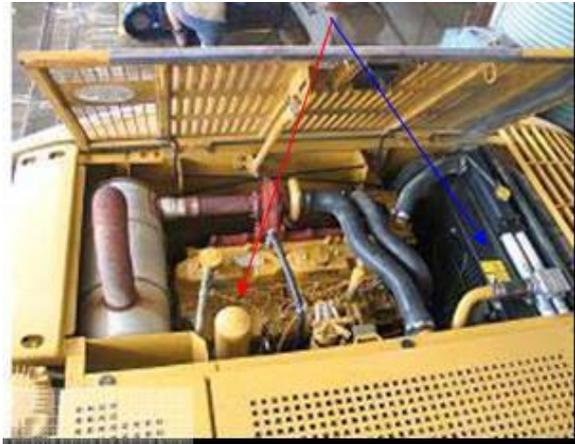
<p>The engine cover open, allowing access to the topside of the engine block (red arrow) and radiator (blue arrow).</p>

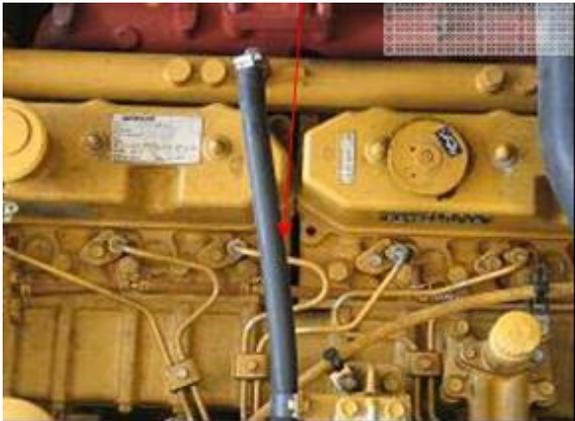
<p>The red arrow highlights a small gap between each tappet cover, which requires thorough cleaning and inspection. Flushing may also be required.</p>

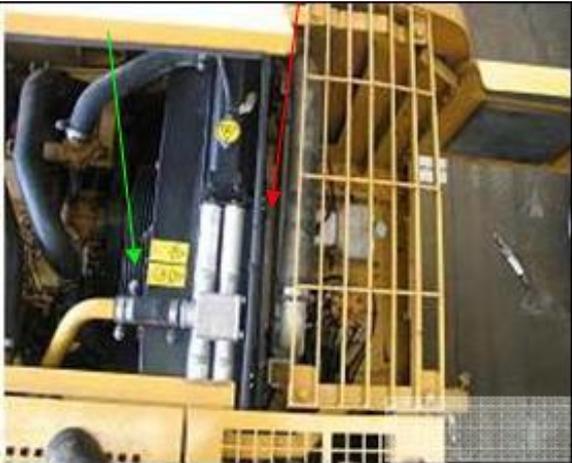
Description	Images
<p>The green arrow highlights the radiator shroud wire grill. This needs to be dismantled to allow access to the inside of the shroud and remove all BRM. The red arrow highlights the small gap between the radiator core and the oil-cooler cores. Check the cores by thorough flushing.</p>

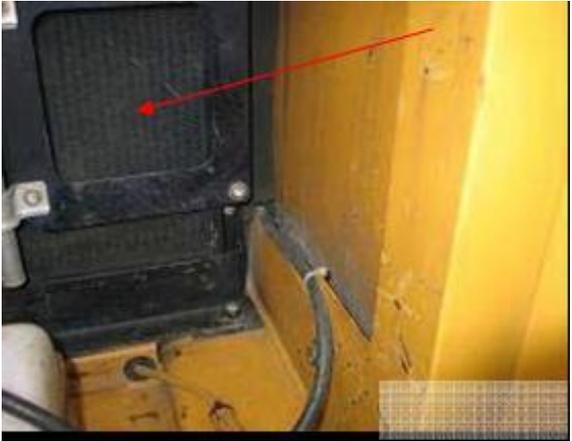
<p>On some models, a mesh grill protects the radiator core. These mesh grills (red arrow) need to be removed as the gauge is small and prevents BRM caught in the radiator fins from being successfully removed.</p>

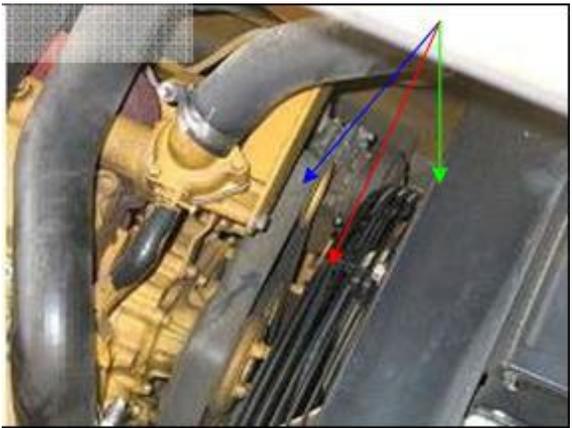
<p>Check the sides of the block, including the harmonic balancers (blue arrow) as BRM can become caught in front of these open ended flywheels. The red arrow indicates the radiator grill, which if still present, prevents access to the bottom of the radiator shroud (green arrow).</p>

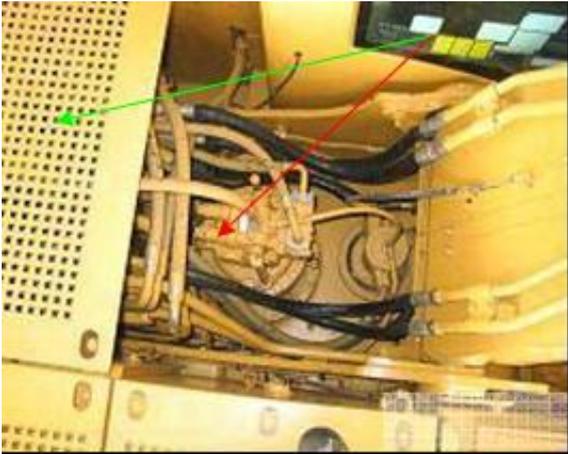
Description	Images
<p>The accumulation of hydraulic hoses (red arrow) situated just behind the boom stick. Sometimes this area may be covered by a non-affixed panel, which will need to be dismantled to allow access. Other non-affixed panels (green arrow) can also be dismantled to facilitate the cleaning and inspection process.</p>

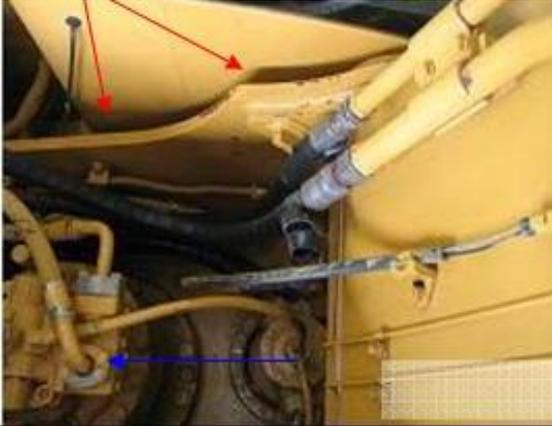
<p>Ensure that the small gap between the cabin wall and the base of the boom stick (red arrows) is cleaned and inspected. BRM can often accumulate inside the small gaps where the hydraulic hoses connect, indicated here by the blue arrow.</p>

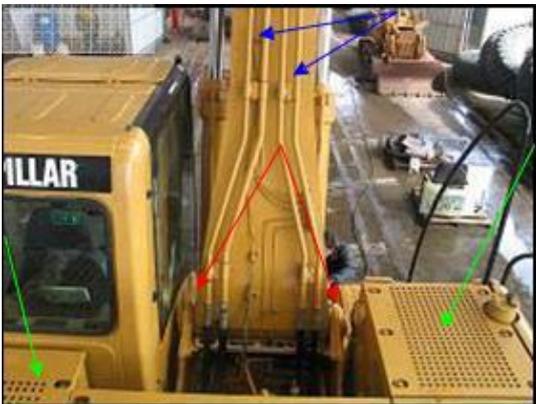
Description	Images
<p>The base of the boom stick and checker-plate above the engine. Ensure all contaminated grease is removed from the pivot-points (red arrows). Flush under all the check-plates as indicated by the green arrows. Check all hydraulic lines and mounting points (blue arrows). The boom can be extended and lowered to address work health and safety concerns (otherwise use scaffolding or cherry picker).</p>

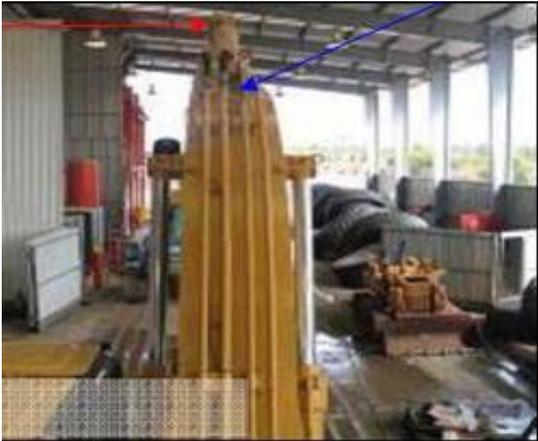
Description	Images
<p>Check along the length of the boom, ensuring all BRM including contaminated grease is removed (red arrow). All hydraulic lines need to be cleaned and inspected (blue arrow).</p>

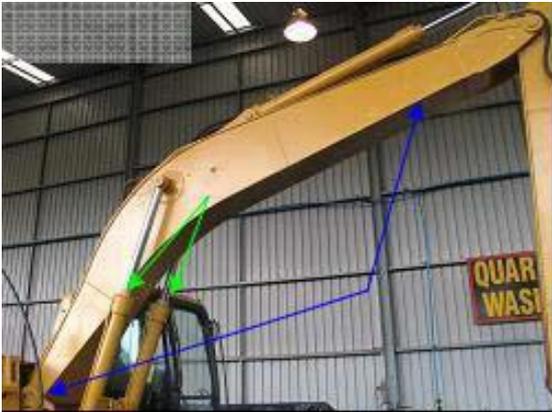
<p>Check along all surfaces, hydraulic rams (green arrows) and for the presence of any drainage holes or openings in the boom stick (blue lines).</p>

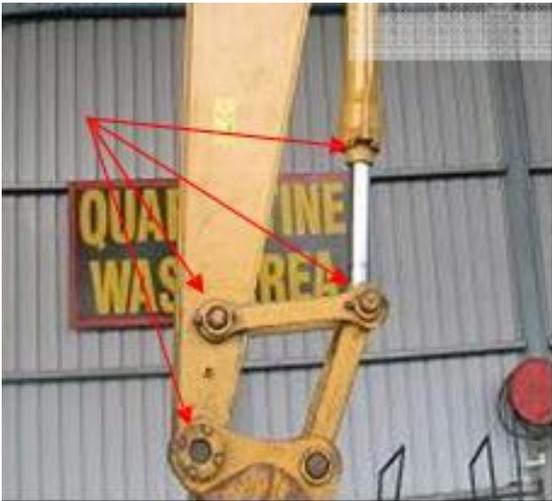
<p>Ensure all rams and pivot points are clean and free of contaminated grease (red arrows).</p>

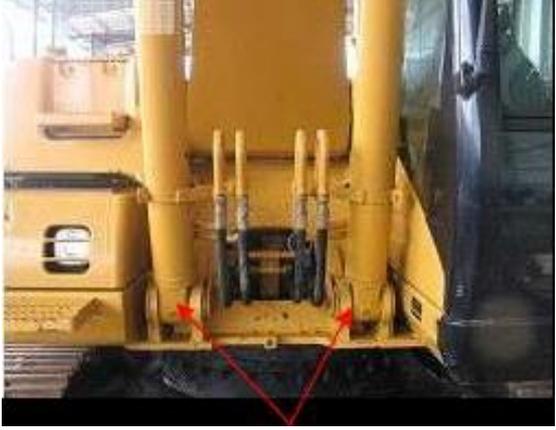
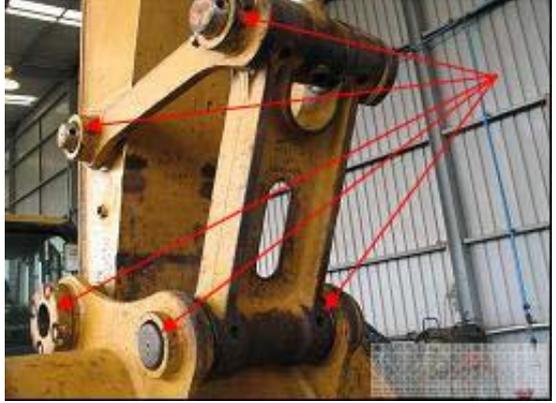
<p>Check all pivot points above the bucket and ensure all contaminated grease is removed (red arrows).</p>

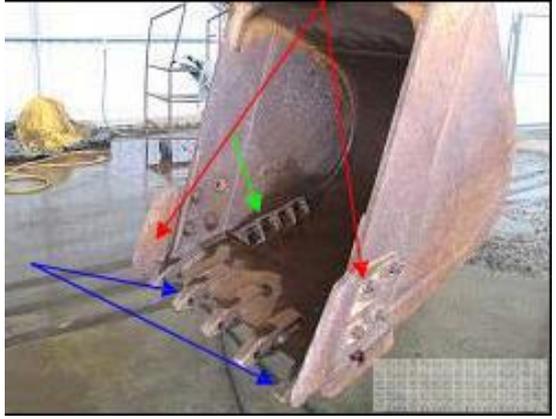
<p>The wear plates (red arrows) either side of the bucket must be either dismantled or at the very least loosened off and flushed behind. All cutting teeth (blue arrows) must be removed and the teeth can be seen here in the bucket (green arrow).</p>

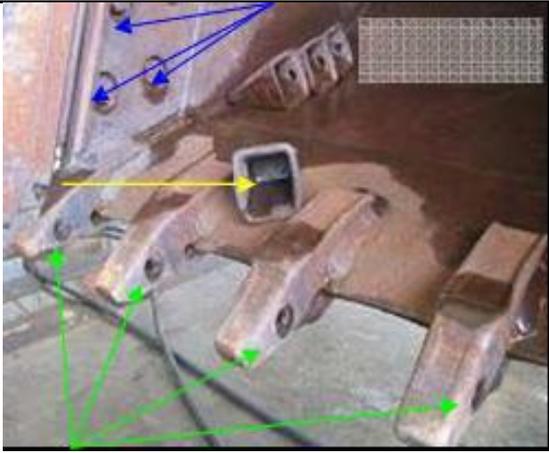
<p>The cutting teeth have been removed, exposing the hole through the centre (green arrows), which cannot be verified while the teeth are still in place. Ensure the countersunk holes (blue arrows) where the wear plates attach are free of all BRM. The yellow arrow shows the inside of the cutting teeth – quick and easy to verify if presented in this manner.</p>

<p>A close-up photograph of the cutting teeth of an excavator bucket. Several blue arrows point to a narrow opening between the teeth. A yellow arrow points to a small rectangular component. Green arrows point to the circular pinholes on the teeth.</p>
<p>A close up of the boots and where the cutting teeth are mounted. Ensure around each pinhole is clean (green arrows). The blue arrows highlight a narrow opening that tends to become compacted with BRM and can be overlooked if the cutting teeth are still attached.</p>

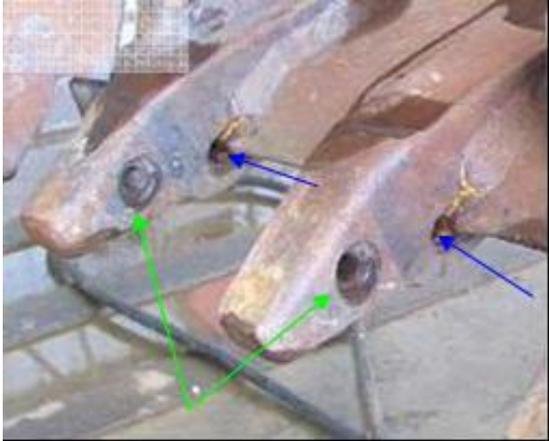
<p>A close-up photograph of the excavator boots. Blue arrows point to a narrow opening between the boots. Green arrows point to the circular pinholes on the boots.</p>
<p>Evidence of a crack/split (blue arrow) in the wear plate on the underside of the bucket. Side wear plates (yellow arrow) need to be either removed or loosened and flushed. Cutting teeth (aqua arrows) must be removed at the time of inspection.</p>

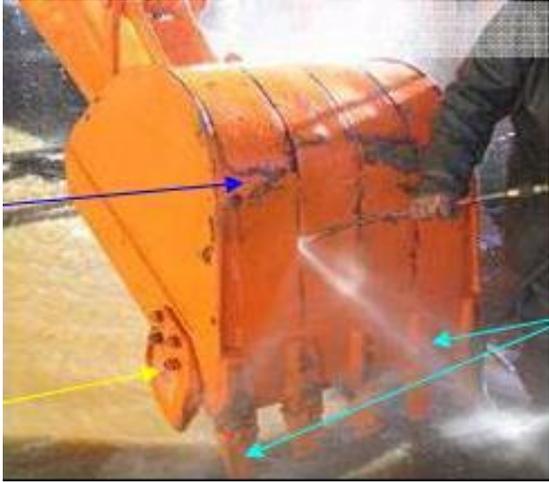
<p>A photograph of an excavator bucket being inspected. A blue arrow points to a crack in the wear plate. A yellow arrow points to a side wear plate. Aqua arrows point to the cutting teeth. A person's leg is visible on the right side of the bucket.</p>

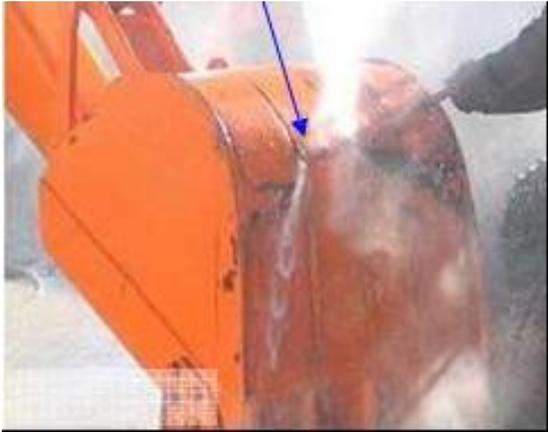
Description	Images
<p>If wear plates are only spot-welded as seen in the examples above, ensure that these are verified. For example; by witnessing high-pressure water being flushed through (blue arrow).</p>

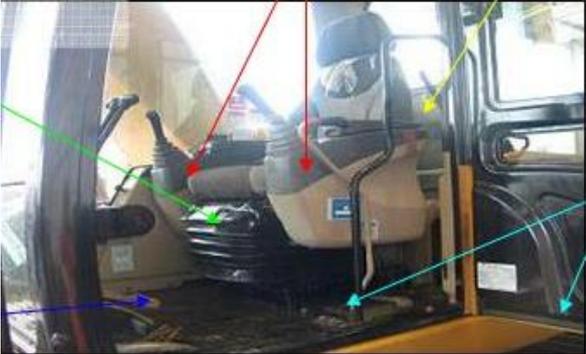
Description	Images
<p>Landscape shot of the inside of a typical cabin. Access is required to verify the cleanliness of the internal workings or the joystick controls (red arrows). The seat shroud (green arrow) must be internally and externally cleaned and inspected. Floor mats must be removed (blue arrow).</p>

<p>A wide-angle photograph of the excavator's operator cabin. The seat is in the center, with joystick controls on the left. A red arrow points to the joystick control panel, a green arrow points to the seat shroud, and a blue arrow points to the floor mat area. A yellow arrow points to the seat base.</p>
<p>Access will be required to check the internal workings of the joystick control panels (red arrow).</p>

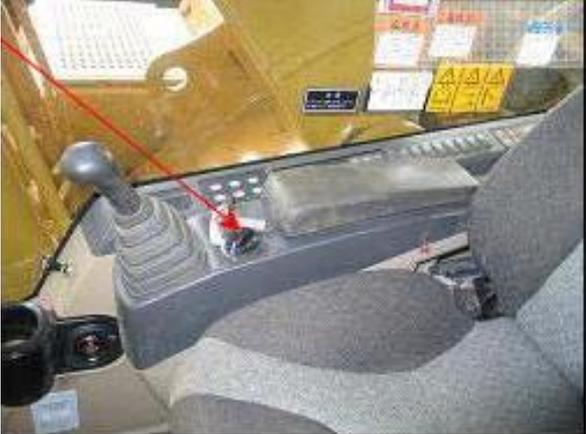
<p>A close-up view of the joystick control panel. A red arrow points to the internal mechanism of the joystick. The panel is grey and has several buttons and switches.</p>

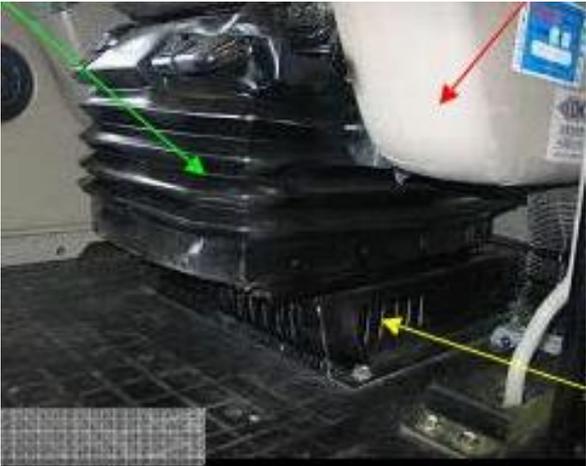
<p>The box section below the seat needs to be thoroughly cleaned (yellow arrow). Proper access can only be achieved once the four bolts are removed and the seat moved. Access into the joystick control panels (red arrow) is required. Inside the seat shroud (green arrow) must be cleaned and inspected.</p>

<p>A close-up view of the seat base and joystick control panel. A red arrow points to the joystick control panel, a green arrow points to the seat shroud, and a yellow arrow points to the box section below the seat. The seat is white and has a blue label on it.</p>

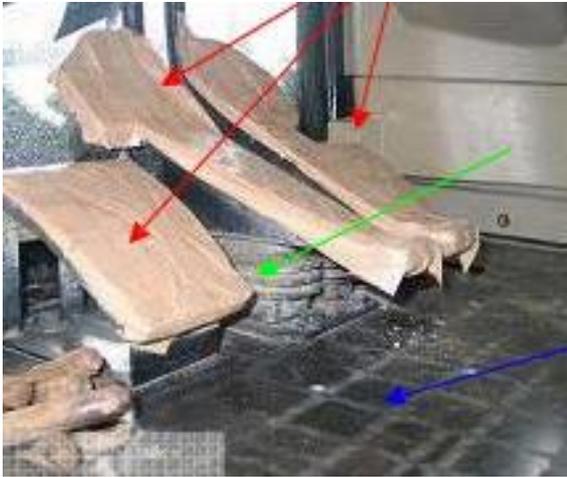
A photograph of the interior of an excavator cab. The view is from the operator's perspective, looking towards the front window. The dashboard and control panel are visible. Three arrows point to specific areas: two red arrows point to air vents on the dashboard, and one blue arrow points to a storage compartment below the dashboard.
<p>If rubber or plastic foot pedal covers (red arrows) are in place, remove and clean. Rubber shrouds below pedals (green arrow) must also be verified clean inside. Under the floor mat must be clean (blue arrow).</p>

A close-up photograph of the foot pedals in an excavator cab. There are several wooden or cardboard covers on the pedals, indicated by red arrows. A green arrow points to the rubber shroud below the pedals. A blue arrow points to the floor mat area.

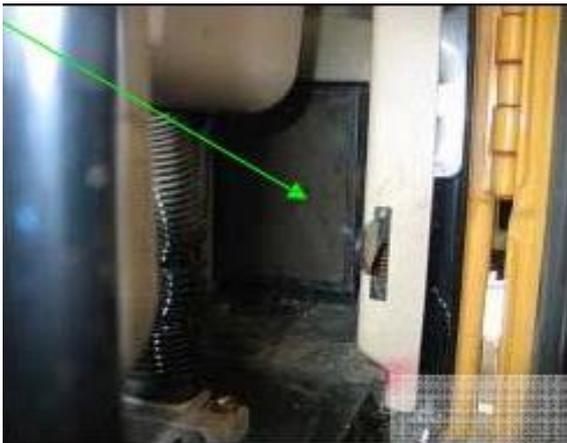
<p>Located behind the seat in some models is the air-conditioning filter (green arrow). The filter must be removed, the filter and surrounding area cleaned and verified.</p>

A close-up photograph of the air-conditioning filter located behind the seat in an excavator cab. A green arrow points to the filter, which is a cylindrical, pleated component.

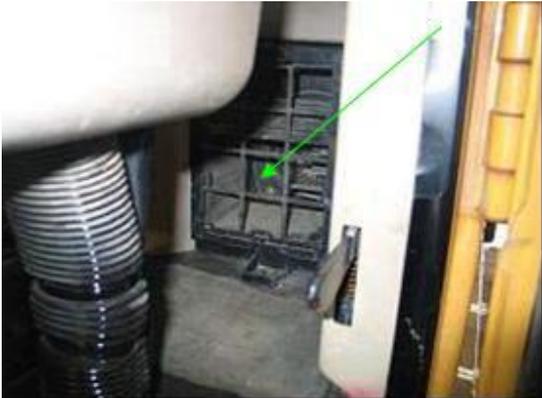
Description	Images
<p>The filter has been removed (green arrow), revealing BRM inside which must be removed.</p>

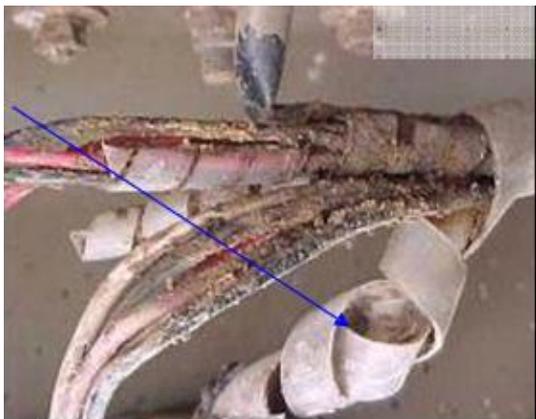
Description	Images
<p>Ensure that all looming (blue arrow) around hydraulic hoses and lines is free of all BRM. Flushing these areas with the looming still in place rarely removes all BRM as can be seen in this illustration.</p>

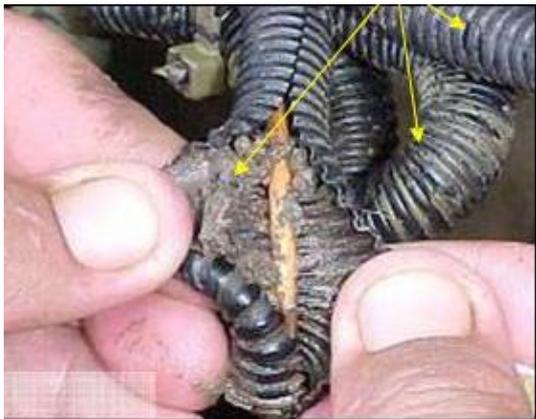
<p>All wiring harnesses (yellow arrows) must be thoroughly inspected for internal BRM as seen in this image.</p>

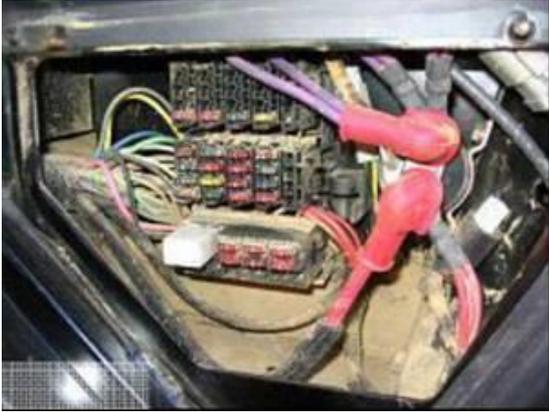
Description	Images
BRM inside the fuse box must be removed.

A photograph showing the interior of a fuse box. The box is open, revealing a complex arrangement of electrical components. In the center, there is a fuse block with several fuses. To the right, there are two prominent red components, possibly relays or solenoids, connected to thick red wires. Various other colored wires (yellow, green, blue, purple) are visible, some bundled together. The background shows the metal structure of the fuse box and some internal wiring harnesses.
