Australian Government
Department of Agriculture
and Water Resources

Machinery Cleaning Guide - Skid Steer Loaders/Bobcats

April 2016

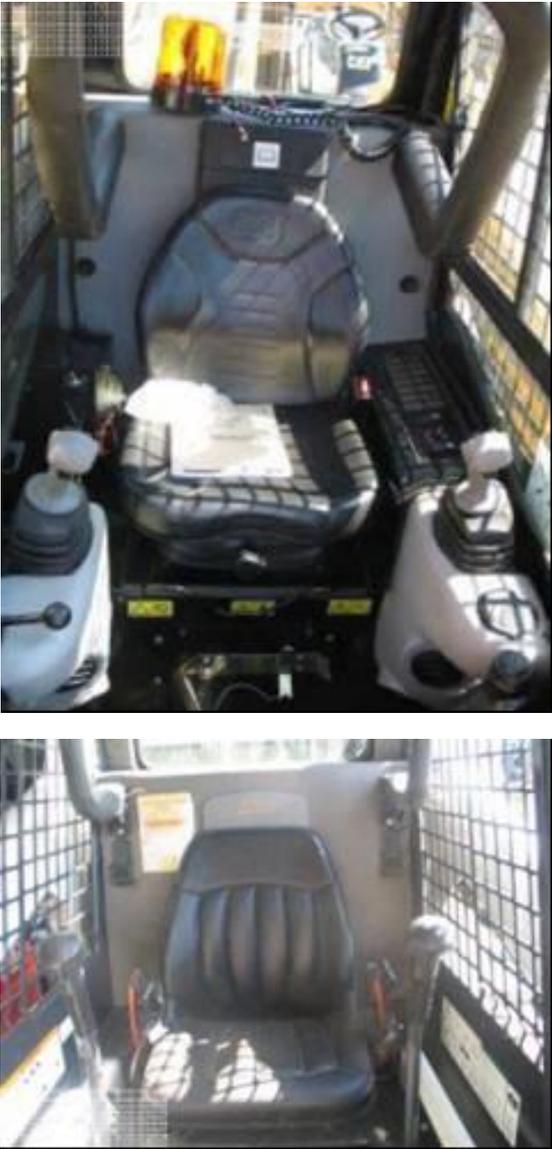
Description	Images
<p>These illustrations highlight the cabins of different skid steers. Some are more complex and enclosed with air-conditioning as shown in top image, while in bottom image a very simple example is provided. Examples of how to clean the cabins and present these machines for inspection follows.</p>

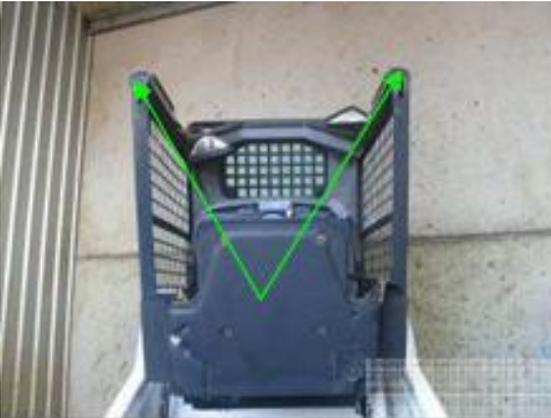
Description	Images
<p>On most models the housing, including the seat can be hydraulically lifted, exposing the back of the engine block and housing under the seat. While the cabin is elevated, check for any drainage holes on the cabin frame (green arrows) and flush to verify internal cleanliness.</p>

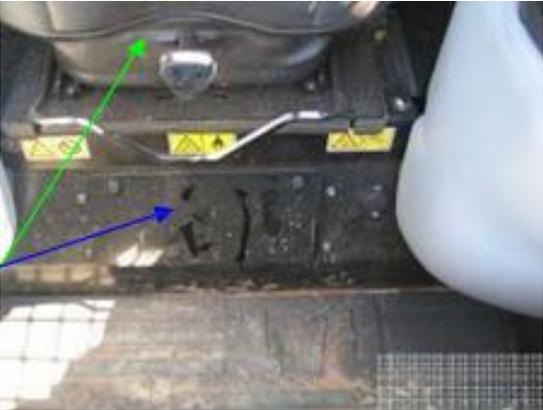
<p>On other models, the box section under the seat may be accessible via small non-affixed plates like the one illustrated by the blue arrow. The rubber seat shroud (green arrow) must be thoroughly cleaned both inside and out.</p>

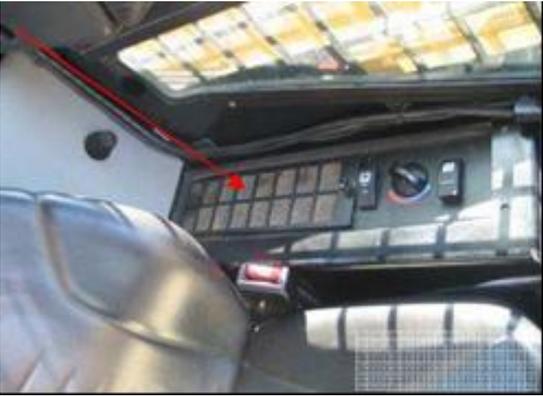
Description	Images
<p>Remove all air-conditioning filters (red arrow) from inside the cabin and clean. These areas must be accessible for inspection.</p>

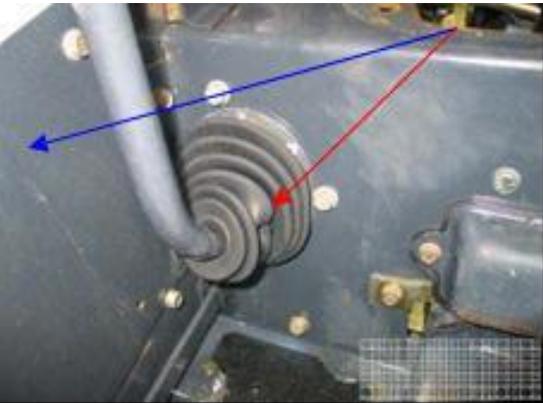
<p>All rubber shrouds (red arrow) must be cleaned (check for cracks or splits) and all non-affixed panels (blue arrow) must be removed for internal cleaning and all areas are to be accessible at the time of inspection.</p>

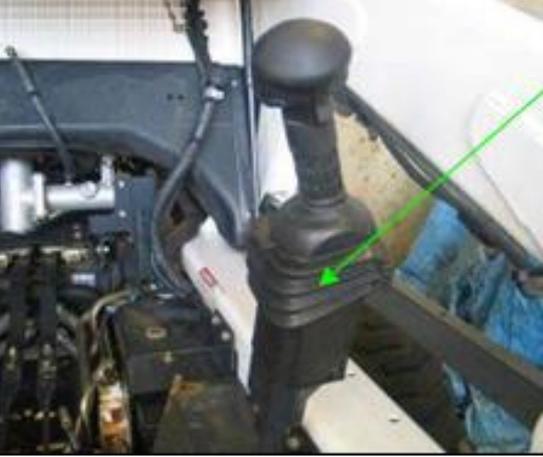
<p>Check all rubber shrouds on joystick controls (green arrow), externally and for any cracks or splits which could allow biosecurity risk material inside.</p>

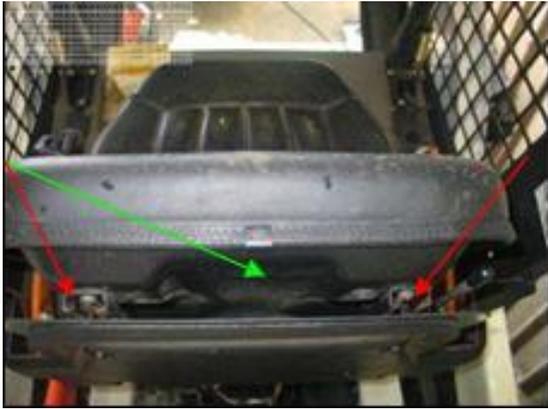
Description	Images
Clean along the seat running tracks (red arrows) and under the seat (green arrow).

A photograph showing the rear view of a vehicle seat. A green arrow points to the underside of the seat, and two red arrows point to the seat tracks on either side.
On some models a small sunroof may be present (red arrow). Ensure that all rubbers and seals around the sunroof are clean.

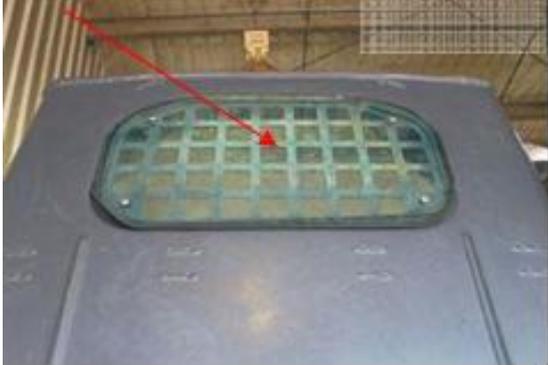
A close-up photograph of a sunroof on a vehicle. A red arrow points to the rubber seal around the sunroof.

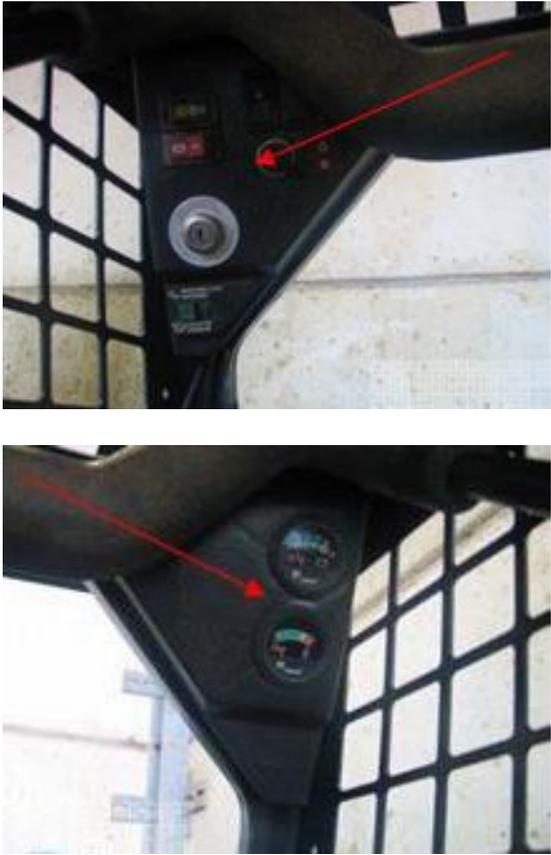
Description	Images
<p>From inside the cabin, most skid steer loaders have gauges or instrument panels (red arrows) mounted to the vertical housing. Biosecurity risk material can easily enter behind these gauges and the areas behind, must be cleaned and accessible at the time of inspection.</p>

<p>The top photograph shows a close-up of the vertical housing in the skid steer loader cabin. A red arrow points to a gauge or instrument panel mounted on the housing. The bottom photograph shows a similar view from a slightly different angle, with a red arrow pointing to another gauge or instrument panel on the vertical housing.</p>
<p>This centre switch panel cover (red arrows) must also be internally examined for cleanliness.</p>

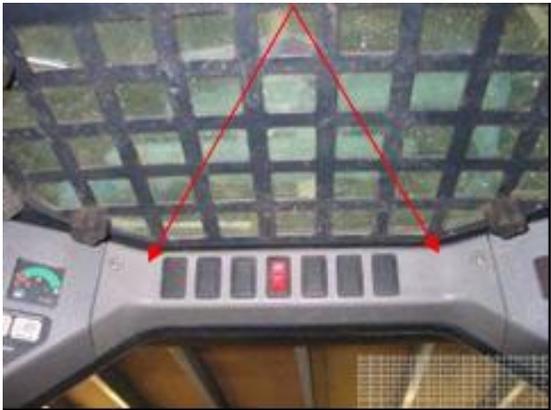
<p>The photograph shows the interior of the skid steer loader cabin, focusing on the center console. A red triangle is drawn over the center switch panel cover, indicating that it must be internally examined for cleanliness.</p>

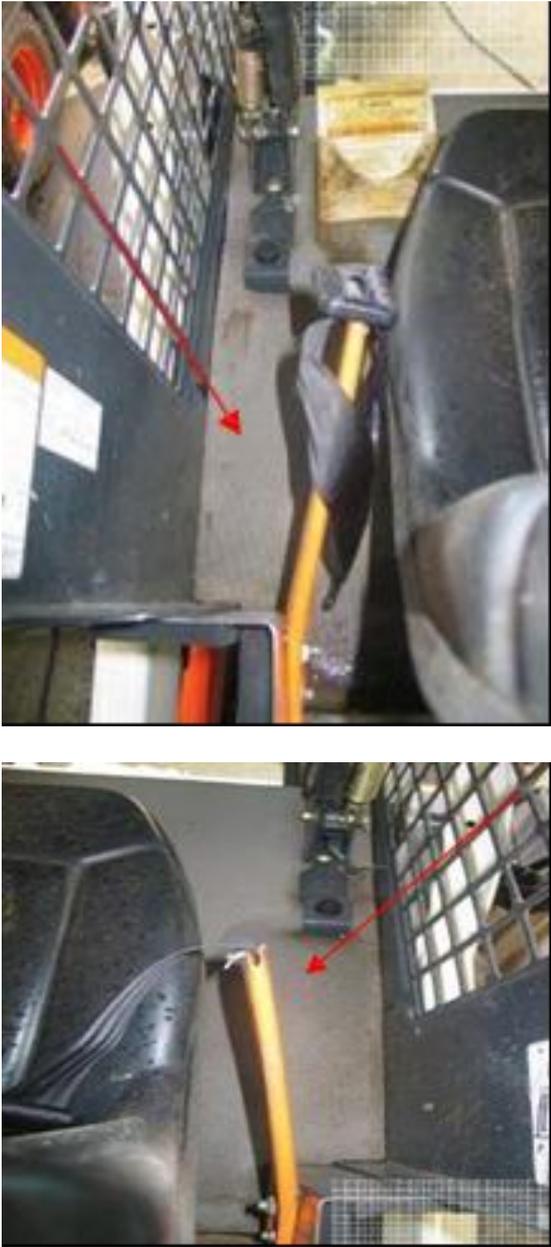
Description	Images
<p>Highlights the insulation cover (red arrows) behind the seat inside the cabin. The glue holding these in place generally becomes redundant over time and any biosecurity risk material found behind must be removed.</p>

<p>The images consist of two photographs showing the interior of a skid steer loader cabin. The top photograph shows a red arrow pointing to a yellow insulation cover behind a seat. The bottom photograph shows a red arrow pointing to a yellow insulation cover behind a seat.</p>

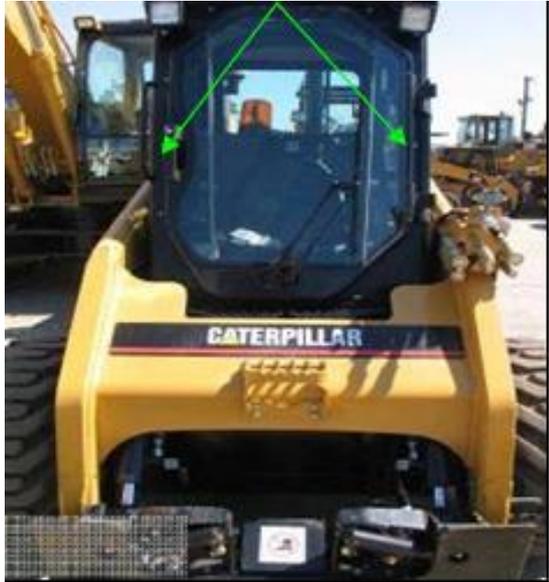
<p>The external of the sealed, air-conditioned cabin. Check all windows and sills (green arrows) for biosecurity risk material.</p>

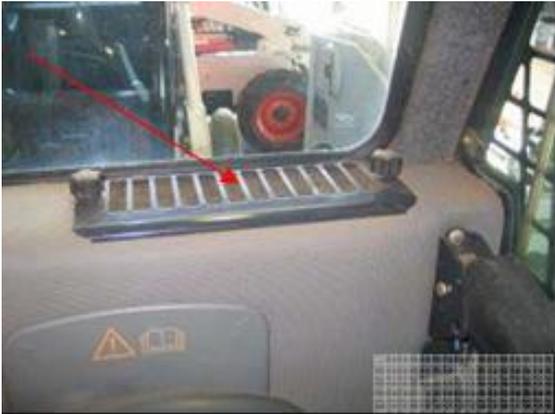
Description	Images
<p>Another example of an internal air-conditioning vent (red arrow) that must be removed for cleaning and inspection.</p>

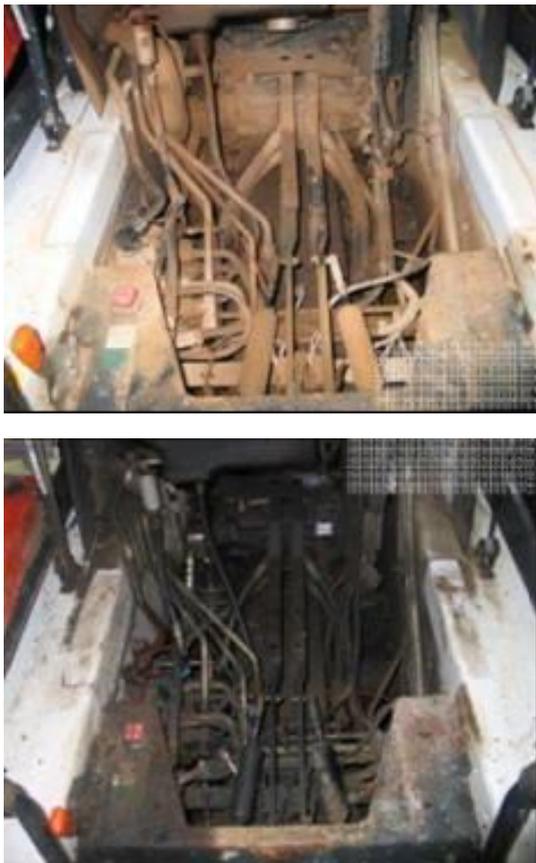
Description	Images
<p>Several examples of the confined space under the cabin floor of the skid steer loader. This area can harbour significant amounts of biosecurity risk material (as highlighted). Most skid steer loaders have non-affixed belly plates which makes the removal of biosecurity risk material from under the cabin very difficult. To remove all biosecurity risk material, the skid steer may have to have the front end raised on ramps, allowing the biosecurity risk material to be flushed out the rear.</p>

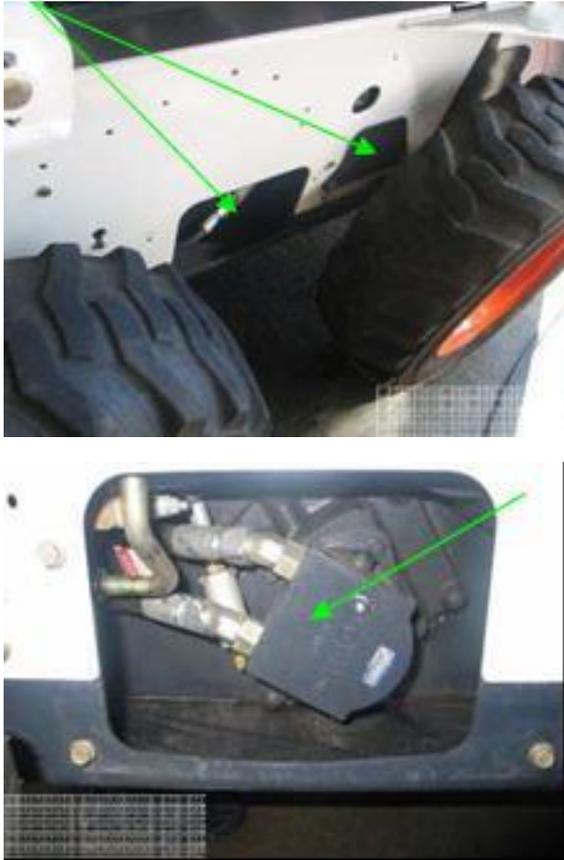
Description	Images
<p>The following photos demonstrate how on some models the side panels can be removed (green arrows), allowing cleaning and inspection access under the cabin. Removing these panels is not possible on all models of skid steer.</p>

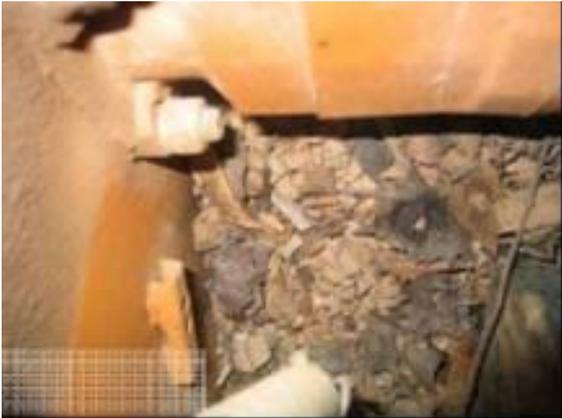
Description	Images
<p>This image illustrates the amount of biosecurity risk material that can be found under the foot pedal of a skid steer loader.</p>

A close-up photograph showing a significant amount of dark, clumpy, and moist soil or organic matter accumulated underneath a metal foot pedal of a skid steer loader. The material is piled up against the underside of the pedal's housing.
<p>On the floor under the cabin large amounts of biosecurity risk material can be seen in this illustration (green arrow). All biosecurity risk material including plant material and contaminated grease must be removed.</p>

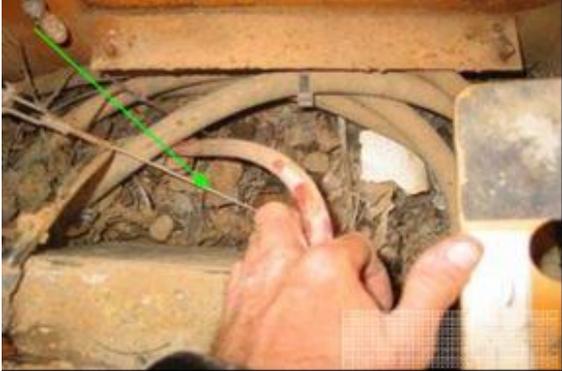
A photograph taken from inside the operator's cabin, looking down at the floor. A hand is visible in the foreground, and a green arrow points to a large, dark, and messy pile of soil and organic debris on the floorboards. The debris appears to be a mix of dirt, plant matter, and possibly grease.

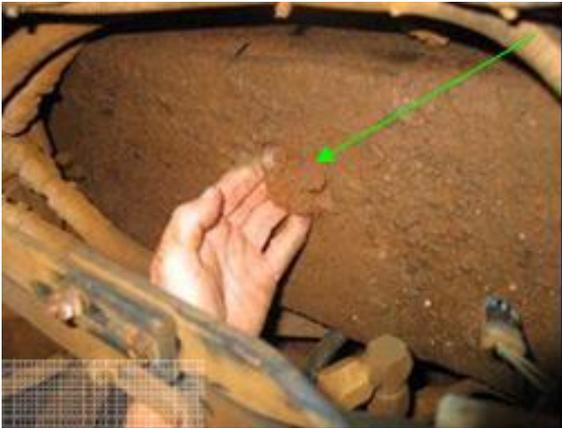
<p>The internal walls under the cabin must be free of all biosecurity risk material. This illustration highlights the amount of biosecurity risk material that can be found under the cabin (green arrow).</p>

A photograph showing the interior wall of the skid steer loader's cabin. A hand is holding a small, dark, clumpy piece of soil or organic matter. A green arrow points to this piece, which is being held up to show its texture and color. The background shows the dark, textured surface of the cabin's internal wall.

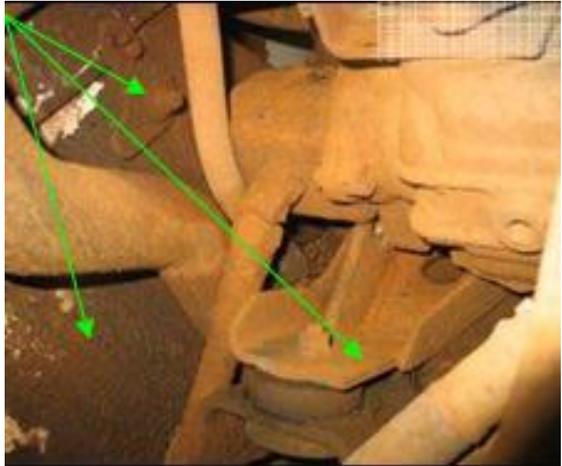
A photograph showing the underside of the vehicle cabin. Several green arrows point to various surfaces, including metal plates and structural components, which are heavily covered with a thick, brownish, crumbly residue, illustrating the amount of biosecurity risk material that can accumulate.

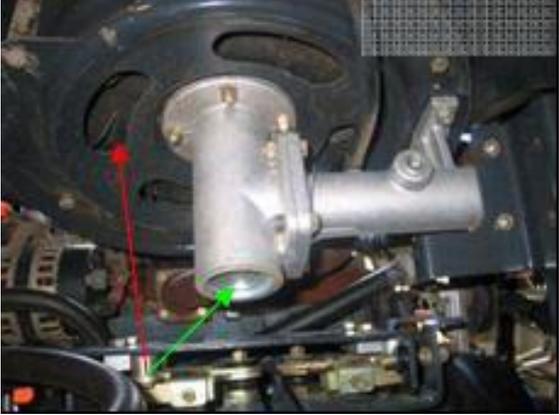
<p>Illustrates the underside of the radiator fan (red arrow), which can be located once the cabin floor has been lifted. All internal surfaces and open-ended tubing (green arrow) must be verified clean.</p>

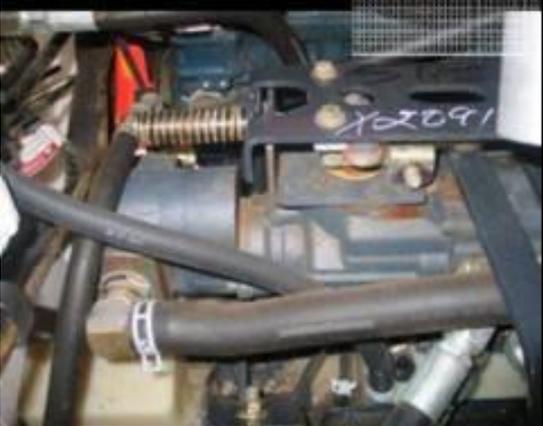
<p>The front of the engine block as seen from under the cabin. This area is very congested with numerous nooks and ledges that will require thorough cleaning and possibly inspection with a flexible mirror.</p>

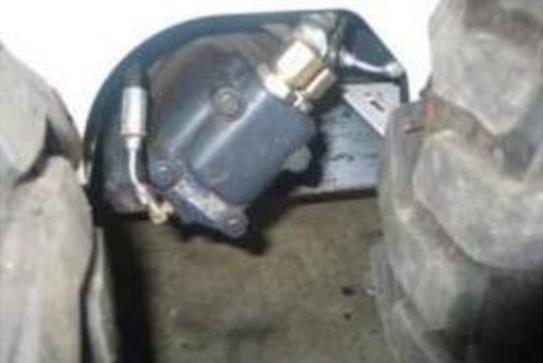
<p>On this model an opening on the side of the skid steer can be found, allowing the contaminants removed from inside, an exit point.</p>

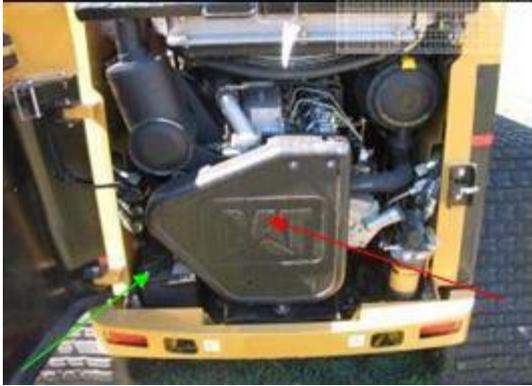
Description	Images
<p>This image highlights the rear of the engine block and surrounding housing. This area is very congested; however some dismantling can facilitate the process. The plastic shroud (red arrow) and the battery (green arrow) can be removed to allow greater cleaning and inspection access.</p>

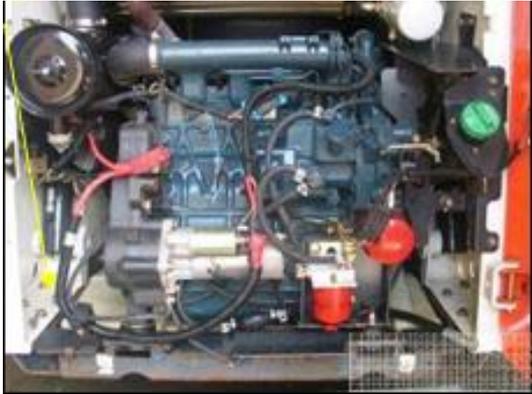
<p>Another example of skid steer engine block. The battery has been removed (yellow arrow) and all non-affixed components have been removed, allowing greater cleaning and inspection access.</p>

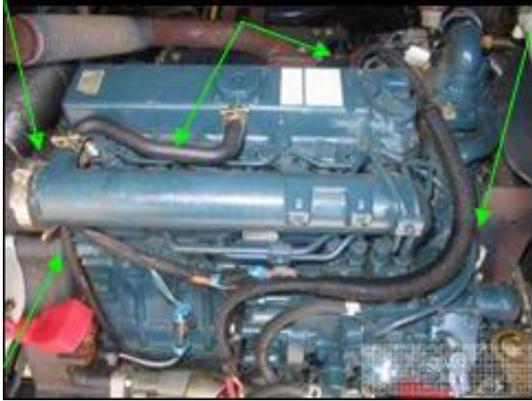
Description	Images
<p>The rear and sides of the engine block (green arrows) can easily be cleaned and inspected, particularly with a 90 degree lance and flexible inspection mirrors.</p>

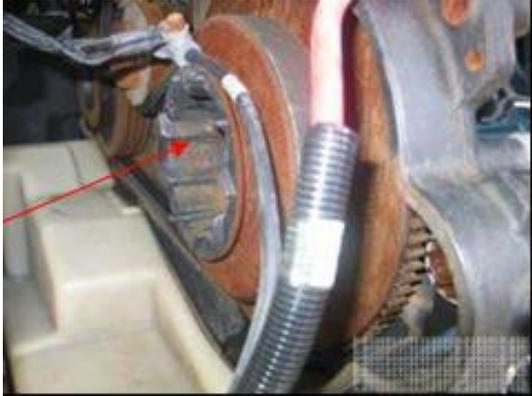
<p>The harmonic balancer (red arrow) is accessible once the plastic shroud has been removed. Most flywheels are concave and can harbour a significant amount of biosecurity risk material and must be verified.</p>

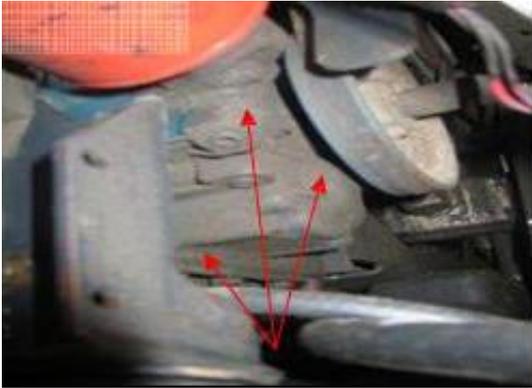
<p>Under the harmonic balancer, the underside of the block (red arrows) may be accessible. All contaminated grease and residues must be removed.</p>

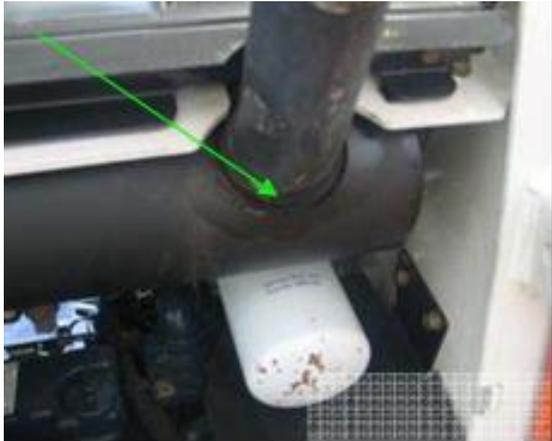
Description	Images
<p>On some models the exhaust housing has an outside shroud with only a small access point highlighted by the green arrow. If present, areas like these must be flushed to verify cleanliness.</p>

A close-up photograph of a dark-colored exhaust housing. A green arrow points to a small, circular access point on the side of the housing. Below the housing, a white cylindrical component is visible.

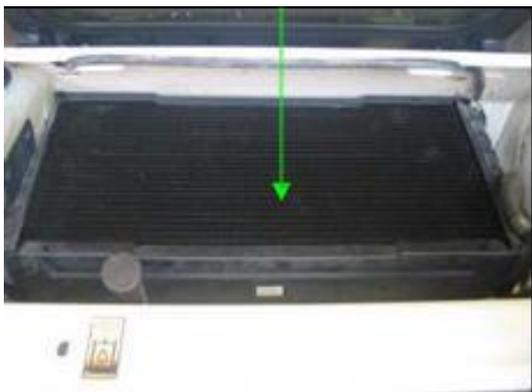
A photograph showing the radiator core after the grill has been removed. A green arrow points to the radiator core. The core is black and has a grid-like structure.

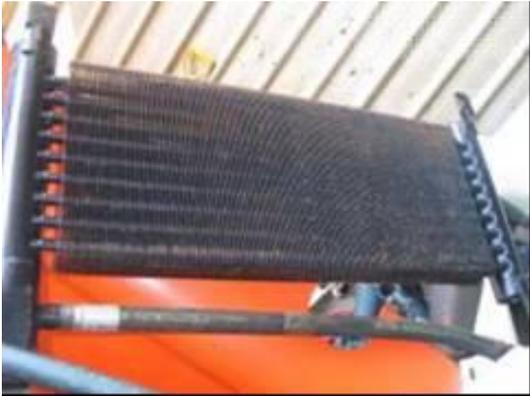
Description	Images
<p>This image highlights the radiator cooling fins. This unit has been unbolted for ease of flushing and inspection.</p>

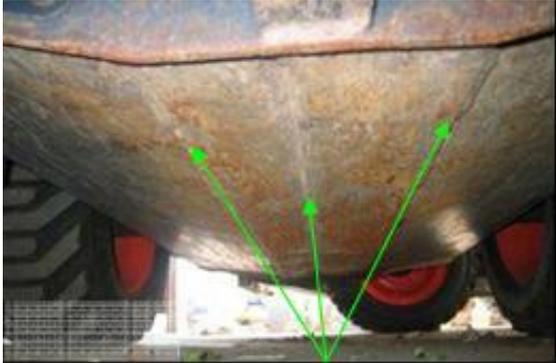
Description	Images
<p>The underbelly of a typical skid steer loader (green arrows). These belly plates are generally affixed therefore making the removal of biosecurity risk material from inside very difficult. On this model, the plates are seam welded and all biosecurity risk material, even minor, must be removed from along the seams.</p>

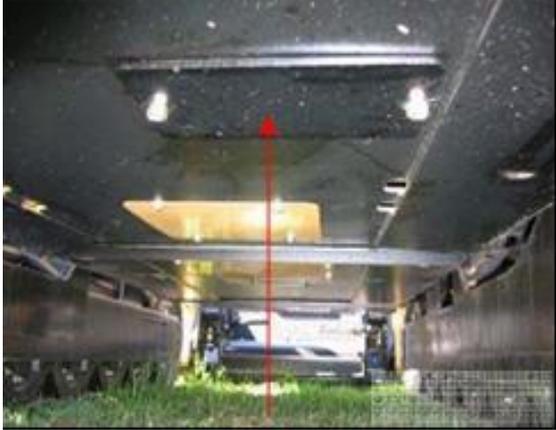
<p>This underbelly is from a tracked model skid steer loader (red arrow). On this model there are several non-affixed panels that can be easily removed, allowing cleaning and inspection access as well as providing exit points for biosecurity risk material under the cabin.</p>

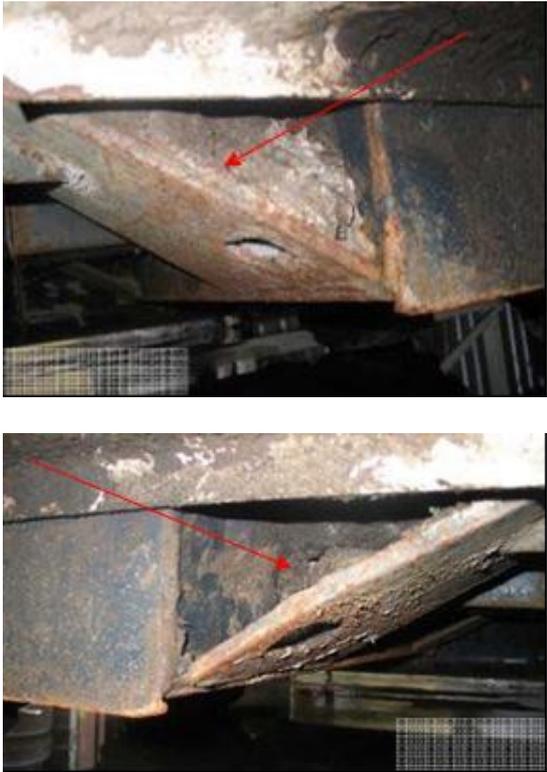
Description	Images
<p>These illustrations highlight brackets (red arrows) that can be found under the rear on some models. These areas can harbour significant amounts of biosecurity risk material as highlighted and therefore require checking to verify cleanliness.</p>

<p>The first image shows a close-up of a metal bracket under the rear of a skid steer loader, with a red arrow pointing to it. The second image shows a similar bracket from a different angle, also with a red arrow pointing to it.</p>
<p>Another example of a small drainage hole (red arrow) on the underside. These drainage holes can be used to flush out all biosecurity risk material removed from under the cabin.</p>

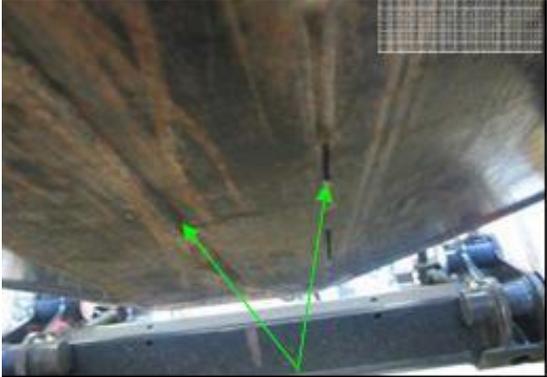
<p>The image shows a close-up of the underbelly of a skid steer loader, with green arrows pointing to small seams or gaps in the metal structure.</p>

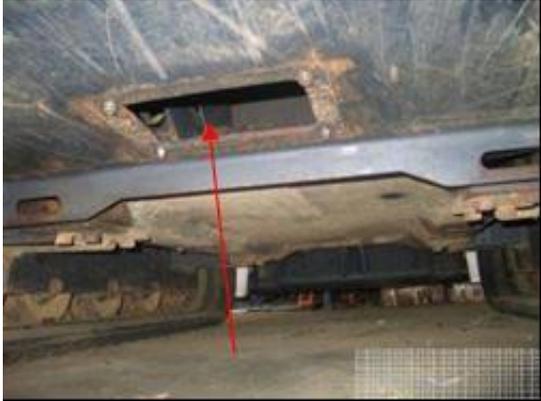
Description	Images
<p>Another small non-affixed plate (red arrow) that can be removed to facilitate the cleaning and inspection process.</p>

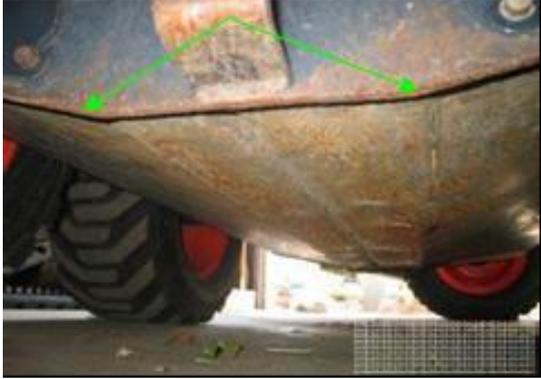
<p>Although not present on this or all skid steers, check all outside surfaces of the housing for any drainage holes that may be plugged. When present, they may be positioned where the green arrows highlight.</p>

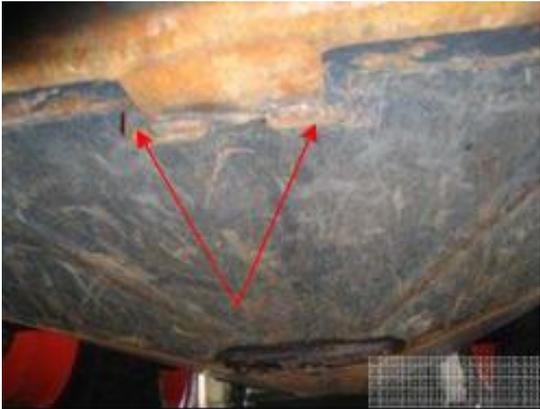
Description	Images
<p>On this model, two small drainage holes can be seen highlighted by the red arrows. These are only small openings and in this instance, they have been clogged with biosecurity risk material to the point where they are hardly noticeable.</p>

A close-up photograph of a metal surface, likely the underside of a vehicle. Two small, circular drainage holes are visible, each highlighted by a red arrow. The surface appears to be covered in a layer of dirt or biosecurity risk material, making the holes difficult to see.
<p>This illustration highlights another underside design where the ledges (red arrows) provide areas for biosecurity risk material to be harboured. All must be verified clean.</p>

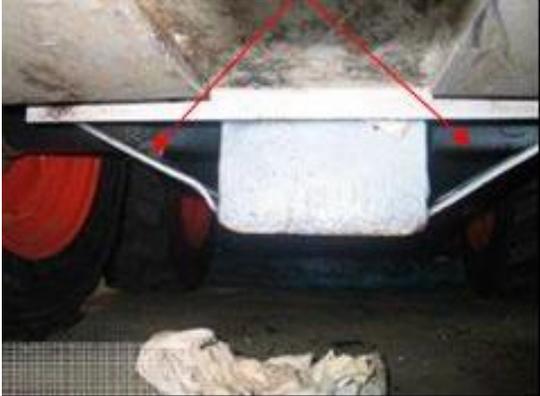
A photograph showing the underside of a vehicle chassis. A white metal ledge is visible, with two red arrows pointing to its edges. The area is cluttered with various components, including a red wheel and a white plastic container, and appears to be harboring biosecurity risk material.

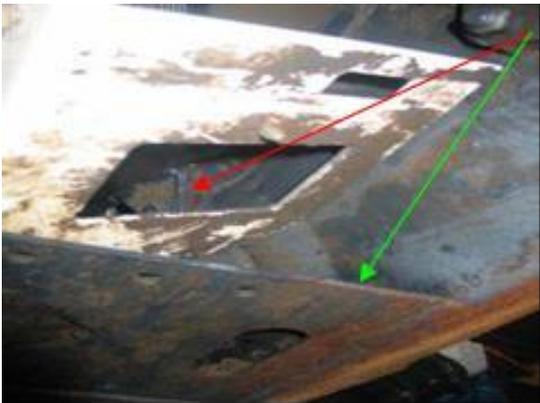
<p>Another non-affixed panel removed (red arrow) and a gusset (green arrow) that can harbour biosecurity risk material. All must be verified clean.</p>

A close-up photograph of a metal gusset and a removed panel. A red arrow points to a small, dark, rectangular panel that has been removed from the metal surface. A green arrow points to a gusset, which is a structural reinforcement that can harbour biosecurity risk material.

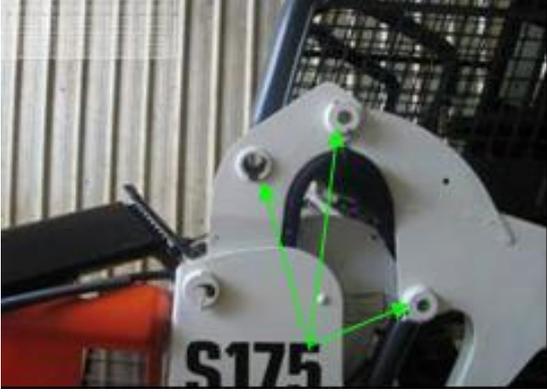
<p>Another illustration of the countersunk pivot points (green arrows) of the push arms that must be checked and free of all biosecurity risk material.</p>

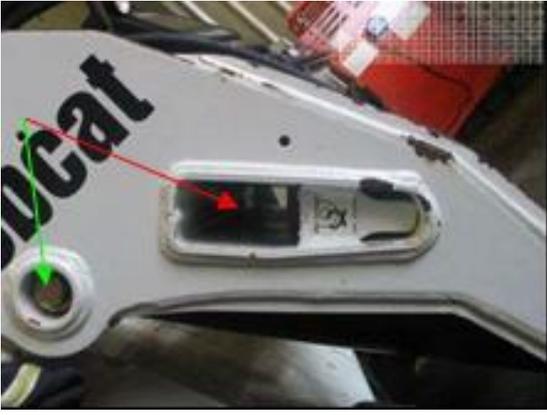
<p>Another illustration of the countersunk pivot points (green arrow). On some models, the crossbar between the two push arms (red arrow) is hollow and must be verified free of all biosecurity risk material.</p>

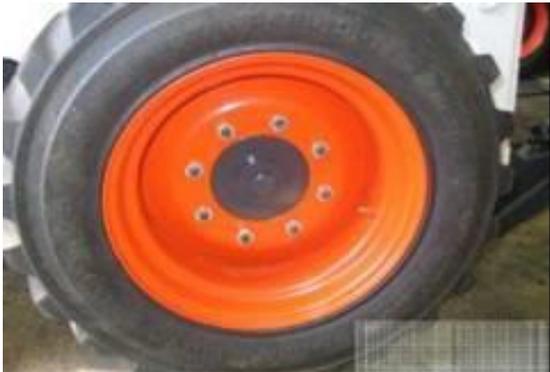
Description	Images
<p>The outside wheel rim found on a typical skid steer loader. Not complex, but must be clean. All cracks and splits in any tyres must be free of biosecurity risk material.</p>

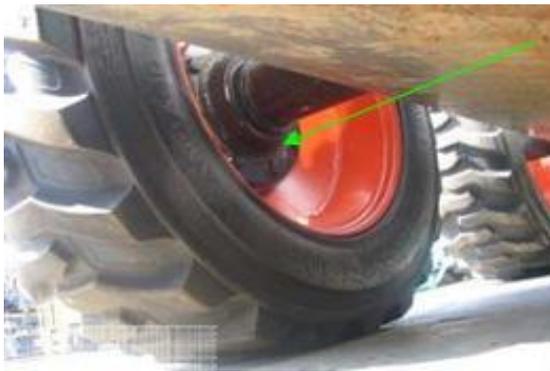
<p>The inside wheel rim. Not complex, but again all surfaces must be free of all biosecurity risk material.</p>

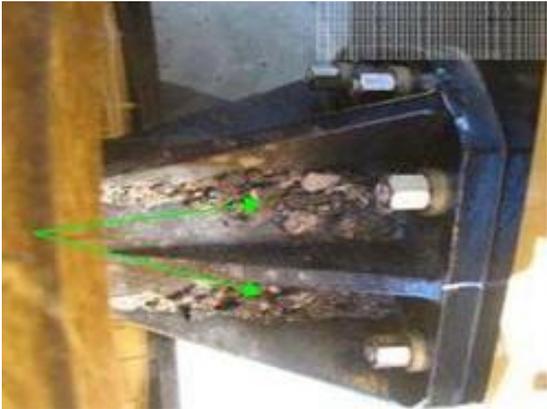
Description	Images
<p>Most wheel axles are round on the skid steers, however on this model several gussets (green arrows) can be seen in this illustration, harbouring biosecurity risk material. All must be removed.</p>

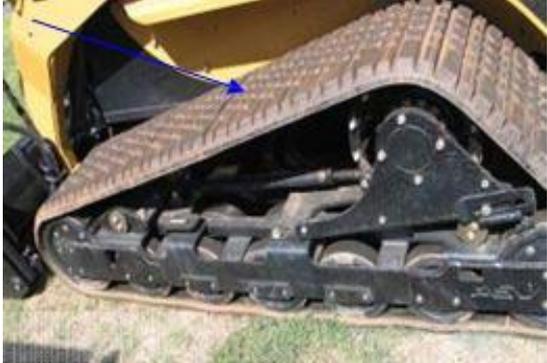
<p>On some of the latest models the rollers are not enclosed, making cleaning and inspection access easier. Each roller and the limited housing still require thorough cleaning and inspection. The track pads must undergo one full revolution to enable full inspection (blue arrow).</p>

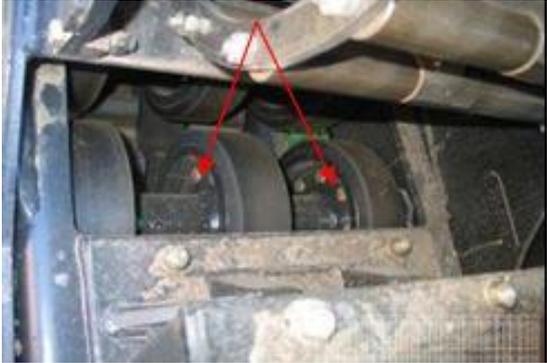
<p>Each individual roller (red arrows), both inside surfaces and out, must be thoroughly cleaned and inspected.</p>

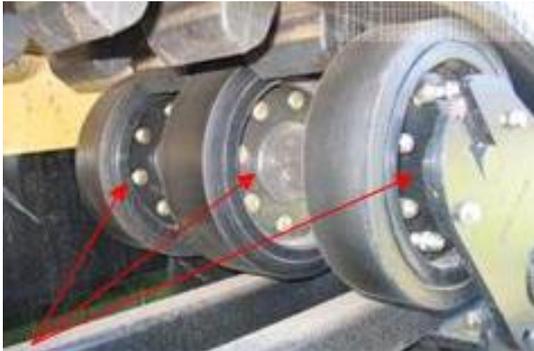
Description	Images
The carrier rollers (red arrows) must also be thoroughly cleaned and inspected.

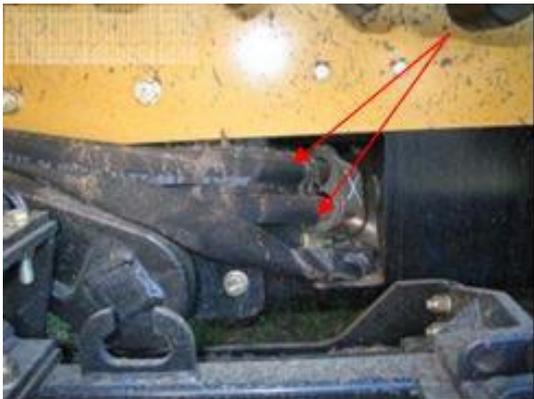
Description	Images
On the tracked models, the hydraulic hoses (red arrows) may enter the side via access holes. All hydraulic hoses must be verified clean.

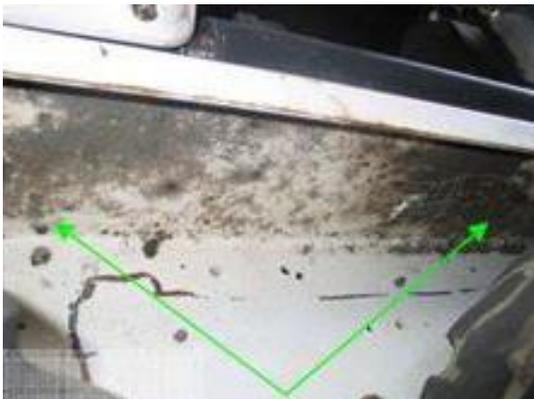
If a wheel arch (green arrows) is present, these must be free of all biosecurity risk material, with particular emphasis on the underside required.

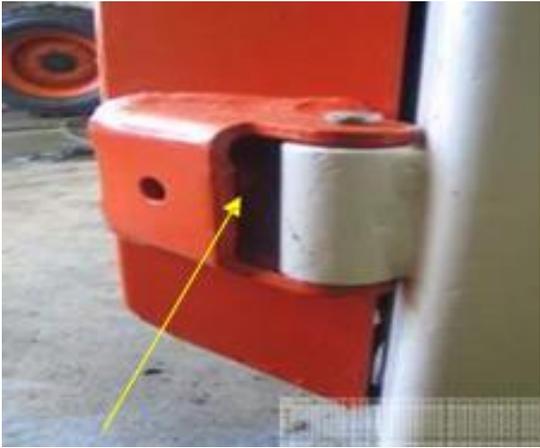
Description	Images
<p>The hinges on the rear door have a small recess (yellow arrow) and must be verified clean.</p>

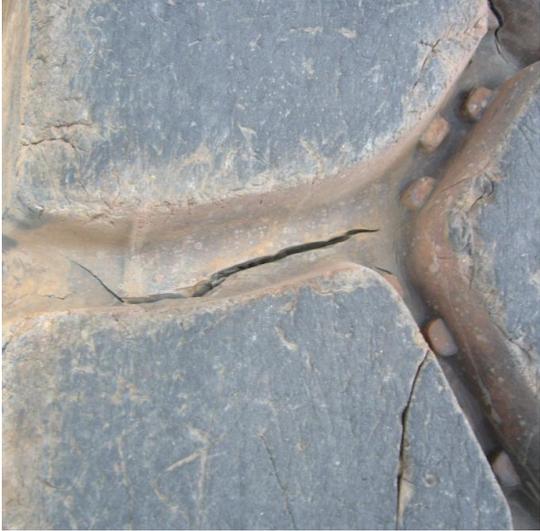
<p>All skid steer tyres must be checked for cracks and splits. If any cracks or splits are present, then all must be verified free of biosecurity risk material.</p>

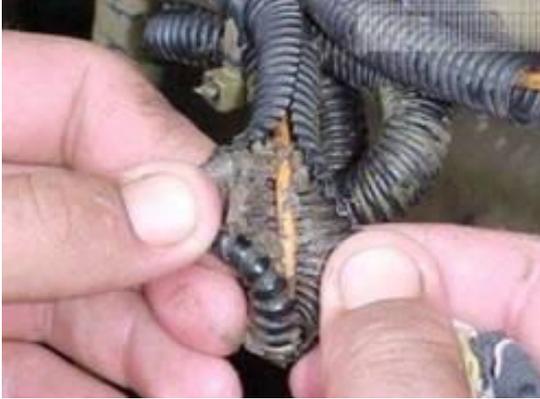
<p>All wiring harnesses are to be carefully cleaned and inspected.</p>

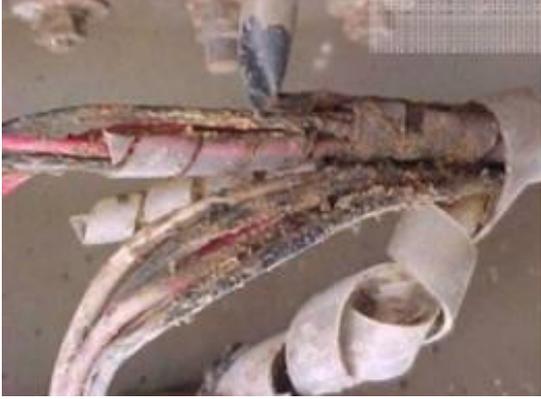
Description	Images
<p>All looms around hydraulic hoses is to be carefully cleaned and inspected.</p>
