# Machinery Cleaning Guide - Caterpillar and Komatsu Dump Trucks

**Biosecurity**

April 2016

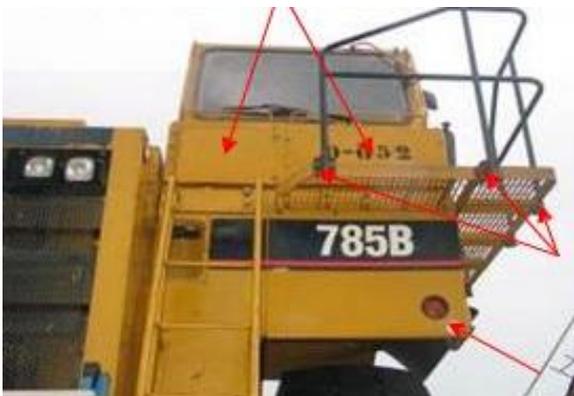
<p>The panels in front of the cabin, which house the air-conditioning and electrics must be removed. All hollow handrail tubing must be flushed in the presence of the inspecting officer. Check all light covers for damage (red arrows).</p>

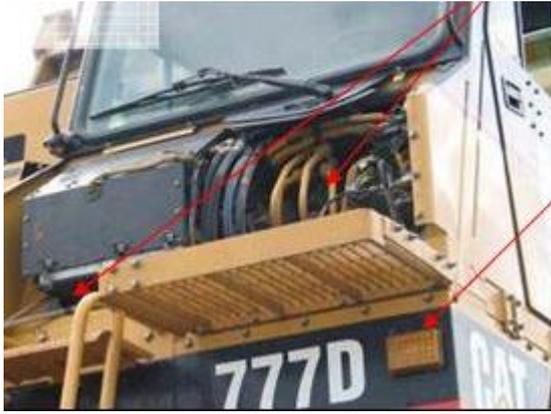
Description	Images
<p>This photo shows the front cabin panels removed, allowing access to the air-conditioning and electrics. Best to use a telescopic or flexible mirror to inspect all areas inside. All light covers must be checked (red arrows).</p>

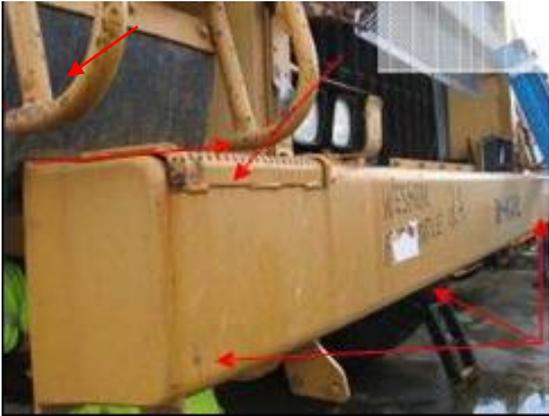
Description	Images
<p>Main focus of this photo is the front drawbar. On some models these have drainage holes either near the ends or along the underside. This drawbar must be fully checked for any evidence of drainage holes, cracks, splits or evidence of repair. Check the access ladders as the one highlighted above is made of hollow tubing with no end caps. These must be flushed in the presence of the inspecting officer. Any checker-plate or non-slip flooring must also be thoroughly flushed.</p>

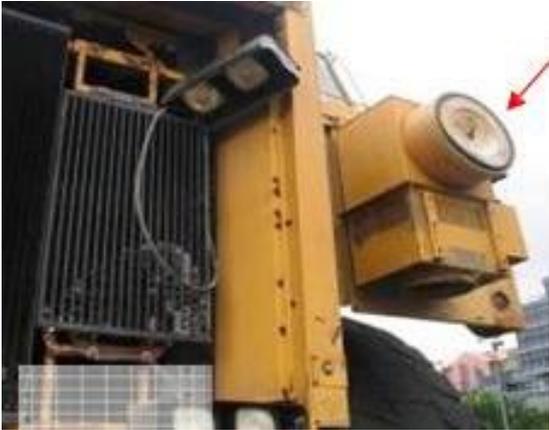
<p>On some models the air-filters are found in a variety of locations. This one is below the cabin and has several hollow channels as highlighted by the red arrow. Filters must be removed and blown with air to verify cleanliness. Have any other non-affixed panels dismantled to allow full access.</p>

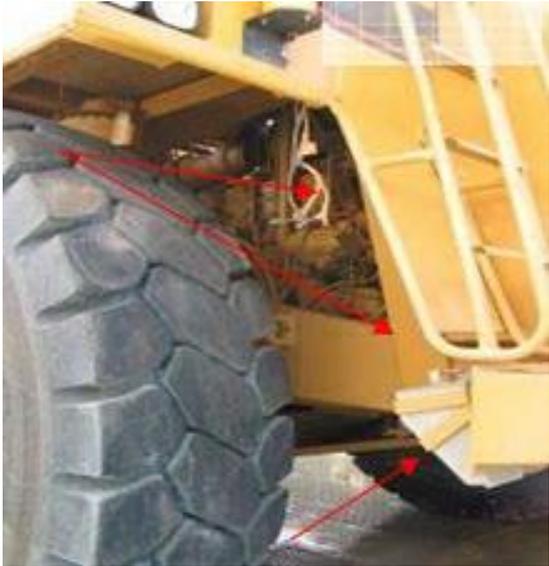
Description	Images
<p>The two red arrows on the centre of the photo show the vertical section of the chassis. These sections are hollow, have drainage holes and require flushing in the presence of the inspecting officer. See next series of photos.</p>

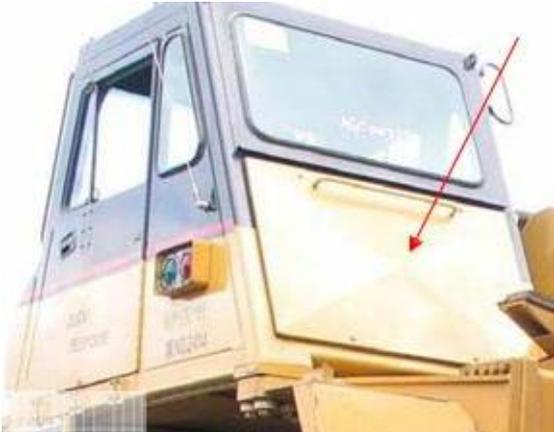
Description	Images
<p>Dump truck cabin. The red arrow shows the rear panel before it is removed.</p>

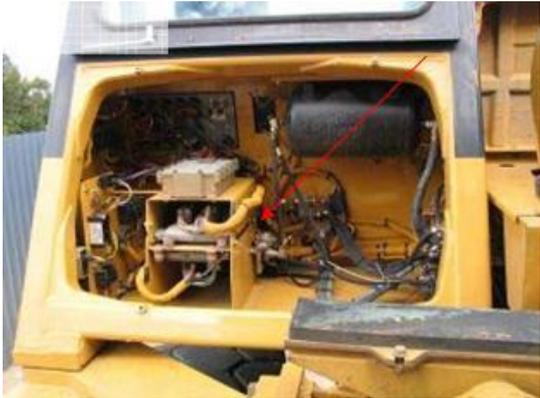
Description	Images
<p>This photo shows the rear panel removed. This area can contain the computer chips (red arrow) so cleaning can be difficult and it is best to clean with a damp rag. This area is usually well sealed, however biosecurity risk material has been found in these areas.</p>

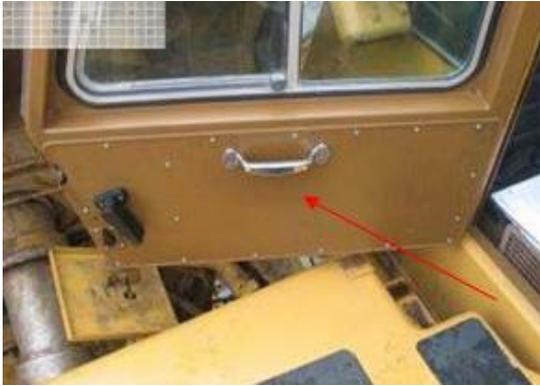
<p>Depending on the configuration, the internal door void (red arrow) may harbour biosecurity risk material.</p>

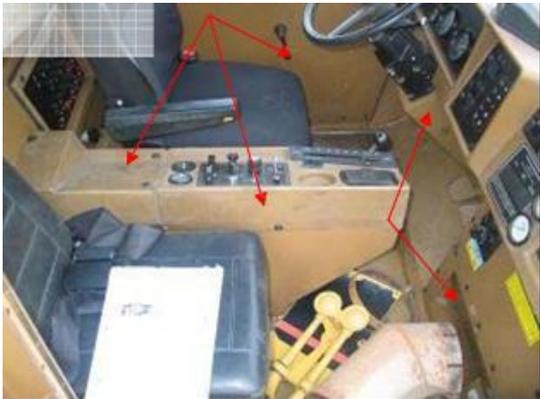
<p>The internal of any cabin requires extensive cleaning and inspection. Biosecurity risk material has previously been found in some air-conditioning vents and therefore is an area of interest to the department (red arrows).</p>

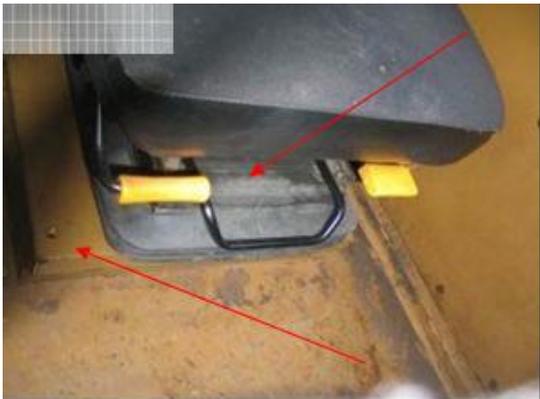
<p>All seats need to be removed to allow proper inspection of the underside of the seat and the rubber shroud. Below the seat, like in the illustration, there is a small hollow box section, which also needs to be inspected (red arrows). Without removing the seat, access may not be possible.</p>

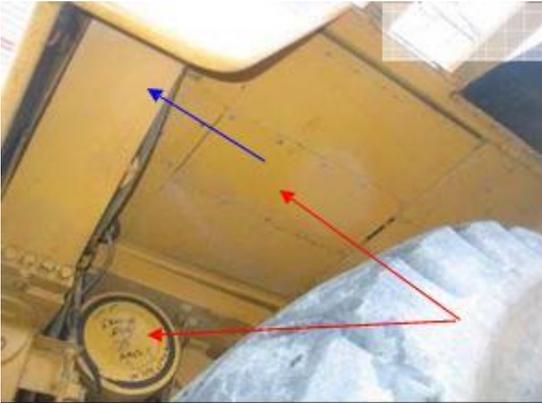
Description	Images
<p>A view of the bottom of the cabin floor as seen from underneath. All non-affixed panels need to be removed to enable thorough cleaning and inspection. Once these panels are removed, this allows rear access to the cabin air-conditioning and electrics as shown on page 3. All air-filters need to be removed and blown with air to verify cleanliness.</p>

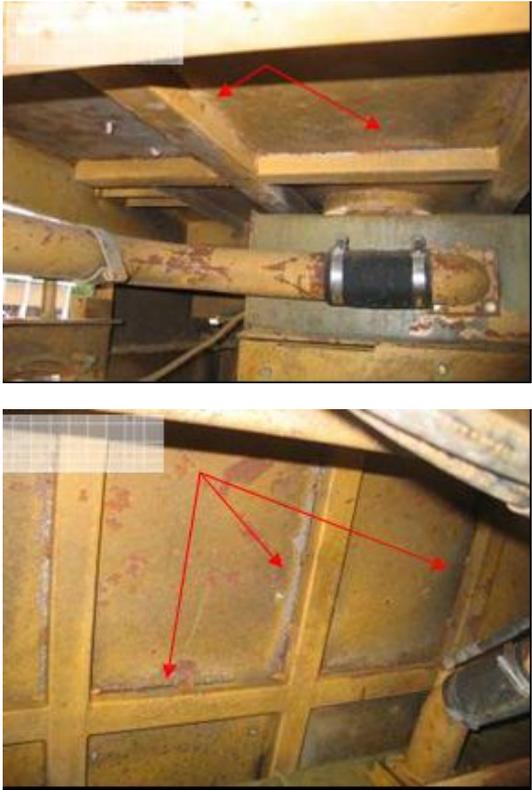
Description	Images
<p>The housing above the radiator. These hollow box sections are only spot welded into place and therefore biosecurity risk material may be present (red arrows). All individual box sections require flushing – a pin jet is best for gaining access.</p>

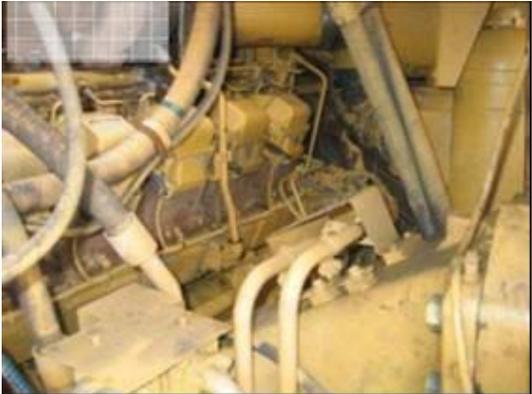
<p>Side view of the right hand side of the engine block. As well as checking all other areas, the gap between the tappet covers can harbour biosecurity risk material. Some flushing in this area is required.</p>

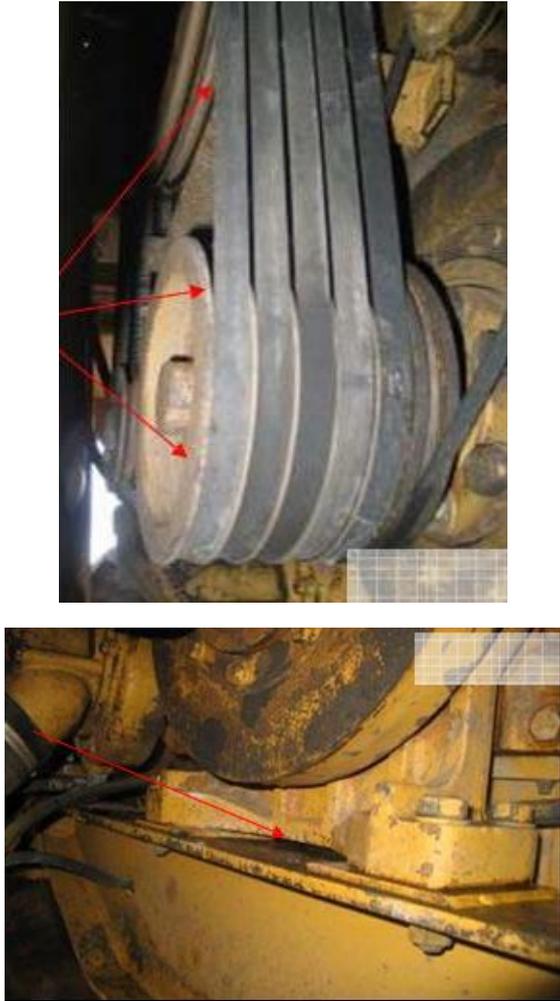
Description	Images
<p>The harmonic balancers must be cleaned as well as the small opening below the block as seen in the picture on the right (red arrows).</p>

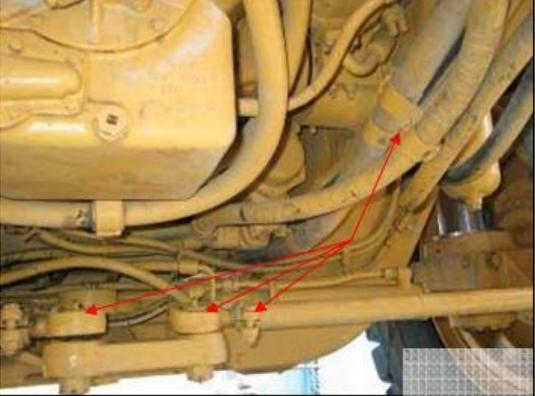
<p>Pivot points and a myriad of hydraulic hoses (red arrows) – all require thorough cleaning and inspection. In some instances, zip-ties may need to be removed to facilitate the cleaning process.</p>

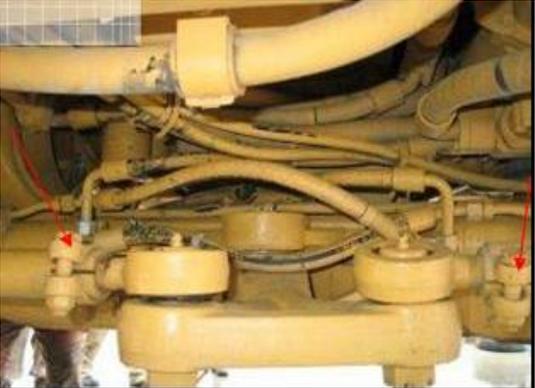
<p>The small openings at the end of the pivot points are often overlooked when cleaning (red arrows). The image to the right shows the area above belly plate (along front of wishbone) that requires thorough inspection.</p>

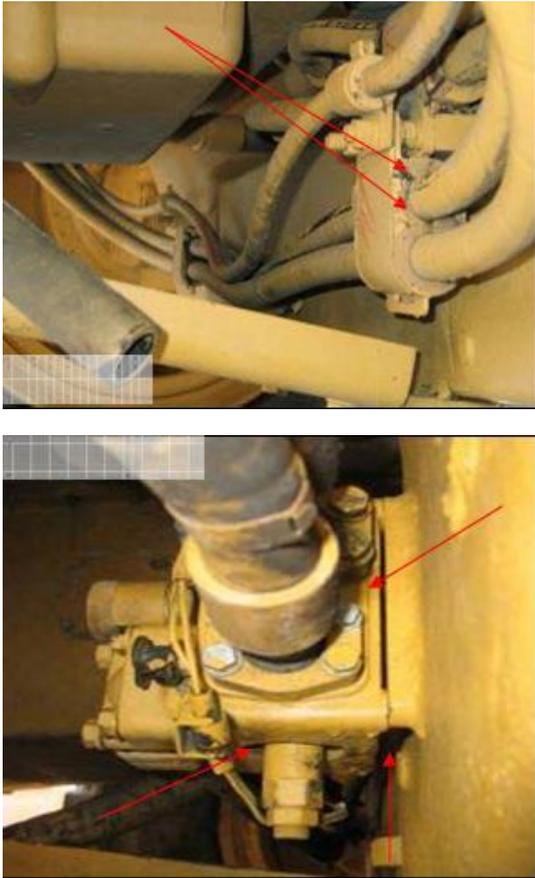
Description	Images
<p>Areas above belly plate (along front of wishbone) that requires thorough inspection (red arrows).</p>

<p>The top photograph shows a close-up of the front suspension assembly, with red arrows pointing to a specific joint or component. The bottom photograph shows a similar view from a slightly different angle, with red arrows pointing to different parts of the suspension system.</p>

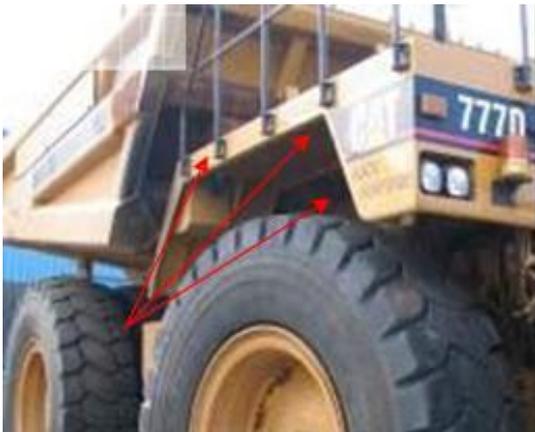
Description	Images
<p>The right hand wheel arch on most dump trucks is the most difficult to clean and inspect (red arrows). These wheel arches consist of box channels, most of which have small triangular openings at the ends. These openings are further demonstrated in this series of photographs. Check all open ended hand rail tubing (will require flushing) and circular tubing around the wheel arch for any drainage points (if present, they will also require flushing).</p>

<p>The photograph shows the right-hand wheel arch of a dump truck. Red arrows point to several areas: the top of the wheel arch, the side of the arch, and the area around the tire. The truck's body and a license plate with the number '7770' are visible in the background.</p>

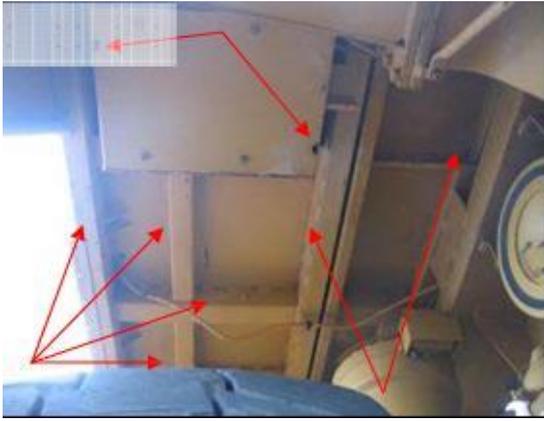
<p>View of the underside of the right hand wheel arch. All these highlighted channels (red arrows) are hollow and have small triangular openings on the ends. All require flushing with a 90-degree lance in the presence of the inspecting officer. If spot welded, they still require verification.</p>

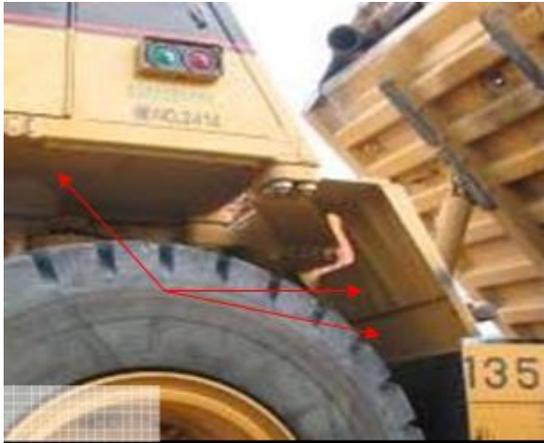
<p>The left hand wheel arch is not quite as complicated, but still requires that the panelling from under the cabin is removed. Check the ledges behind the tyre for biosecurity risk material (red arrows). On some Komatsu models, these ledges are covered but still have access and flushing points.</p>

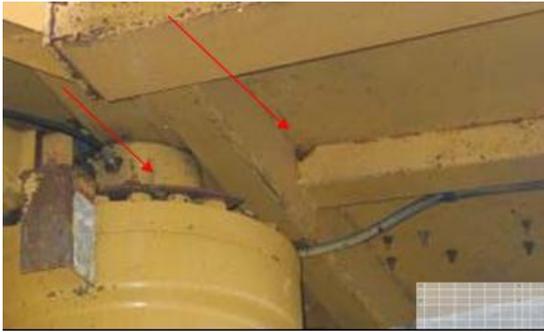
<p>Red arrows indicate the small triangular openings that are found at the ends of these box sections.</p>

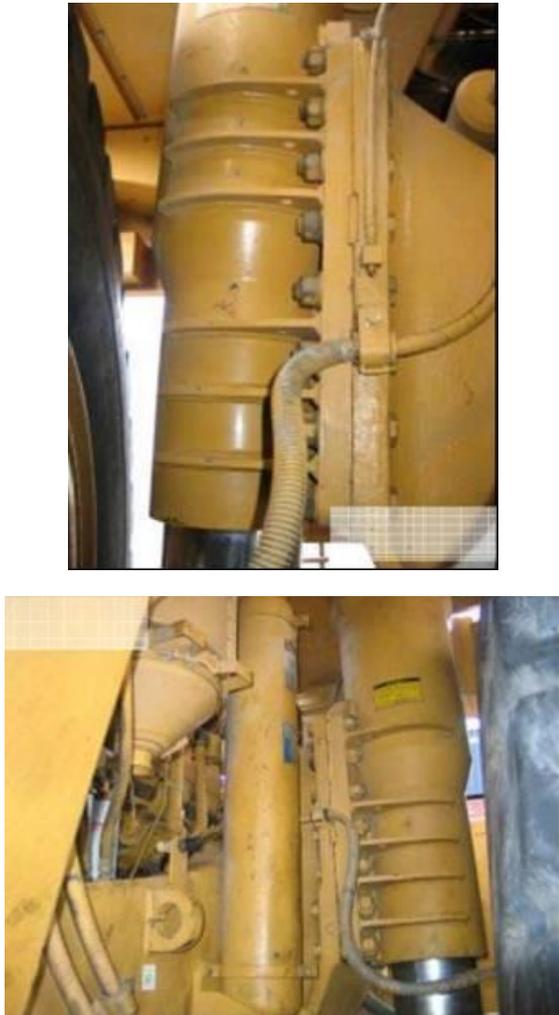
Description	Images
<p>Located just inside each front tyre and rim are two vertical struts. These struts attach to the wishbone, which on the CAT series of dump trucks is a hollow and accessible area that needs thorough flushing to ensure it is clean.</p>

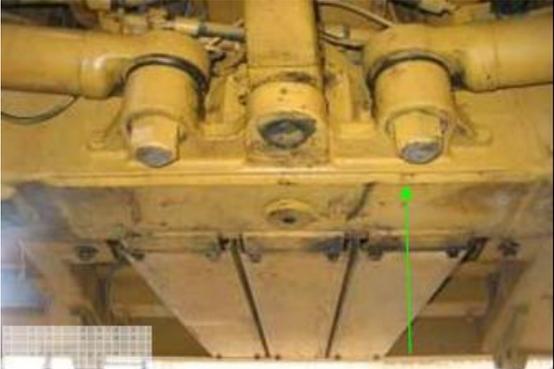
<p>Just right of centre at the rear of the wishbone is a small drainage hole (green arrow). Flushing via the two entrance holes located below either strut will result in water draining from this hole.</p> <p><b>N.B.</b> It can literally take hours to flush this wishbone clean.</p>

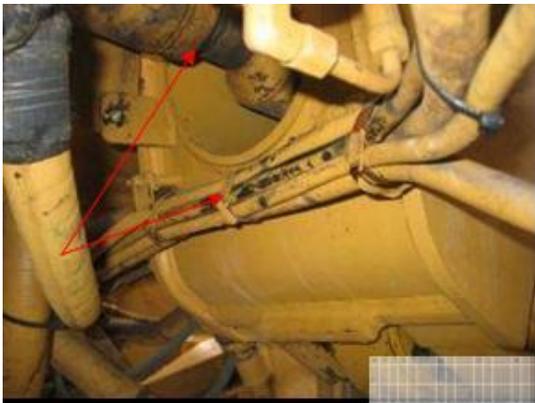
<p>A close up of the underside showing the universal joint and a conglomeration of hydraulic hoses. These hoses require to have the zip-ties or clamps removed to enable cleaning and inspection (red arrows).</p>

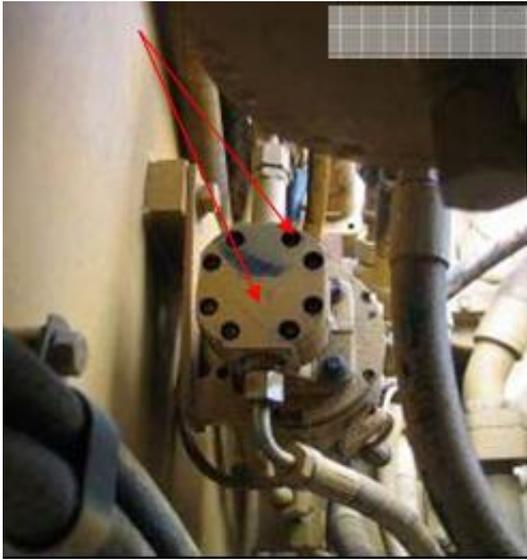
Description	Images
<p>There are numerous structures such as the one highlighted left (red arrows), all requiring inspection from various angles to ensure cleanliness.</p>

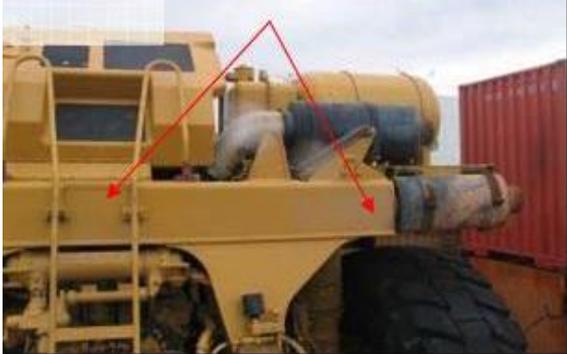
A close-up photograph of a complex mechanical assembly, likely part of a truck's engine or exhaust system. The assembly consists of various pipes, hoses, and metal components. Two red arrows point to specific circular openings or ports on a central component, indicating areas that require inspection for cleanliness.
<p>The red arrows indicate the exhaust pipe housing. On some models a drainage hole can be found either halfway along, or at the end. This housing requires flushing to verify cleanliness. On this model, the area is fully sealed.</p>

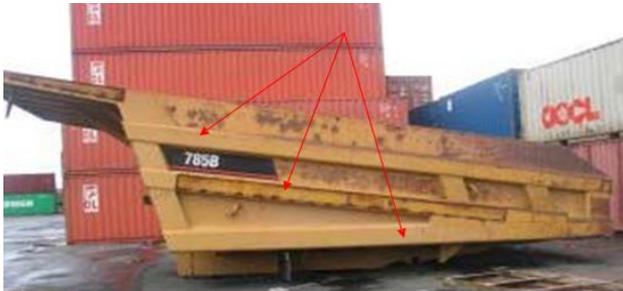
Description	Images
<p>Dump truck trays such as the one illustrated above can be one of the major areas that harbour biosecurity risk material and none may be visible. These trays possess an internal lining or 'skin', which hides a hollow area, capable of harbouring biosecurity risk material. The gussets or ribs along the sides and across the bottom also have the potential to harbour significant amounts of biosecurity risk material (red arrows). Dump trays are prone to damage simply due to the size and weight of the cargo that they carry. If there is any evidence of hairline cracks, splits, new welding or evidence of repair, then all these areas need to be investigated. Trays with suspected biosecurity risk material inside cannot be released until completely verified.</p>

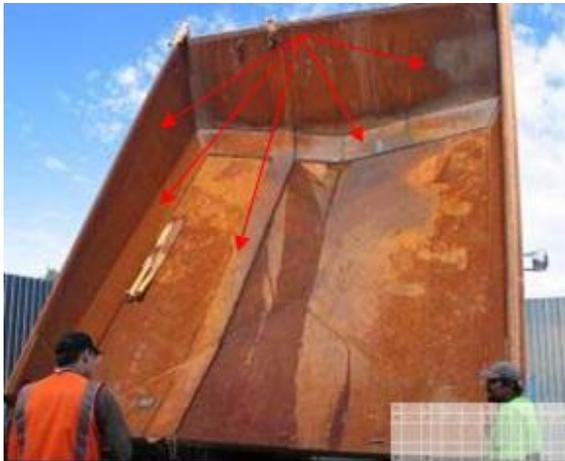
<p>This tray comprises of two segments that are bolted together. Once apart, the ribs along the underside are open and exposed to biosecurity risk material (red arrows).</p>

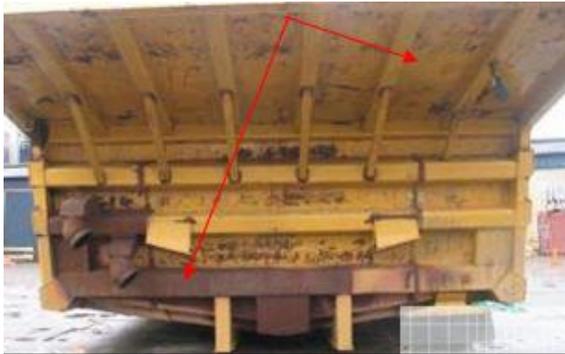
<p>This tray shows evidence of repair and therefore requires investigation of the gussets and ribs (red arrows).</p>

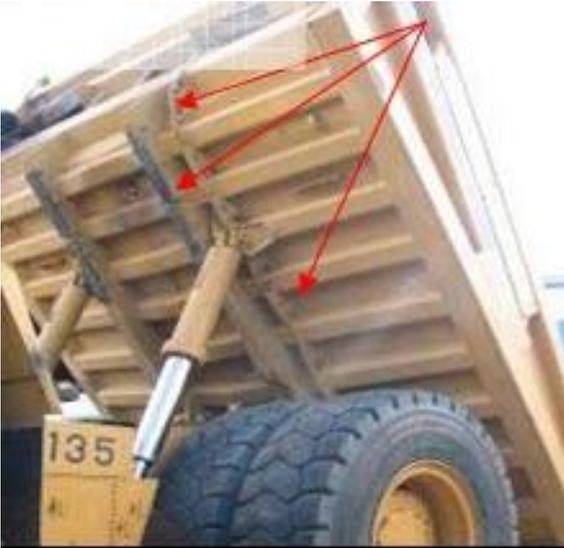
Description	Images
<p>Red arrows indicate where the tray has been bolted together. The black rubber pads on the underside of the tray require thorough flushing to ensure cleanliness.</p>

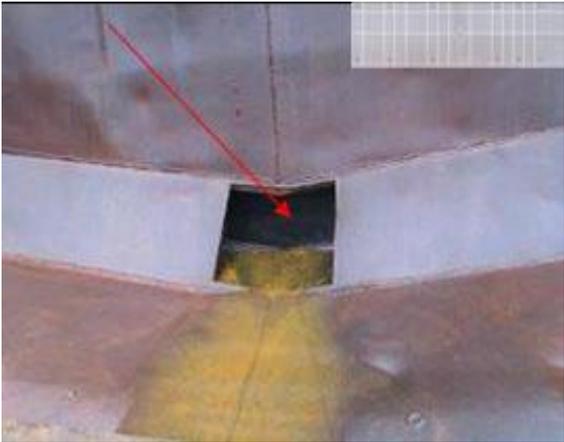
<p>The front of this tray showed signs of damage, and prior to import the biosecurity risk material was removed (red arrow). The department is not in a position to order the cutting of any part of any imported machine. If there is evidence of cracks, splits or repair, then it is the responsibility of the importer to prove that these areas are free of all biosecurity risk material.</p>

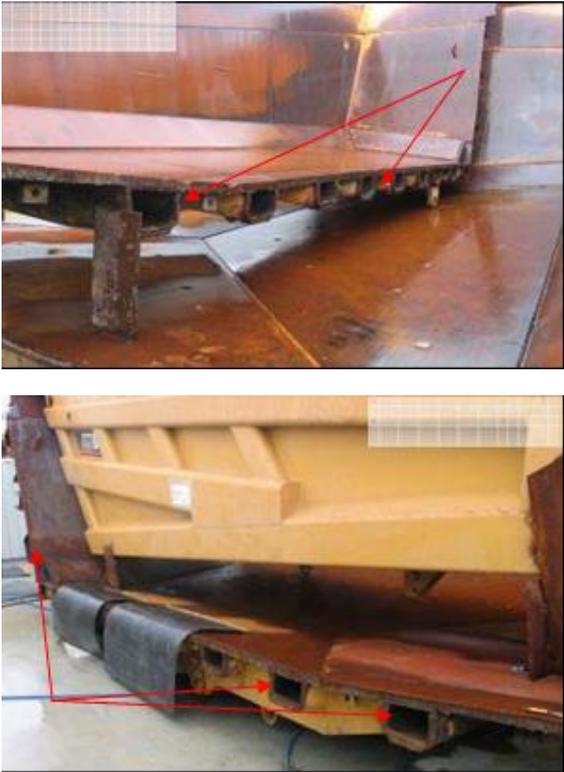
Description	Images
<p>Tray cut prior to import, highlighting the hollow ribs/gussets on the underside of the tray (red arrows).</p>

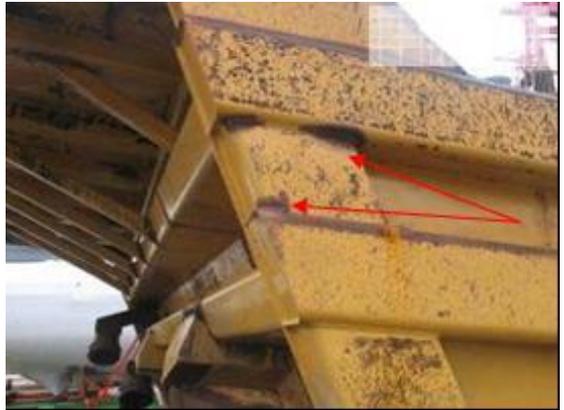
<p>Evidence of new welding on the side of this tray. Due to not being painted over, it appears rusty (red arrows).</p>

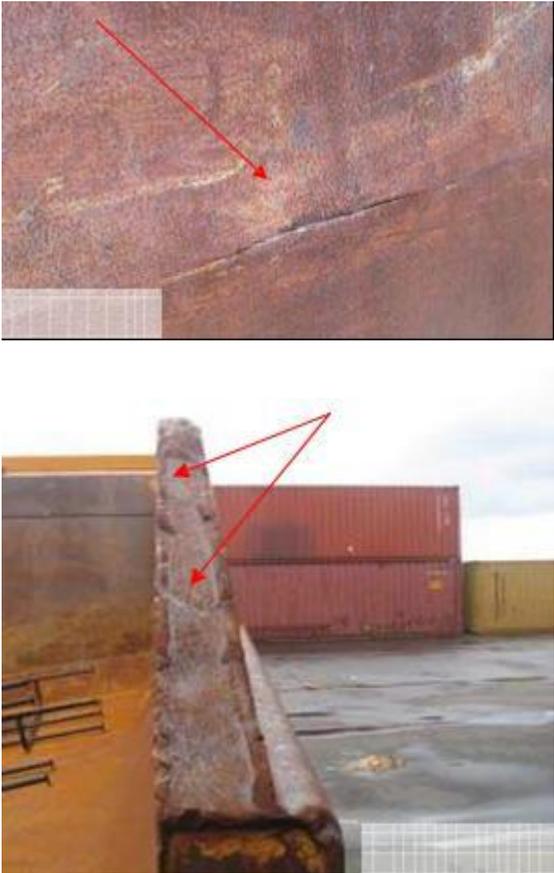
Description	Images
<p>Crack in the 'skin' and damage along the top of the side (red arrows).</p>

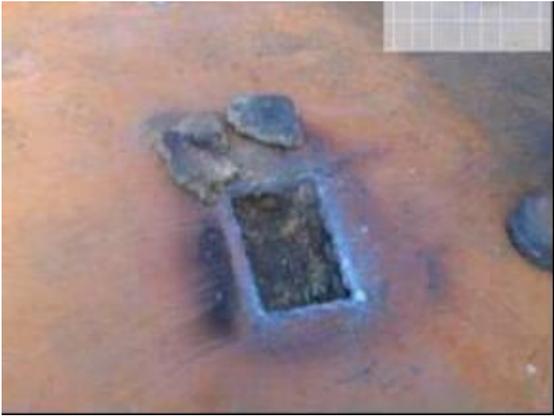
Description	Images
<p>Once this crack was investigated, it revealed biosecurity risk material between the two 'skins'. The department does not direct any cutting, however if any cracks, splits or evidence of repair is evident, then that machine cannot be released until these areas are verified clean. It is the responsibility of the importer to demonstrate that these areas are free of all biosecurity risk material.</p>

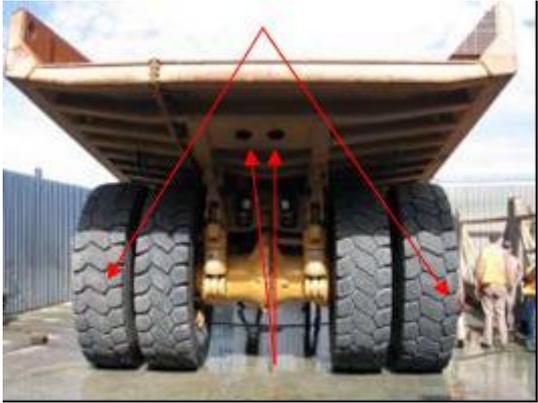
Description	Images
<p>Rear end of a dump truck. The outside dual wheels must be removed to allow a complete inspection. Please ensure that any exhaust channels are free of biosecurity risk material (red arrows).</p>

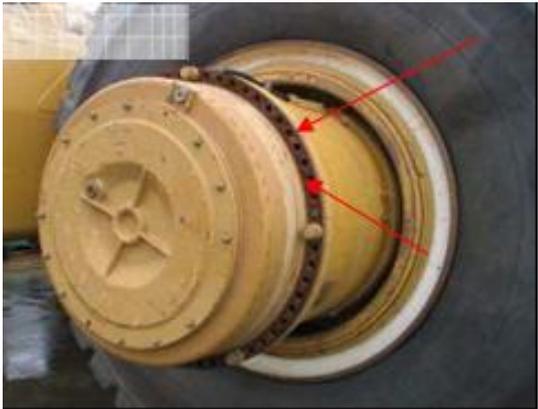
<p>The outside dual wheel removed. On the topside of the rim is a protective plate, which cannot be accessed if the dual wheel is not removed (red arrows). See below.</p>

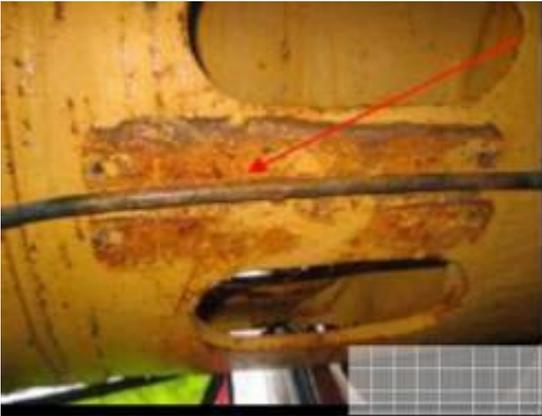
Description	Images
The protective cover on the rim has been removed, revealing biosecurity risk material (red arrow).

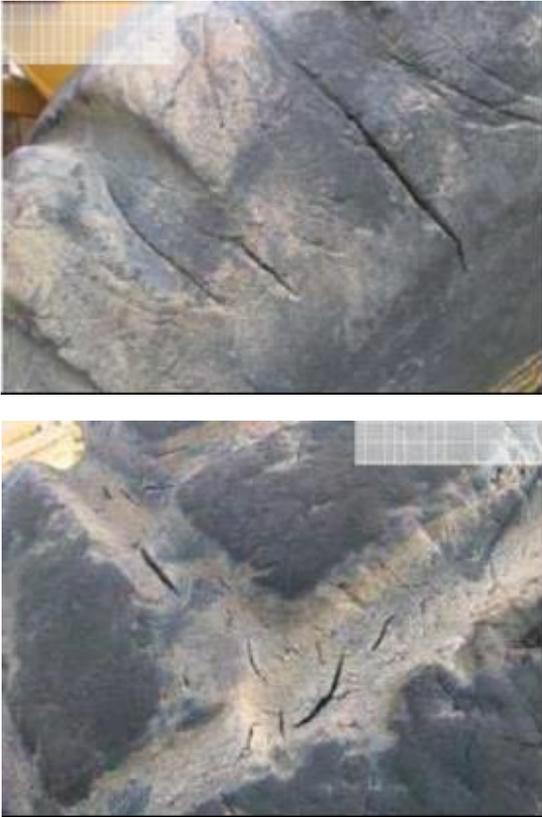
Examples of cracks in tyres that all need to be verified clean.

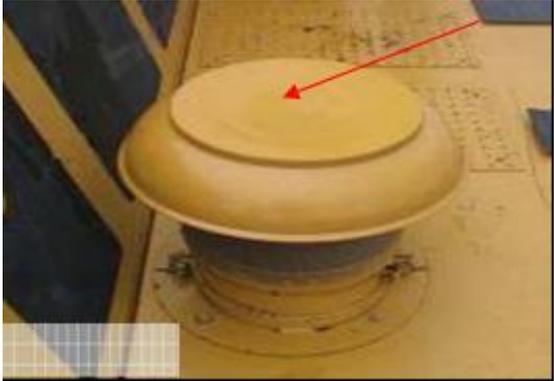
Description	Images
<p>The air-filter pre-cleaner (red arrow). Ensure this housing is removed to enable inspection.</p>

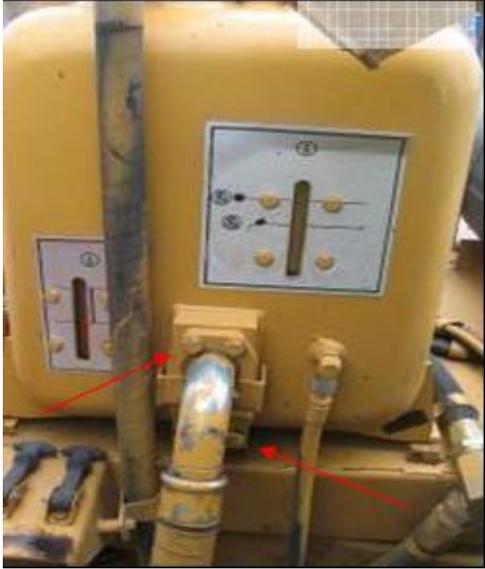
<p>The oil tank situated above the engine is easy to access, however the underside is difficult to inspect and may require the use of a mirror. The coupling also requires inspection (red arrows).</p>

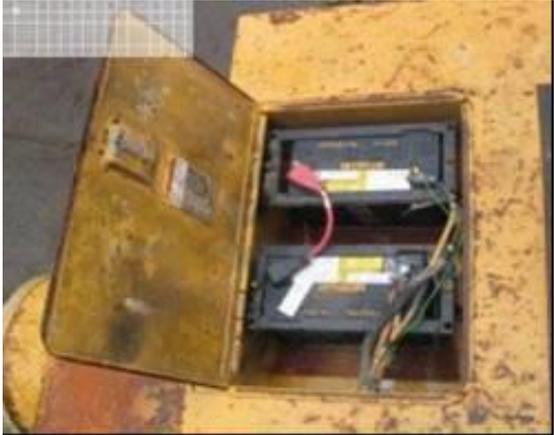
<p>To enable a thorough inspection of the battery box, ensure that the batteries can be lifted and flushed underneath.</p>

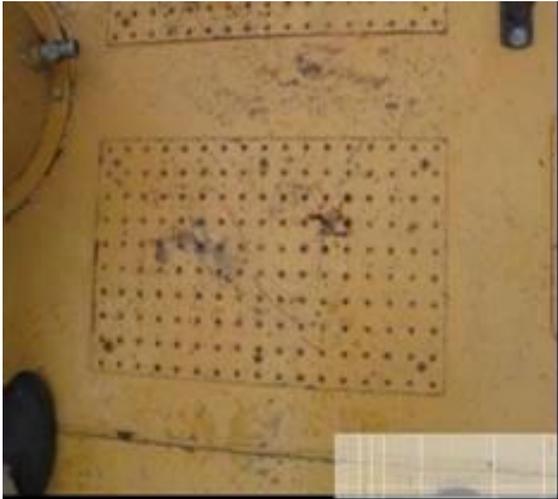
Description	Images
<p>All non-slip checker plate needs to be verified by flushing with high pressure water (some importers have chosen to completely remove).</p>

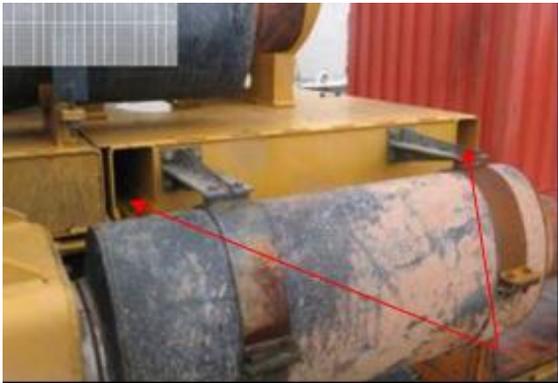
<p>The right hand wheel arch from behind. On some models the box channels are open ended such as the ones illustrated above (red arrows). These require flushing in the presence of the inspecting officer to verify cleanliness.</p>

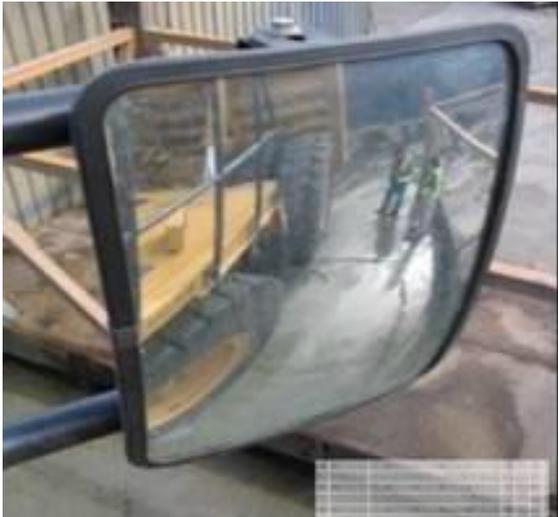
<p>Check all mirrors. If cracked or pieces missing, best to check behind.</p>
