Australian Government
Department of Agriculture
and Water Resources

Machinery Cleaning Guide - Mini Excavators

April 2016

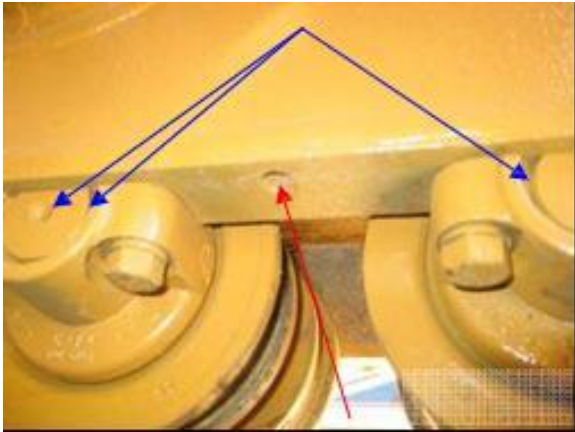
<p>Indicates the top roller above the track frame. The red arrow highlights the small gap at the rear, which must be flushed while the blue highlights the small gap at the rear of the roller.</p>

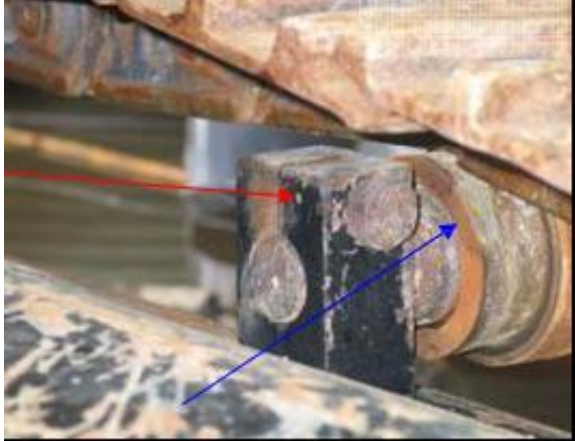
<p>The red arrows show the hollow framework that requires thorough cleaning and inspection. All tracked machines must undergo one full revolution to ensure track pad cleanliness.</p>

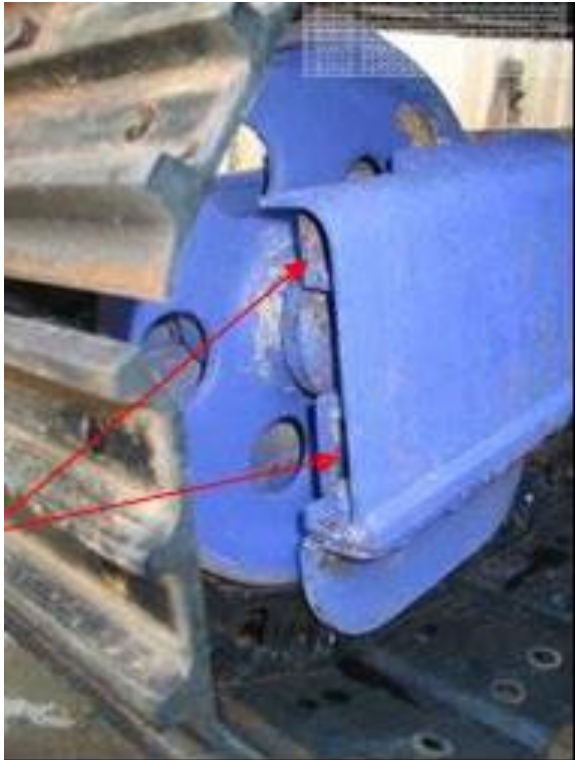
Description	Images
<p>As the tracks revolve, they open slightly (red arrows) allowing cleaning and inspection.</p>

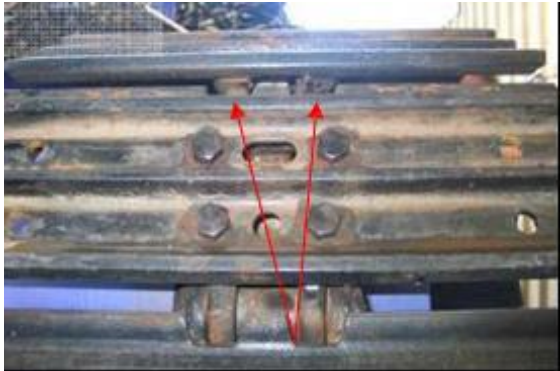
<p>Each individual rubber track pad has been removed, allowing access to the small recesses that can be compacted with biosecurity risk material. Each track pad must be verified clean.</p>

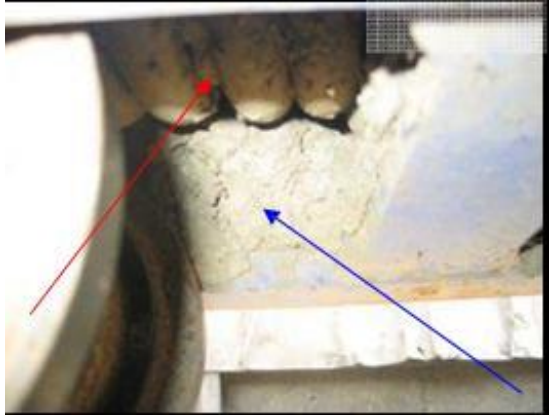
Description	Images
The inside of the track frame, just highlighting the track adjuster spring (red arrow) and biosecurity risk material (blue arrow) on one of the internal ledges that must be removed.

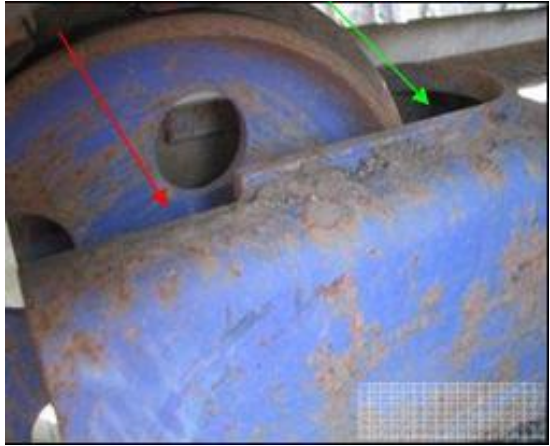
At the opposite end to the drive motor is the idler wheel (red arrow). Ensure that all surfaces either side of the idler wheel are clean as well as any ledges behind (green arrow).

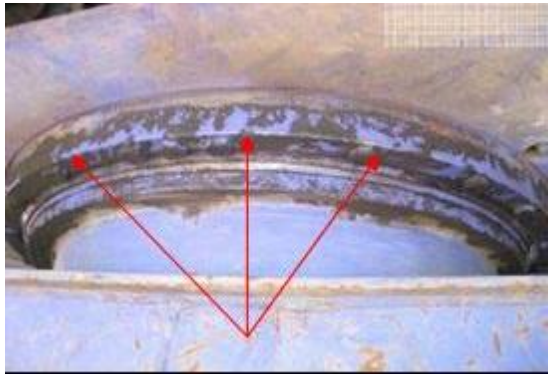
Description	Images
All contaminated grease (red arrows) must be removed from the outer slew ring during the cleaning process.

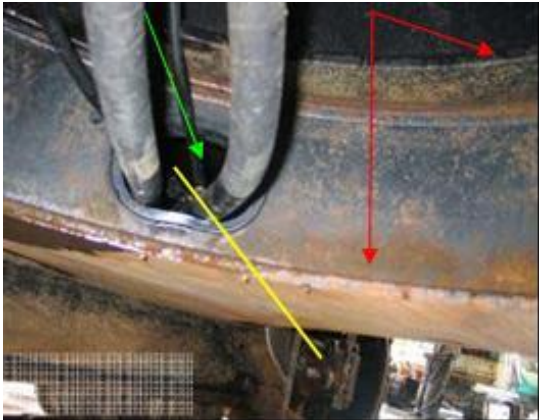
Description	Images
<p>The red arrows highlight the various ledges that can be found inside the turret/slew ring, each ledge requires thorough cleaning. The green arrow points to the hollow channel where the hydraulic hoses run down through the turret housing to the drive motors (yellow line demonstrates the path of the hydraulic hoses). This area must be flushed in the presence of the inspecting officer to verify cleanliness.</p>

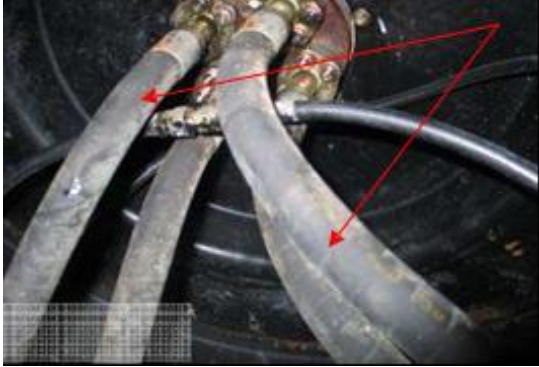
<p>The hydraulic hoses inside the turret/slew ring. Each hose must be individually cleaned.</p>

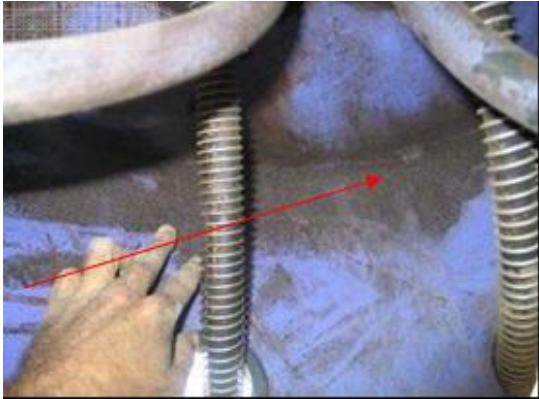
<p>All contaminated grease (red arrow) must be removed from the inside surfaces of the slew ring during the cleaning process.</p>

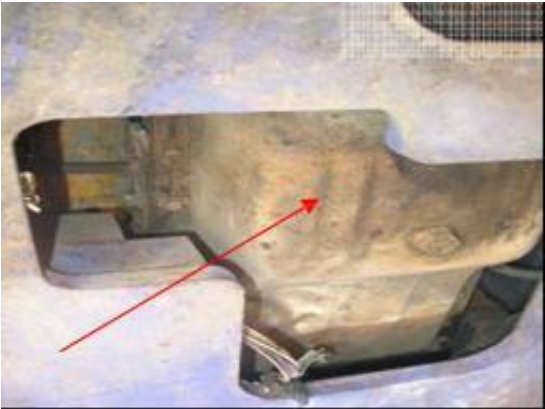
Description	Images
<p>The underside non-affixed panels have been removed, allowing cleaning and inspection access to the sump.</p>

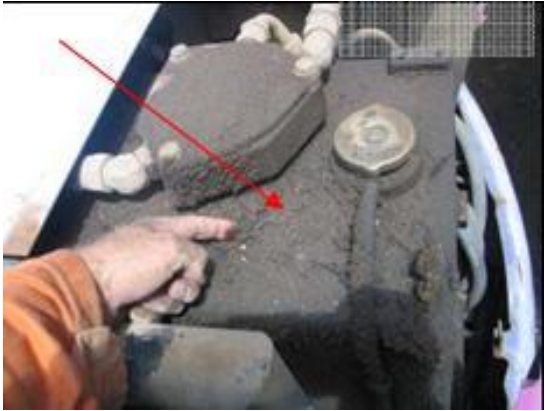
<p>The topside of the fuel cell, accessible for cleaning and inspection after the engine covers are removed.</p>

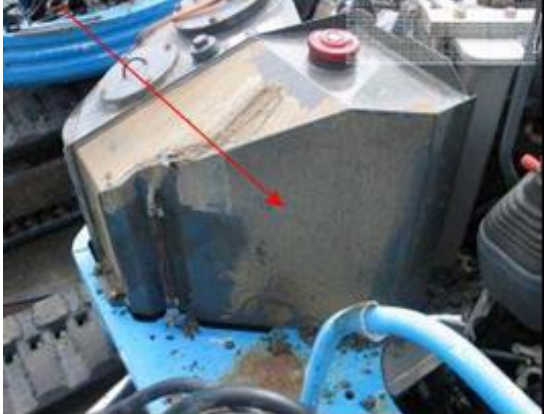
<p>The side of the fuel cell, accessible for cleaning and inspection after the engine covers are removed.</p>

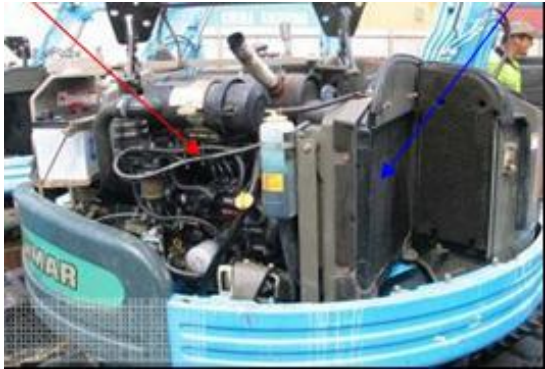
Description	Images
<p>Another example of dismantling to allow access to the engine block (red arrow) and radiator (blue arrow)</p>

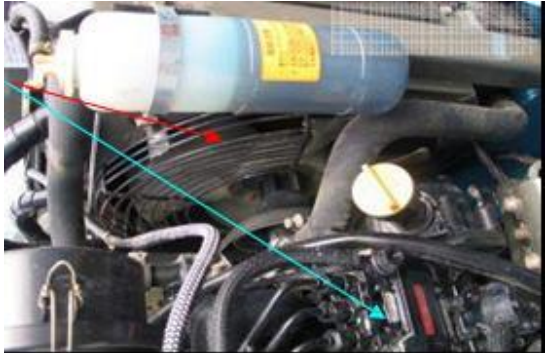
<p>The red arrow highlights the radiator grill that is currently preventing access to the inside of the shroud, whilst the aqua arrow is highlighting the topside of the engine block.</p>

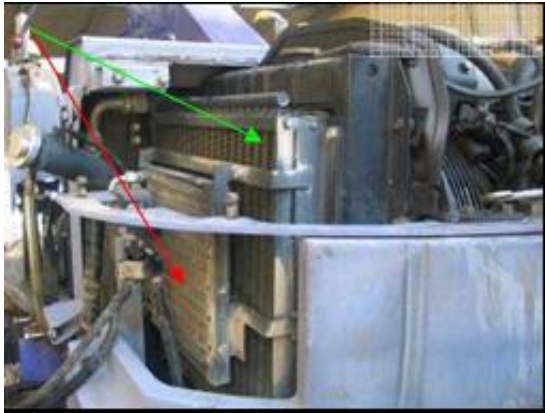
<p>The radiator (green arrow) and oil cooler (red arrow) must be flushed in the presence of the inspecting officer to verify cleanliness of the fins.</p>

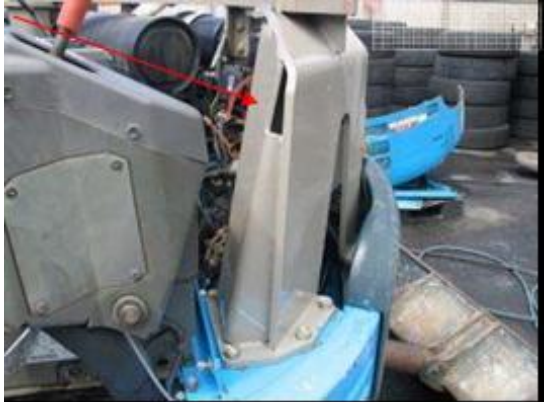
<p>Once the engine covers have been removed, areas like the one highlighted become accessible for cleaning and inspection.</p>

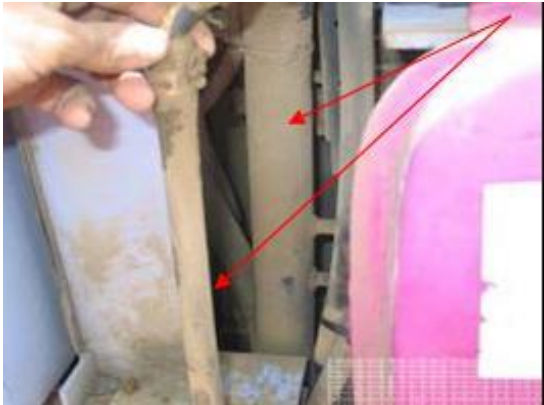
Description	Images
<p>All hoses (red arrows) must be thoroughly cleaned and inspected. These were only accessible for cleaning and inspection after dismantling of the engine covers.</p>

<p>A close-up photograph of the engine compartment of a mini excavator. Two red arrows point to hoses that are accessible after dismantling the engine covers. The hoses are located near a pinkish-red component on the right side of the frame.</p>
<p>Another view of the underside of the block, now accessible for cleaning after all non-affixed panels have been removed.</p>

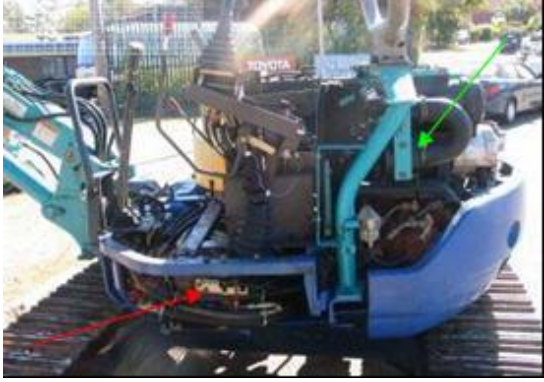
<p>A photograph of a blue mini excavator with its engine compartment open. A red arrow points to a shroud that has been removed, and a green arrow points to an engine cover that has also been removed. The excavator is parked on a paved surface.</p>

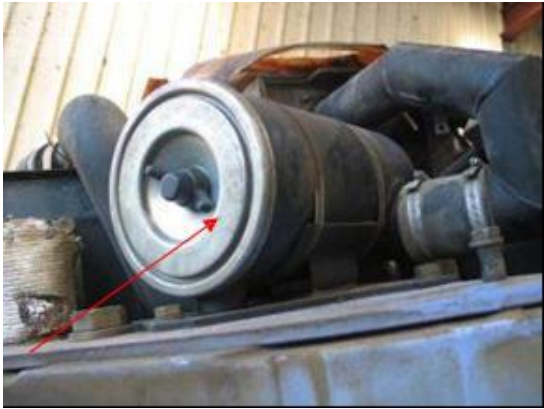
Description	Images
Remove the air-filter and check for cleanliness.

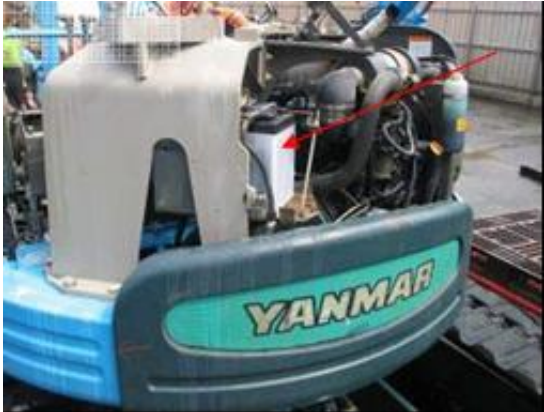
The batteries must be loosened from the tie-down points to allow for cleaning and inspection of the underside.

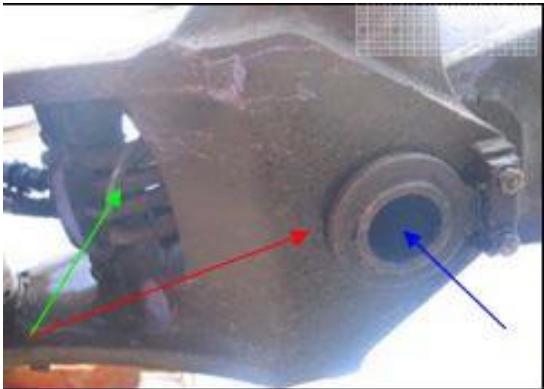
Description	Images
All biosecurity risk material, including dirty grease must be removed from the boom stick (red arrow) and hydraulic hoses (green arrow). Verify hollow areas are free of all biosecurity risk material.

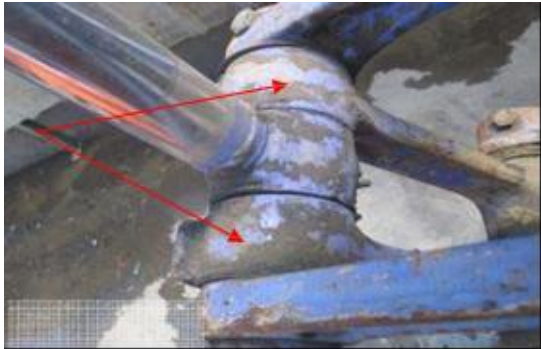
Description	Images
<p>All contaminated grease (red arrows) must be removed from all pivot points along the boom stick.</p>

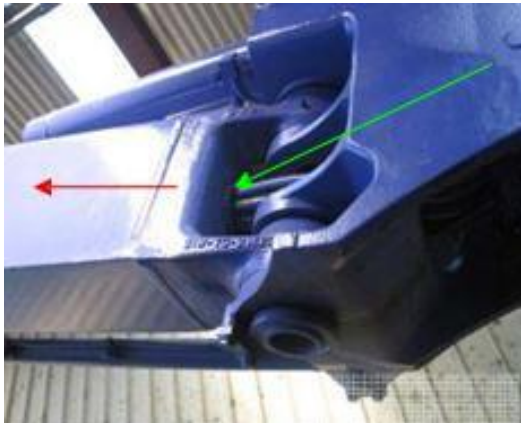
<p>Ensure all hollow cavities where hydraulics run through the boom stick (green arrow) are flushed to verify internal cleanliness.</p>

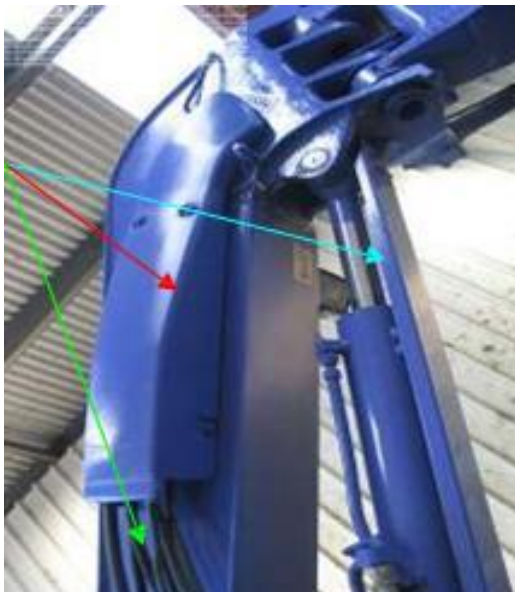
<p>Remove all non-affixed boom stick panels (red arrow), clean and check all hydraulic hoses (green arrow). Clean inside all protective plates (aqua arrow)</p>

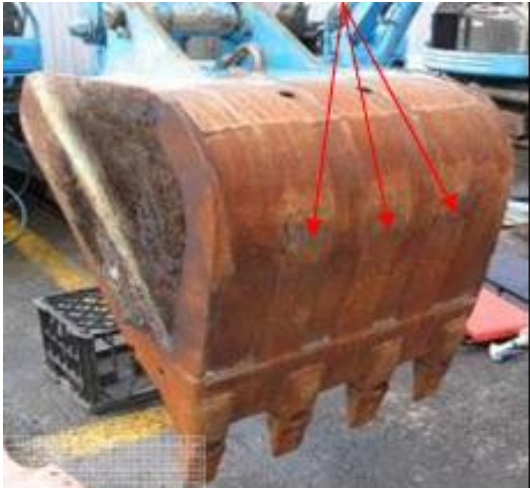
Description	Images
<p>Check all wear plates on the bottom of the bucket. If only spot-welded, these will have to be flushed to verify cleanliness. Check all surfaces of the bucket for any cracks, splits or evidence of repair.</p>

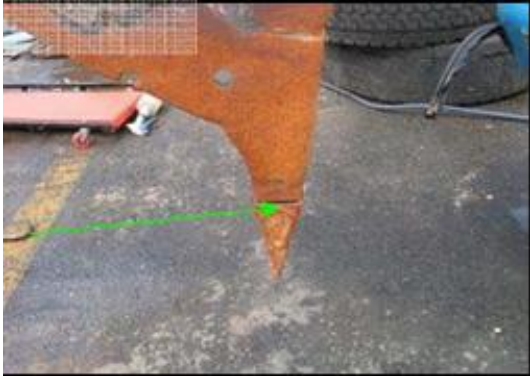
<p>All cutting teeth (green arrow) on the bucket must be removed for internal cleaning and inspection.</p>

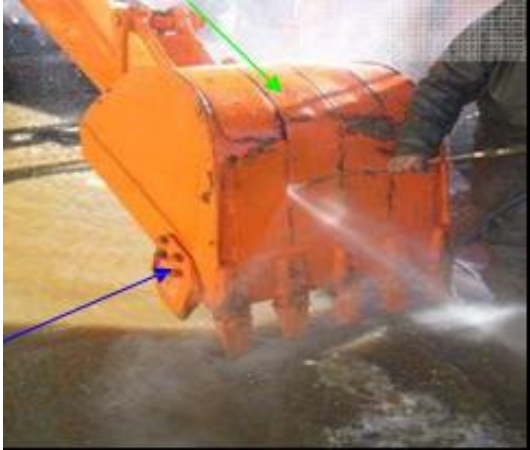
<p>An example of flushing the spot-welded wear plates (green arrow) on the bottom of the bucket. All side wear plates (blue arrow) must be loosened off and flushed.</p>

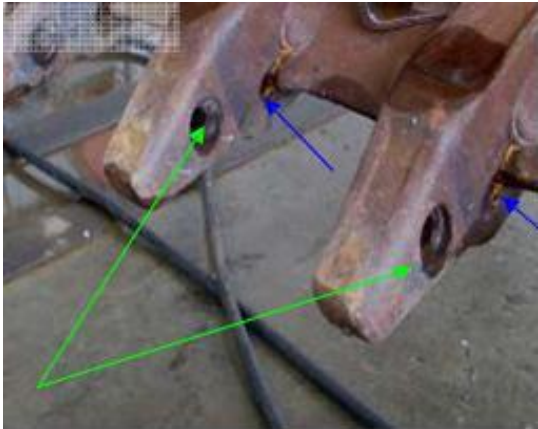
Description	Images
<p>A close up of the boots where the cutting teeth are mounted. Ensure around each pinhole is clean. The blue arrows highlight a narrow opening that tends to become compacted with risk material and can be overlooked if the cutting teeth are still attached.</p>

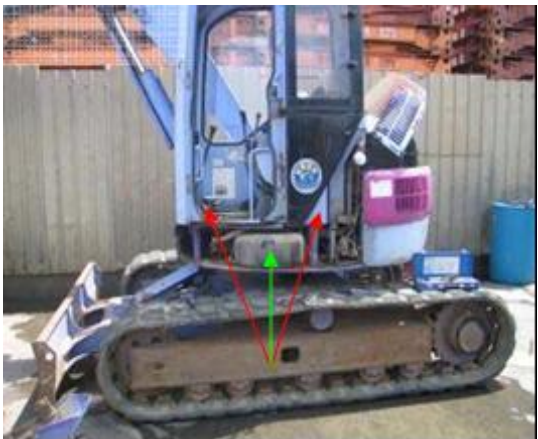
Description	Images
<p>Some mini excavators may have a cabin as illustrated. Check the framework for drainage holes on the underside (red arrows) and the underside shroud (green arrow) has been removed to allow cleaning and inspection access to the myriad of hydraulics under the floorpan. On some models, the cabin may need to be unbolted and lifted to allow cleaning and inspection of the fuel cell and hydraulic hoses under the seat.</p>

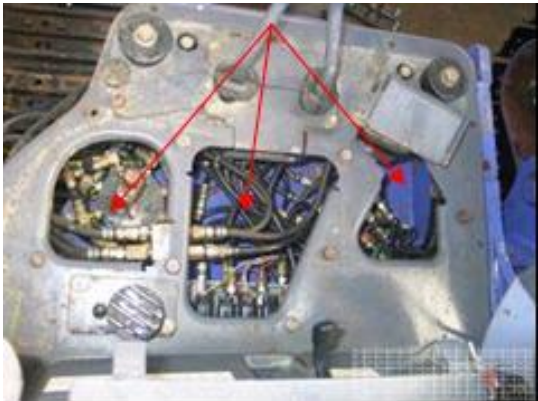
<p>An illustration of the floorpans removed from under the rubber floor matting, exposing the hydraulic hoses underneath.</p>

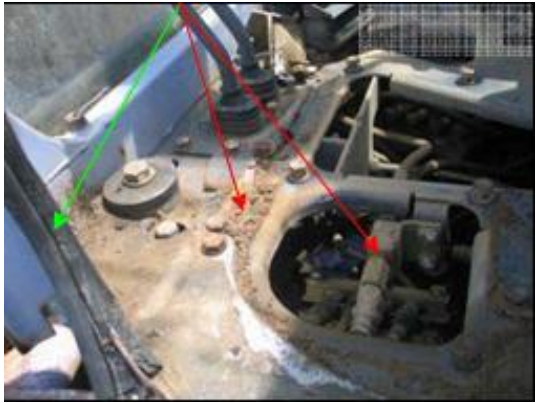
Description	Images
<p>An example of the biosecurity risk material found after the rubber floor mats and floorpans have been removed. Cabin door rubbers (green arrow) can be contaminated and are therefore an area of concern to the Department.</p>

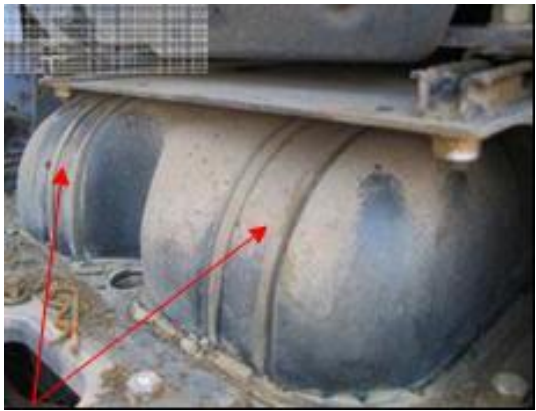
<p>An illustration of the fuel cell under the seat. In some instances, the cabin will require unbolting and lifting to allow cleaning and inspection access to the topside of the fuel cell and hydraulic hoses (currently not in view). The bands around the tank (red arrows) need to be loosened off and flushed to remove any contaminants.</p>

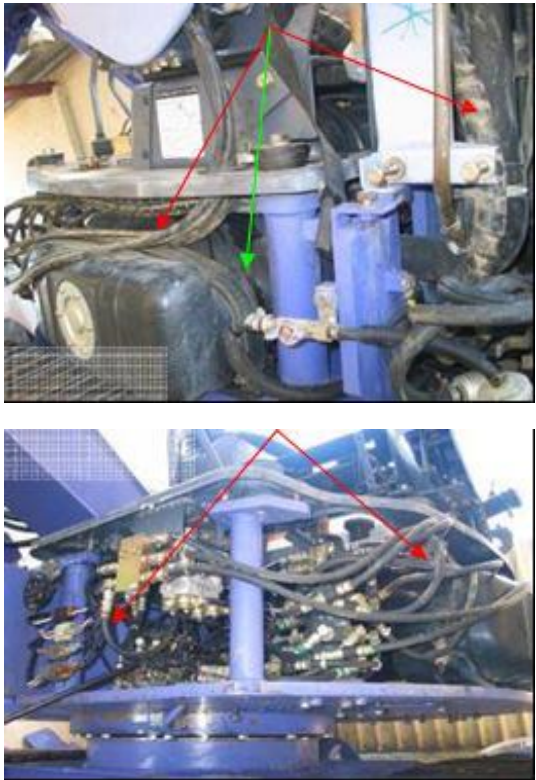
<p>These pictures illustrate the access provided for cleaning and inspection, once the shrouds around the underside of the cabin have been removed. All hydraulic hoses and looming (red arrows) require thorough cleaning and inspection. The bands around the fuel cell (green arrow) also need to be loosened and flushed to remove any contaminants.</p>

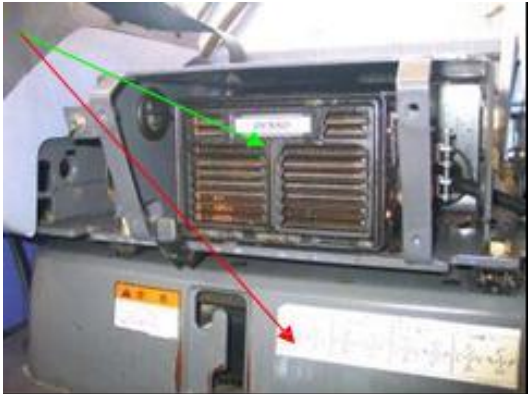
Description	Images
<p>On this model, the air-conditioning system (green arrow) is located under the seat. This area has been opened to allow cleaning and inspection. The plate below (red arrow), is covering the fuel cell and will require dismantling.</p>

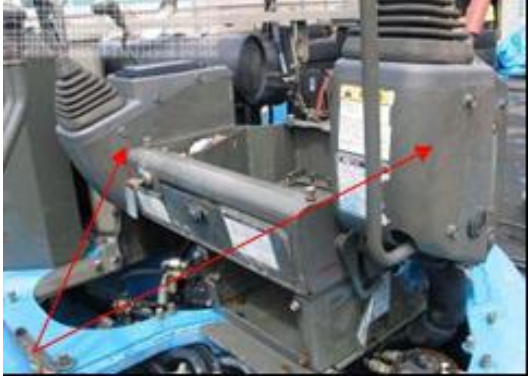
<p>Access will be required to verify the internal cleanliness of the joystick control housing (red arrows).</p>

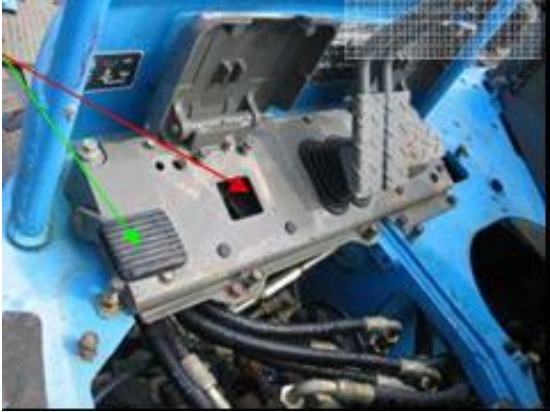
<p>On some models, a hollow section below the foot pedals (red arrow) will require internal cleaning and inspection. Each foot pedal cover requires cleaning (green arrow) – see next illustration.</p>

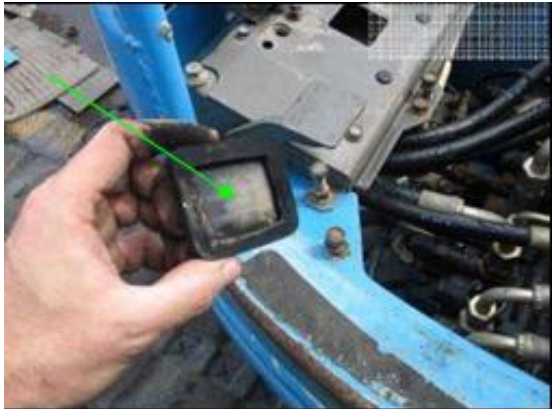
Description	Images
Each individual foot pedal has been removed for cleaning and inspection.

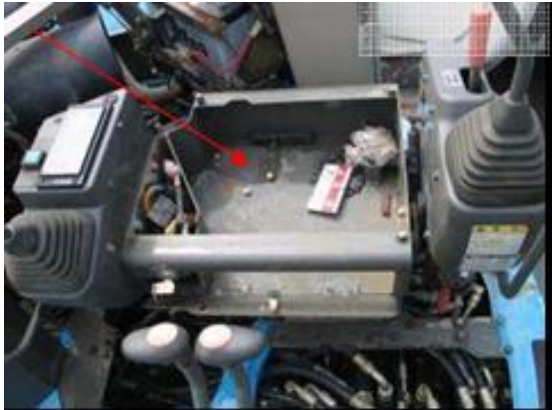
The seat (red arrow) has been removed from this model to allow cleaning and inspection underneath.

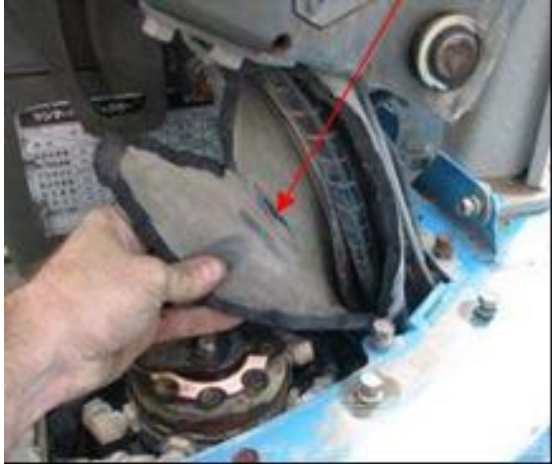
All foam insulation (red arrow) around electrical cabling must be internally cleaned and inspected.

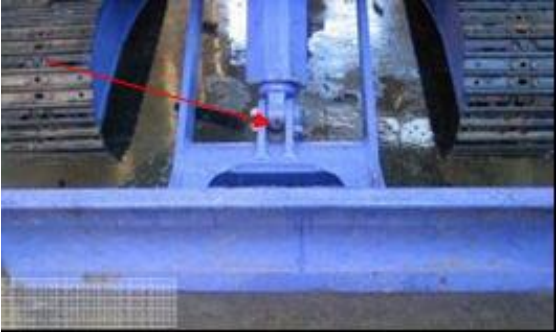
Description	Images
<p>Check all surfaces of the blade to verify free of any cracks, splits or evidence of repair. All contaminated grease must be removed from all pivot points (red arrow).</p>

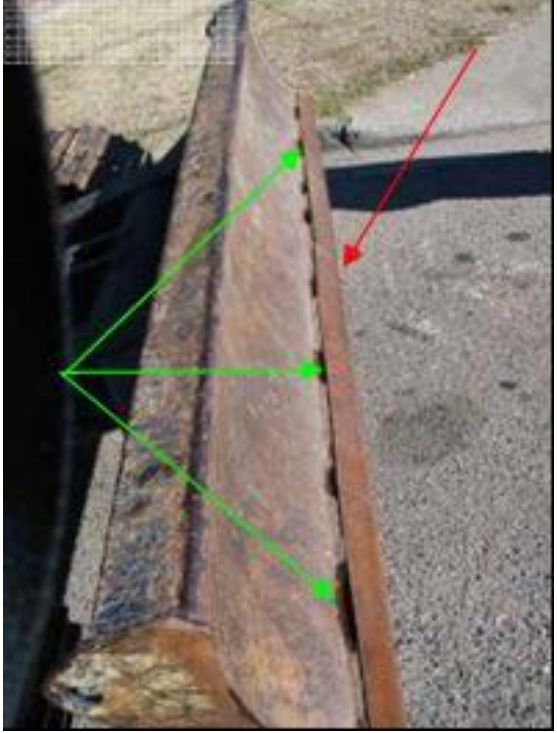
<p>On this blade a cutting blade has been spot welded to the face (red arrow). All recesses (green arrows) along the blade must be flushed to verify cleanliness.</p>

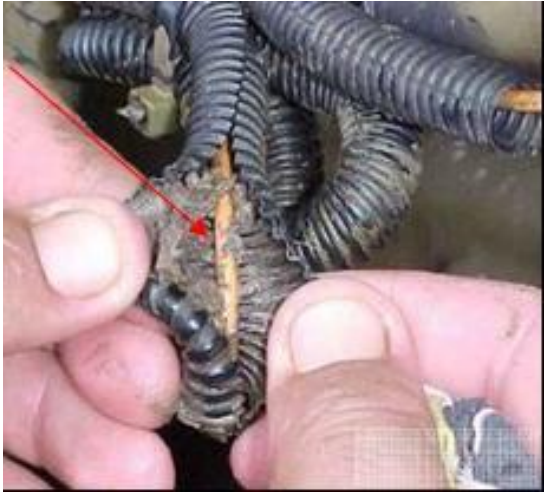
Description	Images
All wiring harnesses must be thoroughly cleaned and inspected.

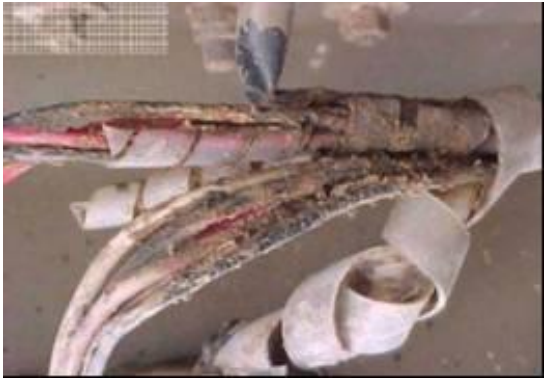
Ensure that all looming around hydraulic hoses is clean and free of all biosecurity risk material.
