Australian Government
Department of Agriculture
and Water Resources

Machinery Cleaning Guide - Mini Tractors

April 2016

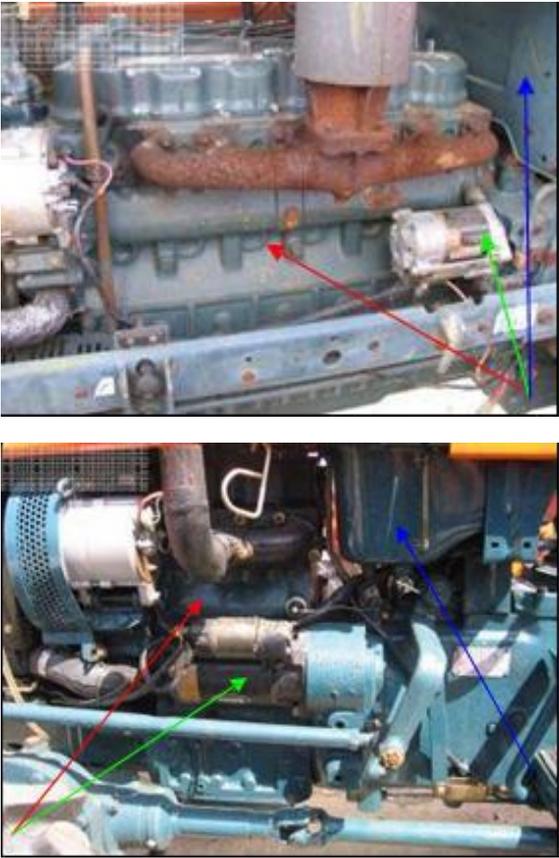
Description	Images
<p>The two sides of the mini tractor engine block. All surfaces of the block (red arrows), around all starter motors (green arrows), oil filters; fuel tanks (blue arrows) must be thoroughly cleaned and inspected.</p>

<p>The first photograph shows the top and side of the engine block. A red arrow points to the top surface of the block, a green arrow points to a starter motor, and a blue arrow points to a fuel tank. The second photograph shows the side of the engine block from a different angle, with red, green, and blue arrows pointing to various components including the block, a starter motor, and a fuel tank.</p>
<p>The topside of the engine block and tappet head cover (red arrow). This area must be thoroughly cleaned and inspected.</p>

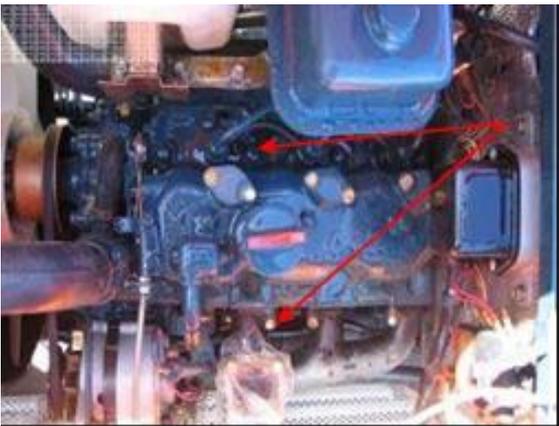
<p>The photograph shows the top of the engine block and the tappet head cover. Red arrows point to the top surface of the block and the tappet head cover, indicating the areas that must be thoroughly cleaned and inspected.</p>

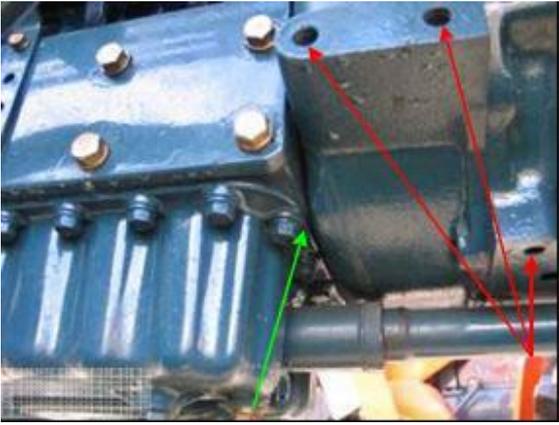
Description	Images
<p>The rear end of the sump. All countersink holes (red arrow) must be free of biosecurity risk material. On this model there is a small recess above the sump (green arrow) that may require flushing to verify cleanliness.</p>

A close-up photograph of the rear end of a blue sump. Several countersink holes are visible, with red arrows pointing to them. A green arrow points to a small recess above the sump. The sump is connected to a steering shaft.
<p>Another example of a small recess (red arrow) behind the sump that must be free of biosecurity risk material.</p>

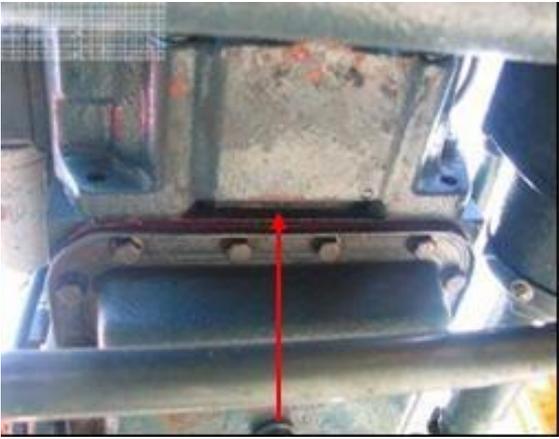
A close-up photograph of a small recess behind the sump. A red arrow points to the recess. The sump is blue and the recess is a darker color.
<p>This illustration shows an unusual sump design with the steering shaft dividing it through the centre. This area (red arrows) can harbour biosecurity risk material and requires flushing to verify cleanliness.</p>

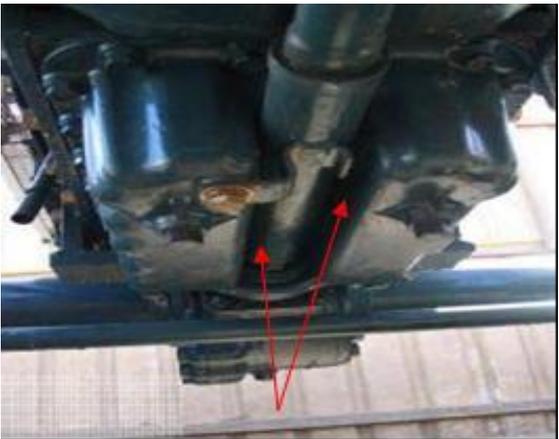
A photograph of an unusual sump design. The steering shaft divides the sump through the center. Red arrows point to the areas where the shaft meets the sump, indicating potential biosecurity risk material accumulation.

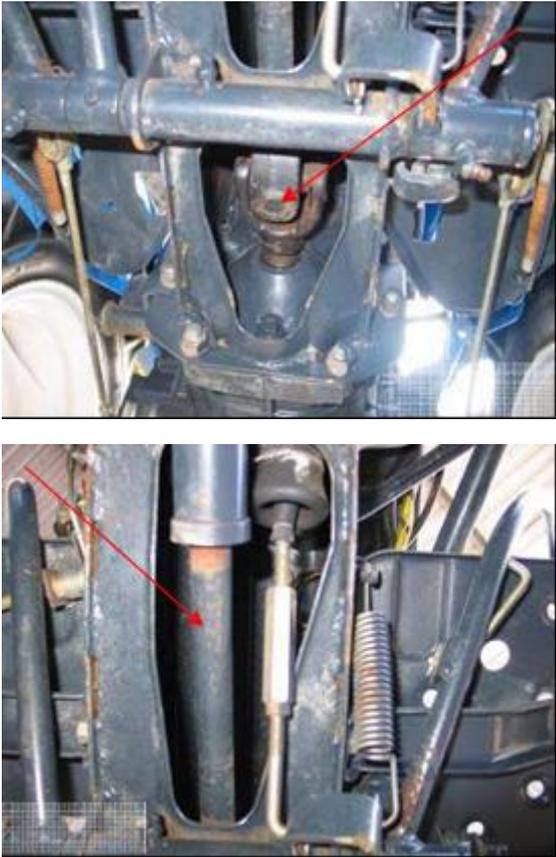
Description	Images
<p>Examples of universal joints and steering shafts (red arrows), accessible for cleaning and inspection after the removal of non-affixed panels. All internal surfaces must be free of all biosecurity risk material.</p>

<p>The first photograph shows a close-up of a universal joint assembly with a red arrow pointing to a specific contact point. The second photograph shows a steering shaft assembly with a red arrow pointing to a joint area.</p>
<p>Small recesses like the one highlighted (red arrows) will require flushing to remove any biosecurity risk material and to verify cleanliness.</p>

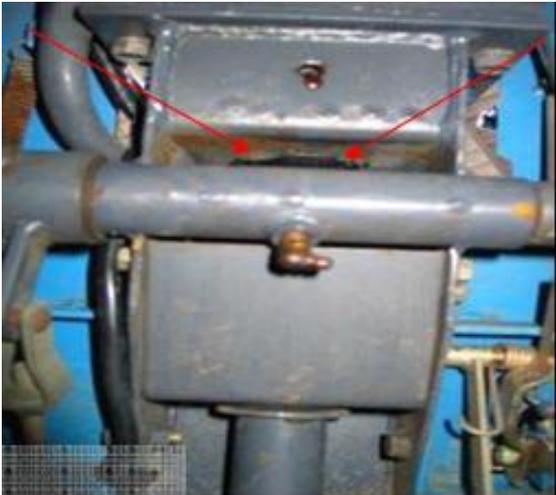
<p>The photograph shows a metal component with a recessed area. Two red arrows point to the recessed area, indicating it requires flushing.</p>

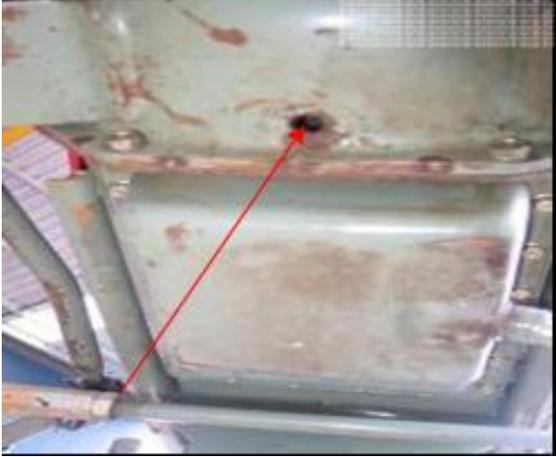
Description	Images
If drainage holes are present (red arrow), flush to verify internal cleanliness.

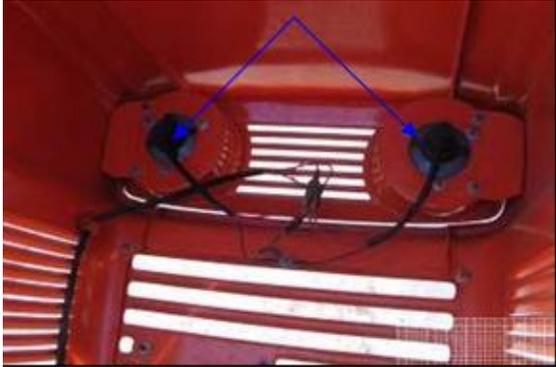
Verify all internal light covers (blue arrows) are clean and free of biosecurity risk material.

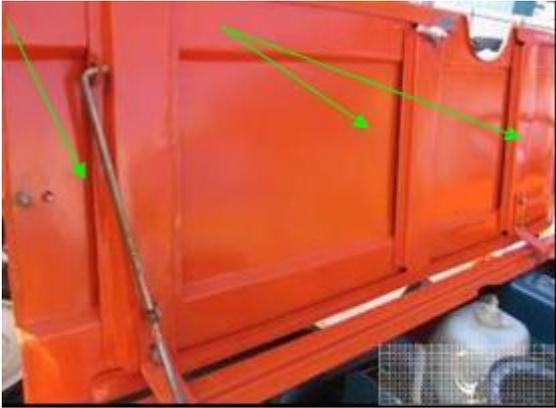
These open support channels (green arrows) inside the top of the engine cover must be thoroughly cleaned and inspected.

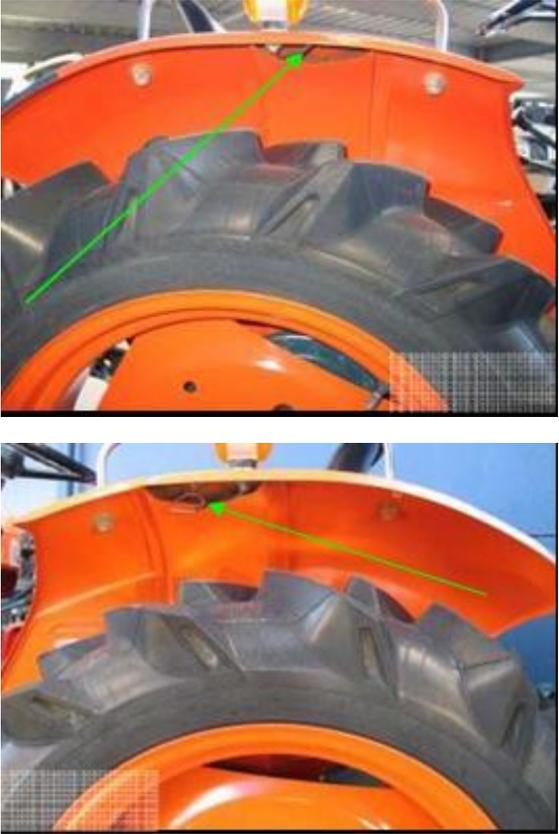
Description	Images
<p>The inside rear wheel arches highlighting the hollow support cavities (green arrows). These hollow channels must be flushed in the presence of the inspecting officer to verify internal cleanliness.</p>

<p>The top photograph shows a close-up of the orange interior of a rear wheel arch. A green arrow points to a small, dark, hollow cavity located above the tire. The bottom photograph shows a similar view from a slightly different angle, with another green arrow pointing to a similar cavity.</p>
<p>On some models, numerous hollow support channels may be found under the rear wheel arches (green arrow). All require flushing to remove any internal biosecurity risk material.</p>

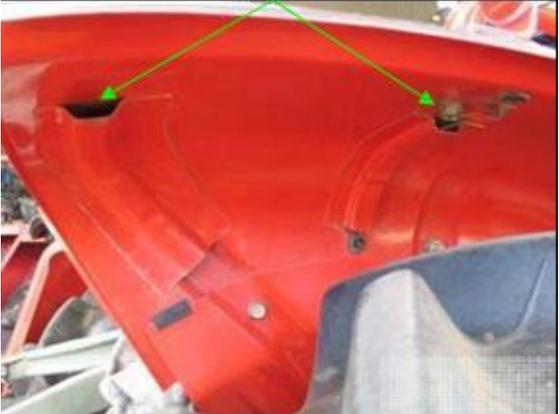
<p>The photograph shows the underside of a red rear wheel arch. Two green arrows point to hollow support channels, one on the left and one on the right, which are located below the main arch structure.</p>

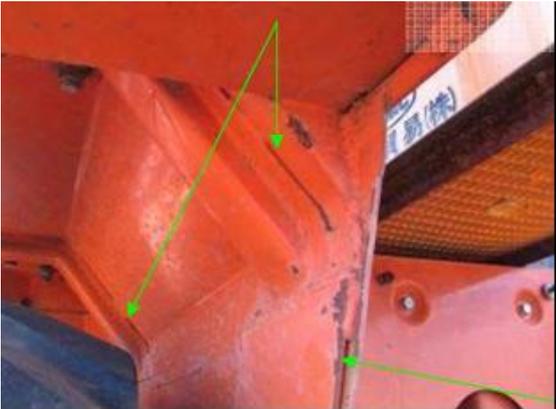
Description	Images
<p>This illustration shows spot-welded hollow support channels under the rear arches. Due to these channels not being sealed units, biosecurity risk material can enter via the small recesses (green arrows) and these require flushing to verify internal cleanliness.</p>

A close-up photograph of a red metal rear arch. Three green arrows point to small, recessed areas where the metal is spot-welded, indicating potential entry points for biosecurity risk material.
<p>The internal cleanliness of the light covers must be verified (blue arrows).</p>

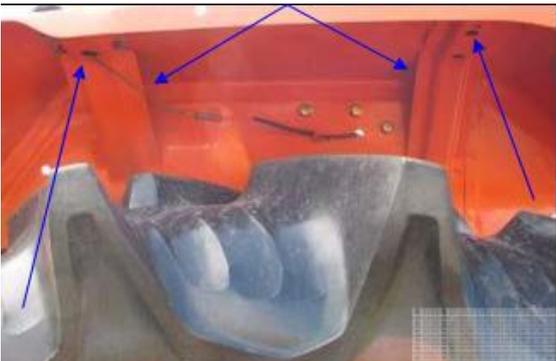
An interior view of a tractor's rear wheel arch. Four blue arrows point to various hollow support channels and recessed areas within the arch, indicating the need for flushing to verify internal cleanliness.

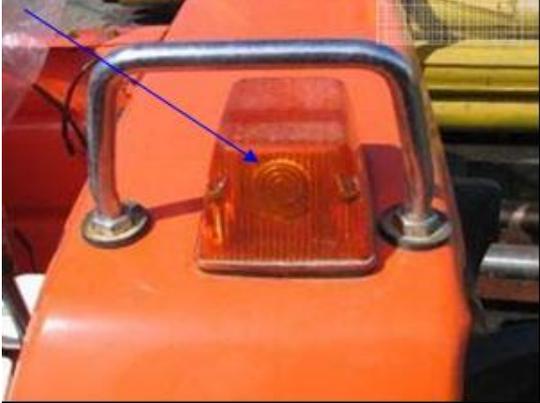
Description	Images
<p>The internal cleanliness of the light covers on top of the wheel arches must be verified (blue arrow).</p>

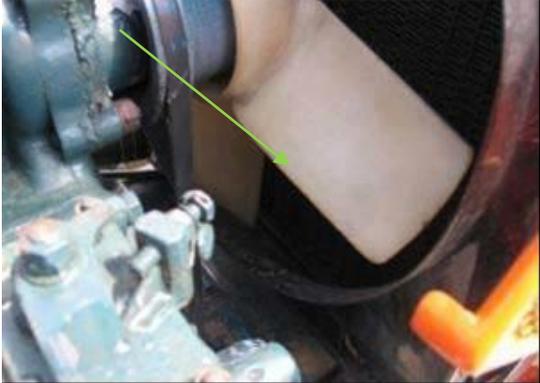
Description	Images
<p>Most radiators do not have an internal grill cover, which allows cleaning and inspection access to the inside of the shroud (green arrow).</p>

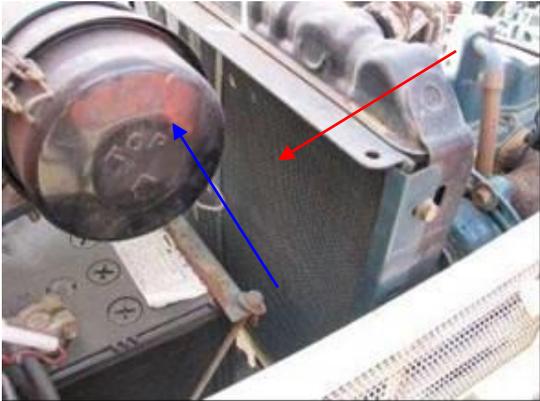
<p>The red arrow highlights the mesh grill commonly found at the front of the radiator. These mesh grills must be removed to allow debris caught in the radiator core to be flushed out and removed. Remove the air-filter (blue arrow) and verify cleanliness.</p>

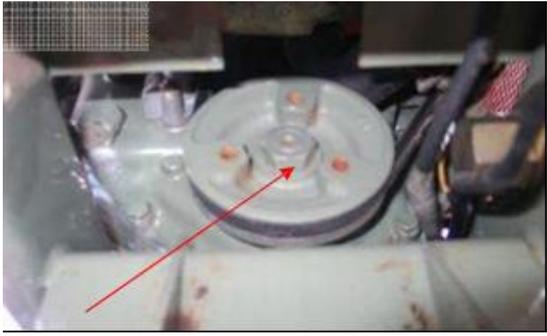
Description	Images
<p>The harmonic balancer found at the front of the engine block (red arrow). These areas are generally concave, can harbour biosecurity risk material and must be verified clean.</p>

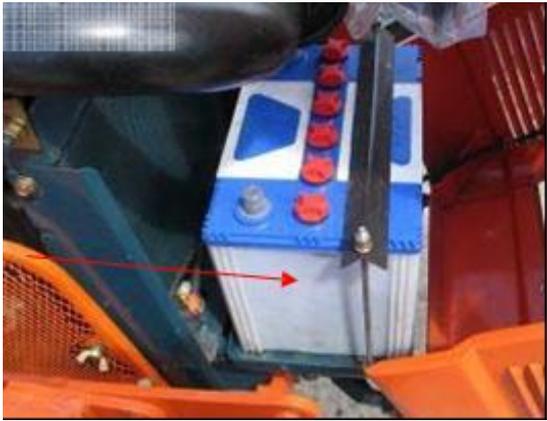
<p>All batteries must be loosened from the tie down points for underside cleaning and inspection (red arrow).</p>

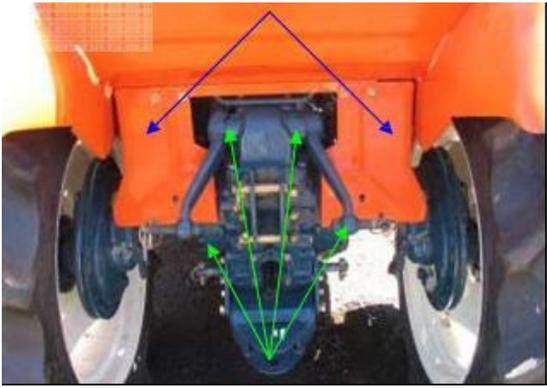
Description	Images
<p>The rear view of a typical mini tractor. To facilitate the cleaning and inspection process, remove all non-affixed panels (blue arrows). All contaminated grease must be removed from the linkage arms and pivot points (green arrows).</p>

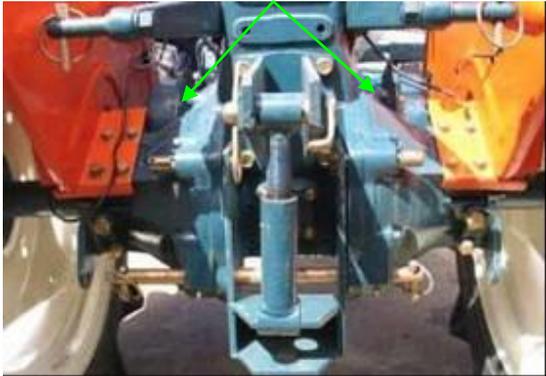
Description	Images
<p>Once these rear panels have been removed, it allows access for cleaning and inspection. The green arrows highlight small recesses between the rear guard and the topside of the axles. See following illustrations.</p>

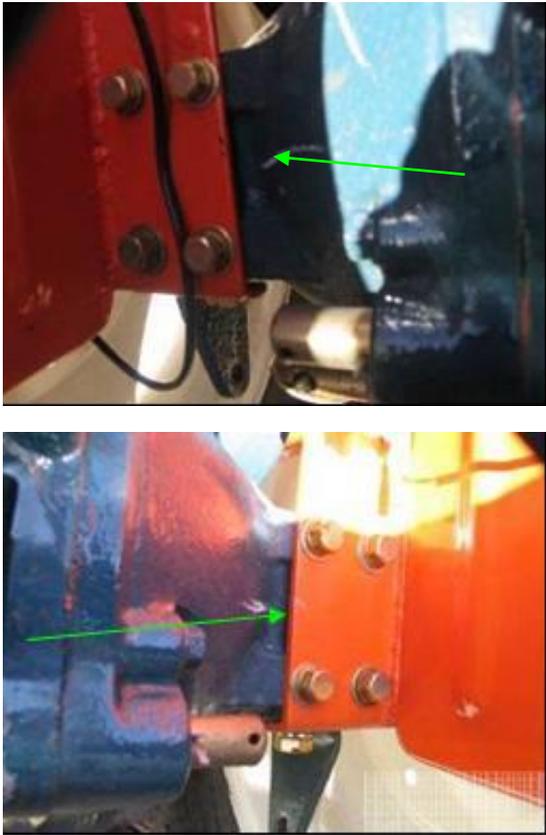
<p>These two illustrations highlight the small recesses that can be found on the rear axles on some models. The green arrows highlight a small gap that must be flushed to verify cleanliness.</p>

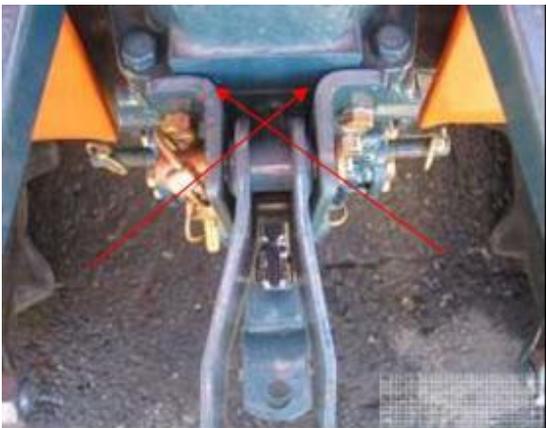
<p>Check for any biosecurity risk material in areas where attachments are mounted to the rear of the tractor (red arrow). Areas like those illustrated by the red arrows may require flushing to verify cleanliness.</p>

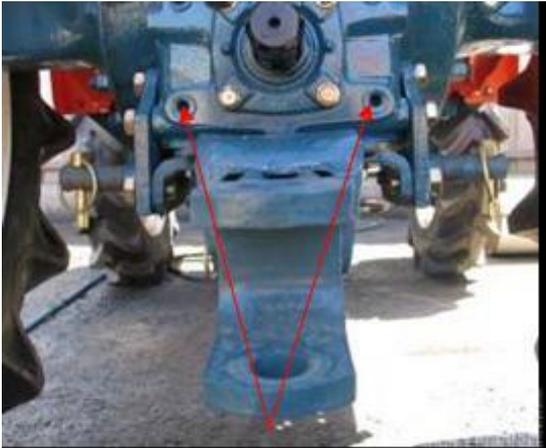
Description	Images
All countersunk holes (red arrows) must be free of biosecurity risk material.

A close-up photograph of a blue tractor component. Two red arrows point to small, circular countersunk holes on the surface of the metal part.
In conjunction with verifying countersunk holes, on some models, other small recesses (green arrows) can be flushed to verify cleanliness.

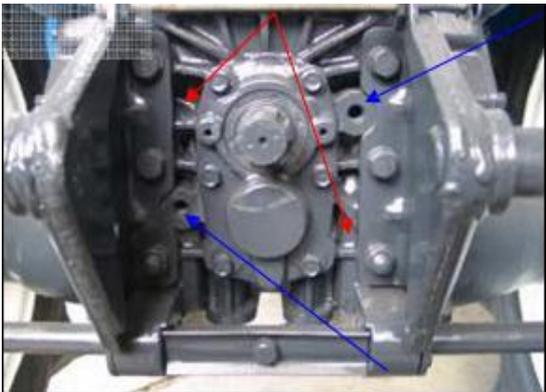
A photograph showing the rear of a mini tractor. Red arrows point to various ledges and protrusions on the metal frame, while blue arrows point to countersunk holes. The tractor is positioned on a concrete surface.

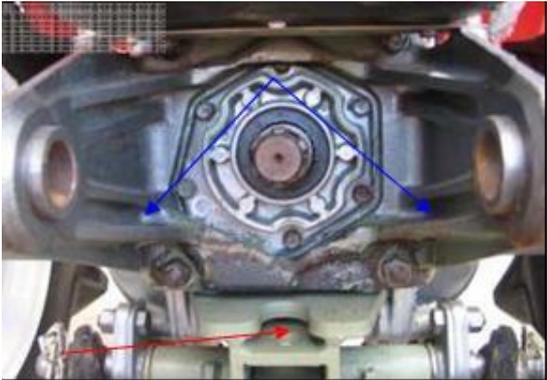
Description	Images
<p>Even though the rear of some models may appear simplified, all have ledges (blue arrow) and nooks (red arrow) that require thorough cleaning and inspection.</p>

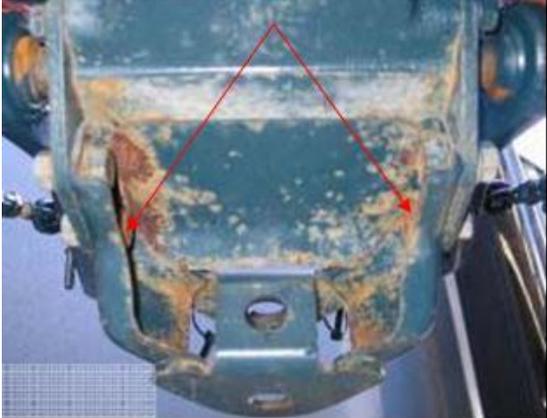
<p>The underside of the linkage at the rear. These generally have small ledges (red arrows) that must be checked for cleanliness.</p>

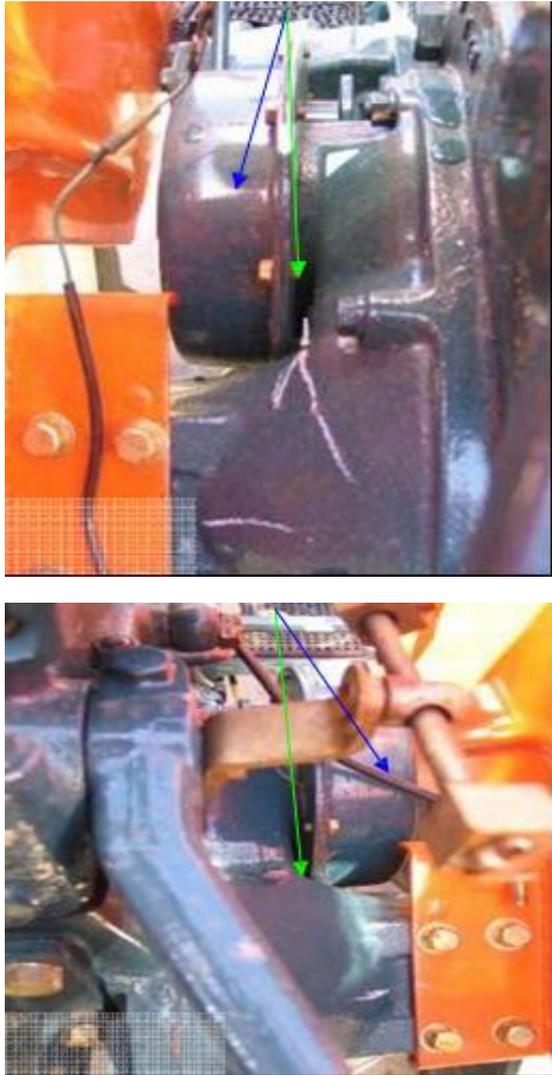
Description	Images
<p>Small recesses between the chain cover (blue arrows) and housing like those highlighted by the green arrows must be verified.</p>

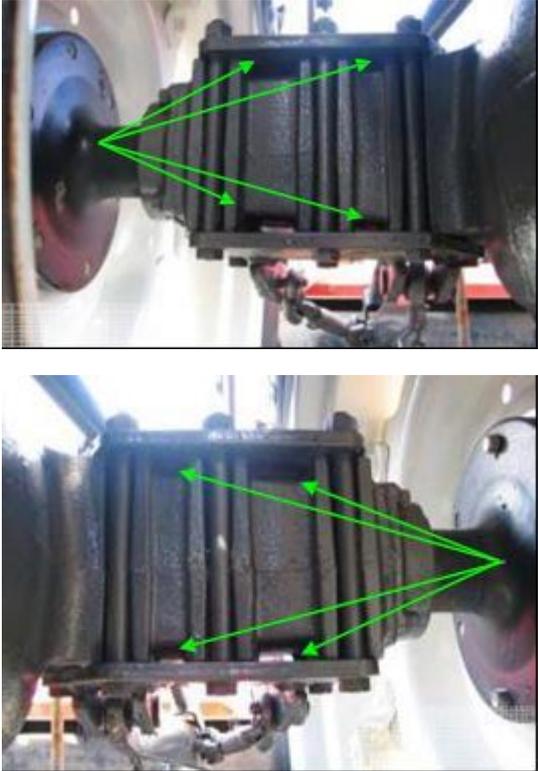
Description	Images
<p>All surfaces of the rear axles must be free of biosecurity risk material and some may require flushing of recesses (green arrows) to verify cleanliness.</p>

<p>The images show two views of a rear axle assembly. The top image shows the axle from a side-on perspective, with green arrows pointing to the recessed areas between the axle and the housing. The bottom image shows the axle from a different angle, also with green arrows pointing to the recessed areas. The arrows indicate the specific locations where biosecurity risk material might accumulate and need to be flushed out.</p>

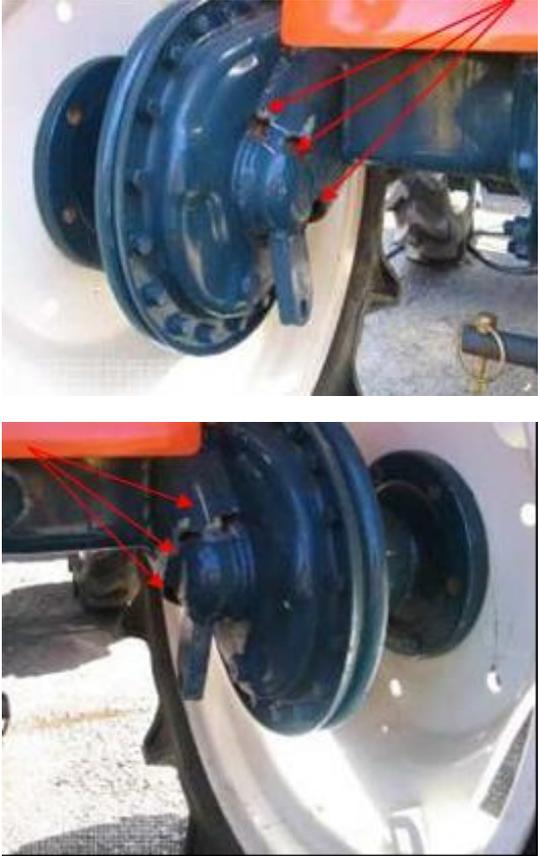
Description	Images
<p>On some models, small gaps can be found in the inside hub housing (red arrows). These areas that can harbour biosecurity risk material will be further illustrated next.</p>

<p>The images show two views of the inside of a rear hub housing. Red arrows point to small gaps between the housing and the hub, which can harbour biosecurity risk material.</p>

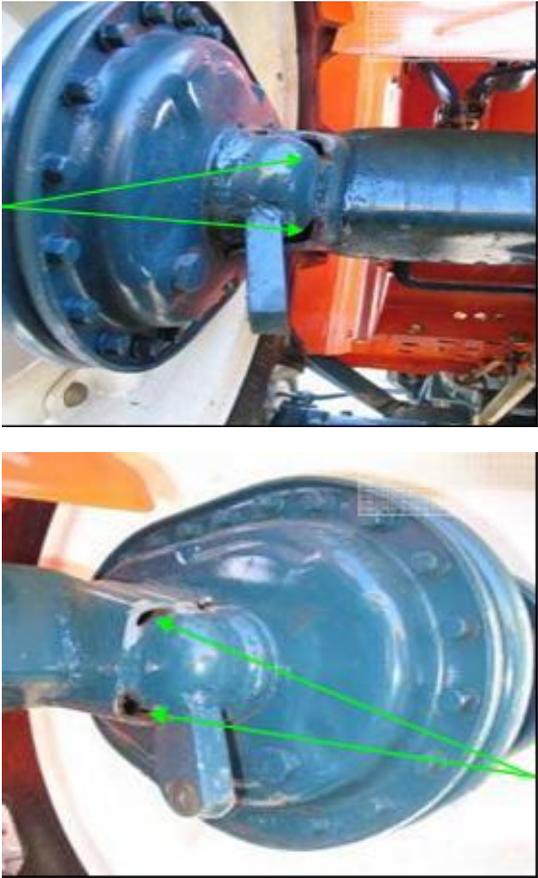
Description	Images
<p>A closer view of the small openings (green arrows) that may be found on the rear hubs on some model mini tractors. These must be flushed to verify cleanliness.</p>

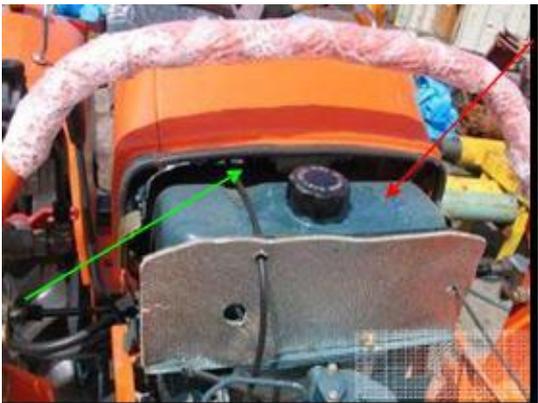
Description	Images
<p>On most models, when the engine cover is lifted, the topside of the fuel cell (red arrow) becomes accessible for cleaning. The front and topside of the fuel cell (green arrow) is covered by the instrument panel, however this area requires thorough cleaning and inspection.</p>

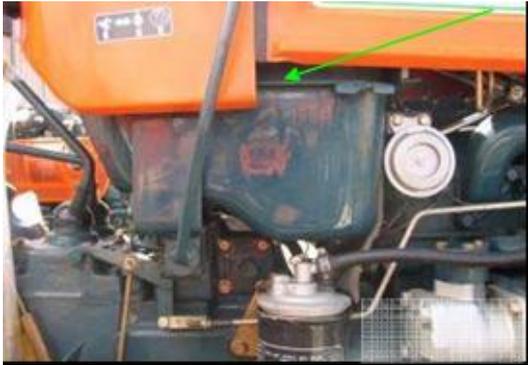
Description	Images
<p>Ensure that the ledge around the fuel cell (green arrow) is verified clean.</p>

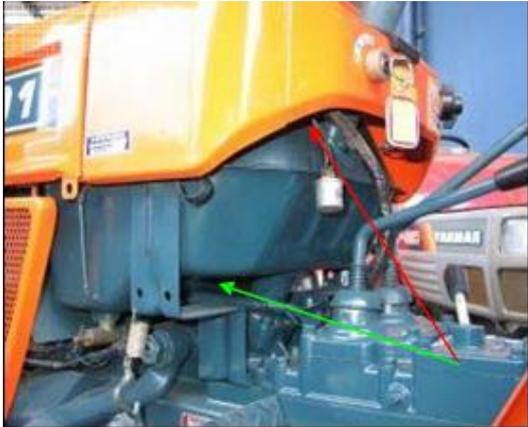
<p>The front, sides and the ledge around the fuel cell (red arrow) can be cleaned and inspected from this angle. The underside of the fuel cell (green arrow) also requires verification.</p>

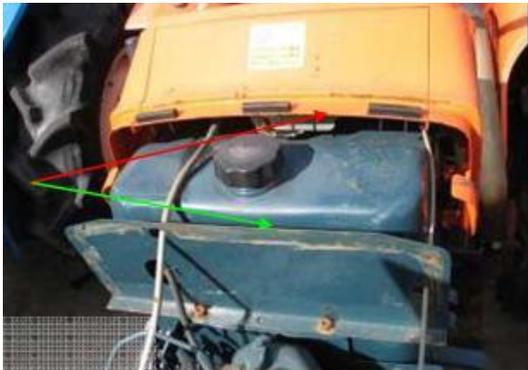
<p>Another view of the topside of the fuel cell (red arrow) and small recess between the rear of the fuel cell and the engine block (green arrow).</p>

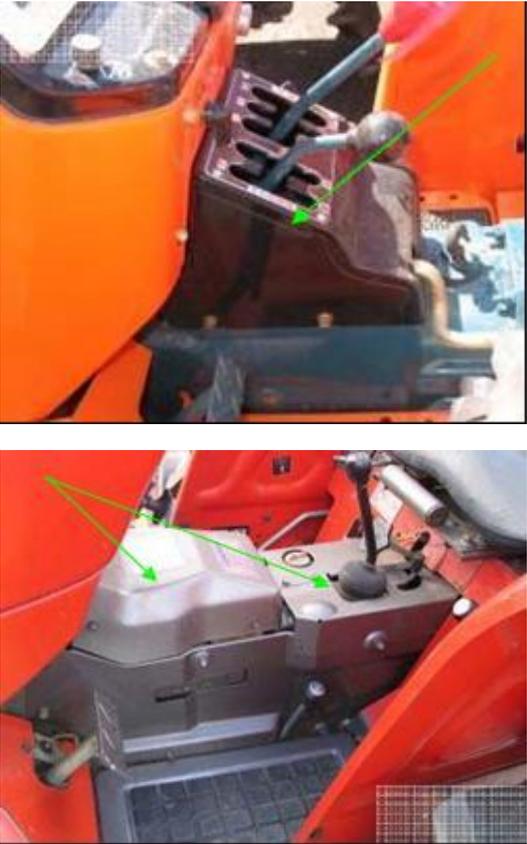
Description	Images
<p>Several illustrations of the variety of gearbox covers (green arrows) found on mini tractors. These non-affixed covers must be removed for cleaning and inspection.</p>

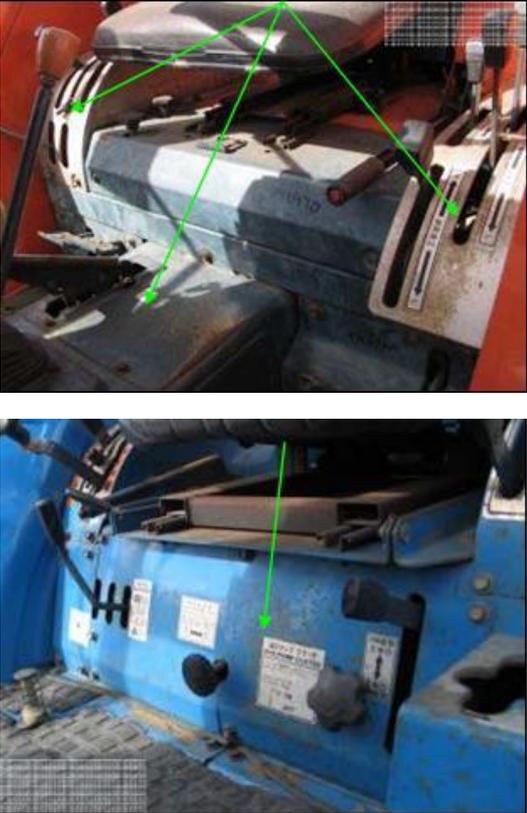
<p>On other models the gear levers may be found under or beside the seat. These non-affixed covers (green arrows) must be removed for cleaning and inspection.</p>

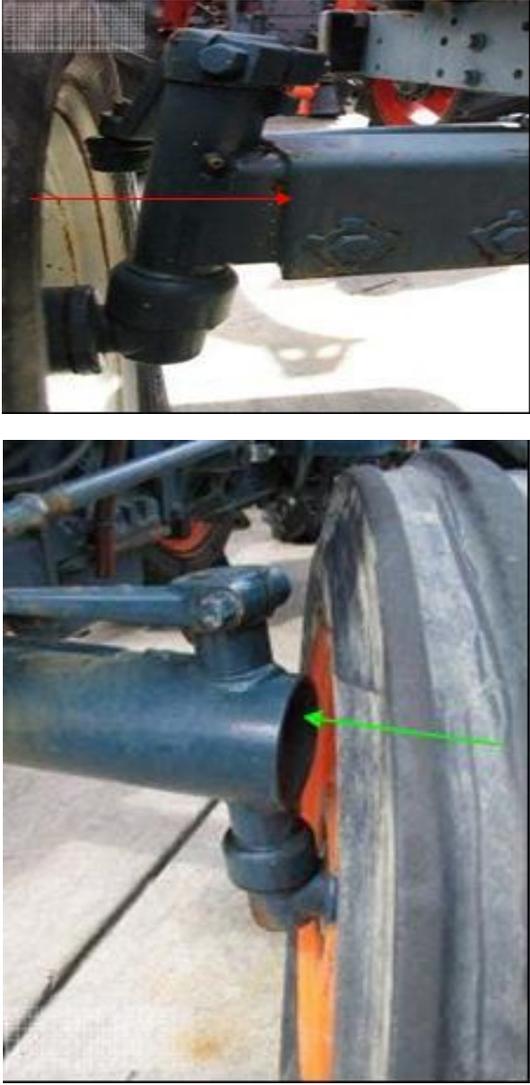
Description	Images
<p>Two examples of hollow front axles that require flushing to verify internal access. While the example on the left only highlights a small recess between the inner and outer sleeve (red arrow), the example on the right shows an open-ended axle (green arrow).</p>

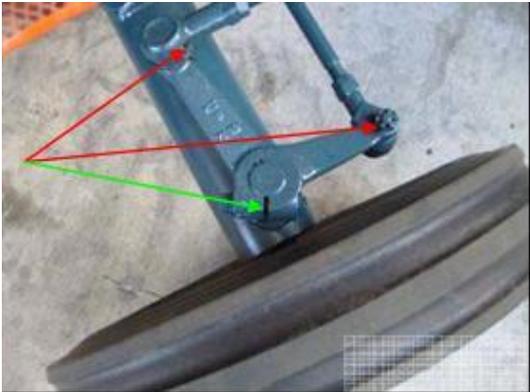
<p>All pivot points and push arms must be free of contaminated grease.</p>

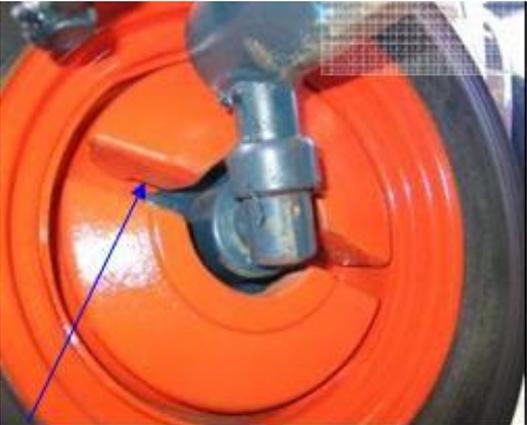
Description	Images
Internal wheel rims such as those illustrated may require flushing to verify cleanliness (blue arrow).

A close-up photograph of an orange-painted metal wheel rim. A blue arrow points to a recessed area on the inner surface of the rim, near a central hub component.
This illustration highlights a few small recesses (red arrows) above the front axle that require flushing to verify cleanliness.

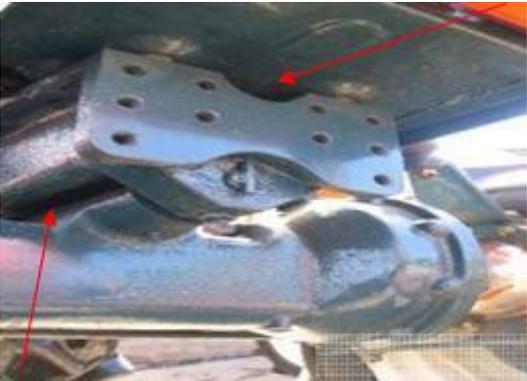
A close-up photograph of a metal chassis rail. Two red arrows point to small recessed areas on the upper surface of the rail, above the front axle assembly.
Under the front nose, hollow cavities (red arrows) inside the chassis rail will require verification via flushing if present.

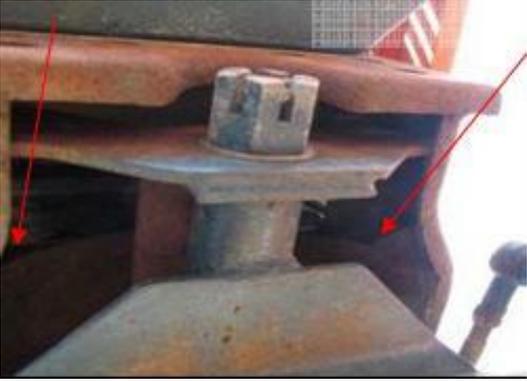
A close-up photograph of a chassis rail. Two red arrows point to hollow cavities or recessed areas on the underside of the rail, near the front nose of the tractor.

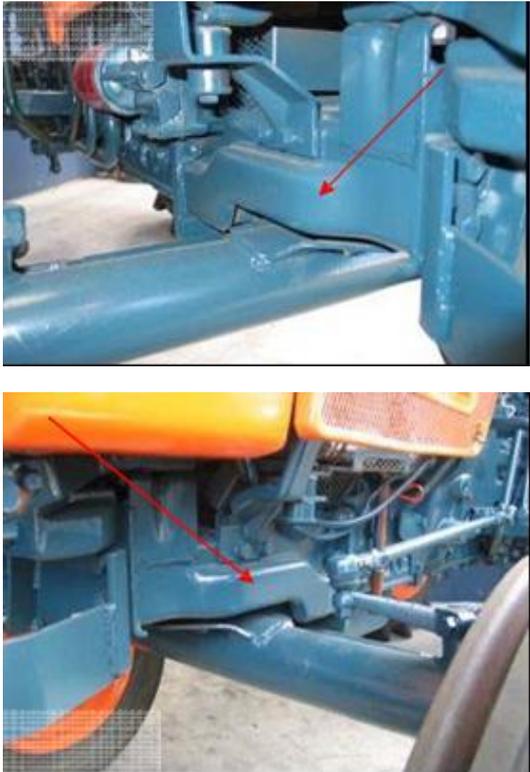
Description	Images
<p>These illustrations highlight the outside of a hollow channel (red arrows) that is present on some models and potentially harbour biosecurity risk material. The following illustrations will highlight the inside access points for flushing.</p>

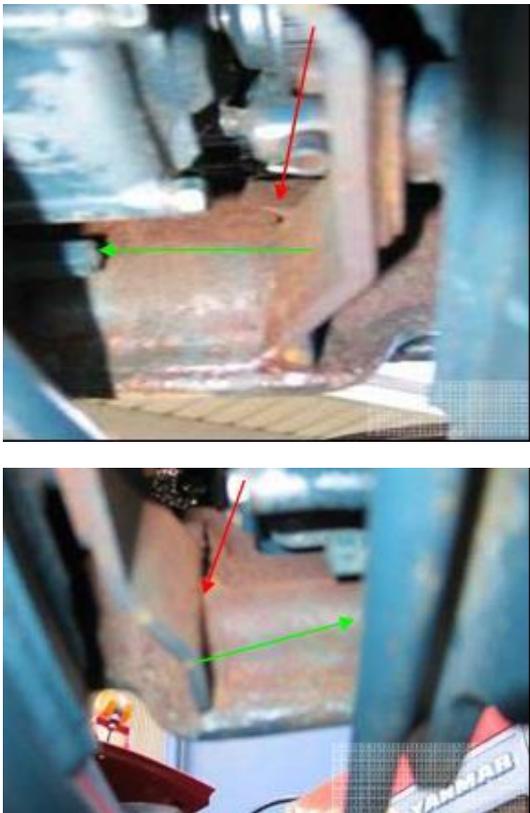
<p>Although not visible in these illustrations, the access points to the hollow channels mentioned above are highlighted by the red arrows. The green arrows indicate the direction of the hollow channel.</p>

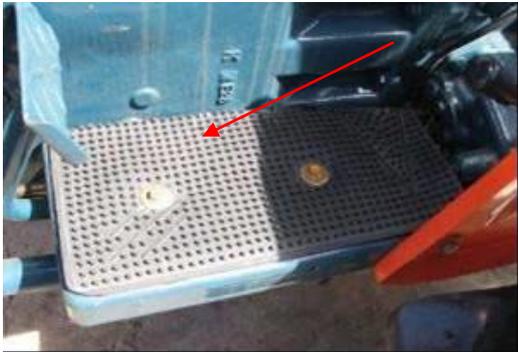
Description	Images
<p>The underside of all rubber mats (red arrow) that may be on mini tractor sidesteps must be cleaned and accessible for inspection.</p>

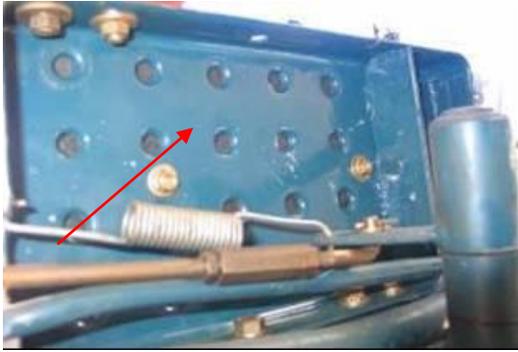
<p>The underside of the side step (red arrow) must also be free of all biosecurity risk material.</p>

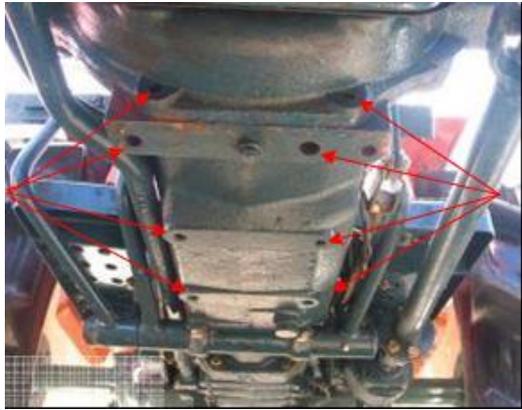
Description	Images
<p>The underside of many mini tractors has numerous countersunk holes (red arrows) which all require cleaning and inspection to verify free of contaminants.</p>

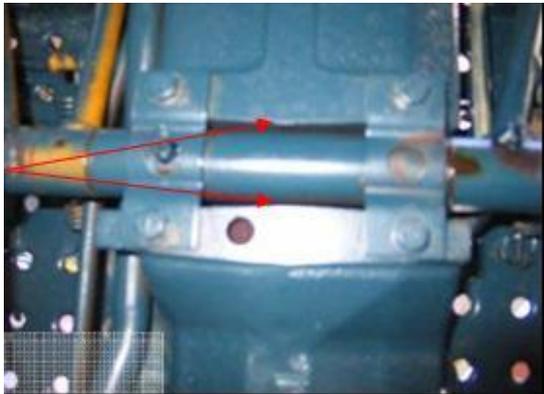
<p>The shaft (red arrows) located halfway along the underbelly will require flushing to verify cleanliness.</p>

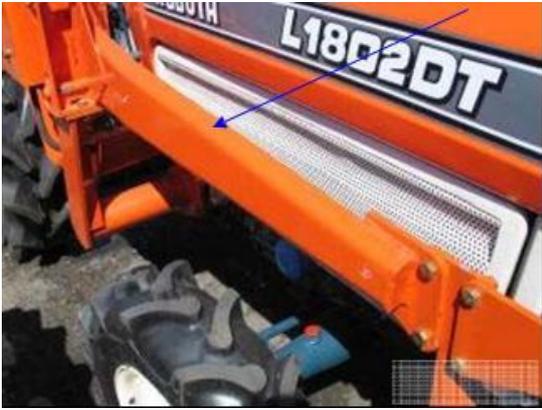
Description	Images
<p>The push arms (blue arrow) may be hollow structures which require internal verification. See next illustration.</p>

A close-up photograph of an orange tractor's push arm. A blue arrow points to the arm. The tractor's body has the text 'L1802DT' visible. A small grid pattern is in the bottom right corner.
<p>On the inside of the push arm, a hollow structure (green arrow) is illustrated and will require verification.</p>

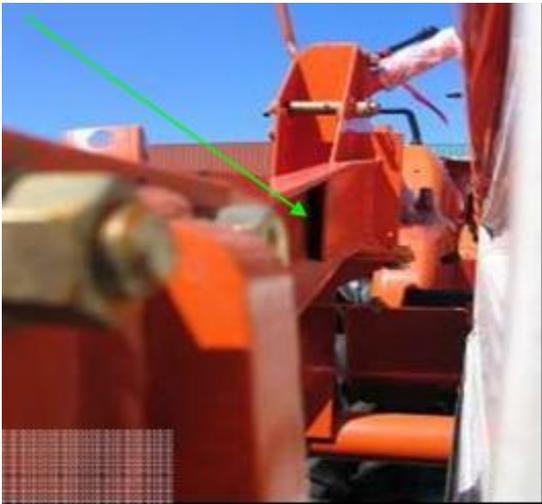
An interior view of the push arm, showing a hollow structure. A green arrow points to this structure. A small grid pattern is in the bottom left corner.
<p>At the base of where the push arms attach to the frame (green arrow) there may be open cavities which will be illustrated next.</p>

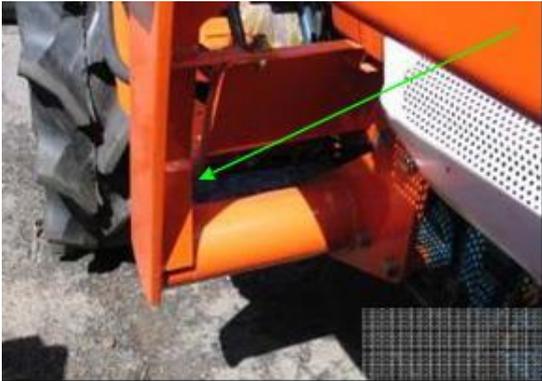
A view of the base of the push arm where it attaches to the tractor's frame. A green arrow points to an open cavity. A small grid pattern is in the bottom right corner.

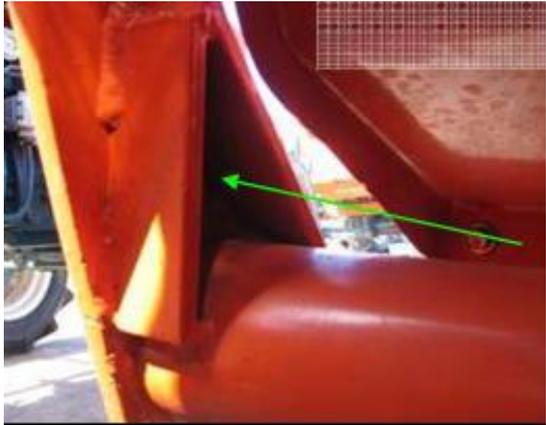
Description	Images
<p>The open cavity at the base of the push arms (green arrow) which will require verification.</p>

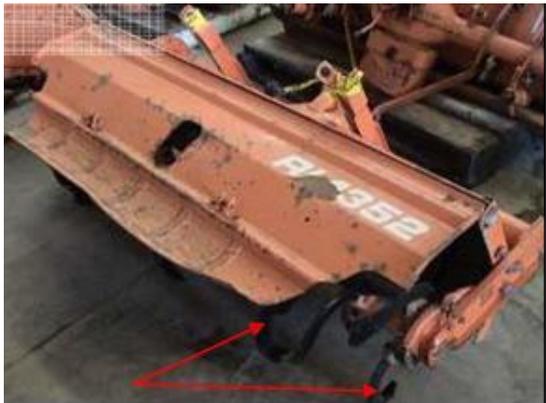
Description	Images
<p>A typical rotary hoe for a mini tractor. All blades (red arrows) must be removed from the tynes for cleaning and inspection. There are numerous cavities and recesses on all surfaces of the rotary hoe and all must be thoroughly cleaned and inspected. Many will require flushing to verify cleanliness.</p>

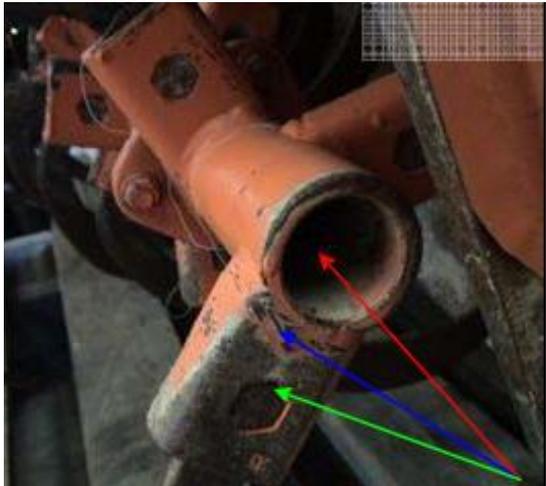
<p>The tyne pockets (green arrow) are hollow (blue arrow) and to verify these, the blades must be removed. Flushing with the blades in place does not suffice. Flush all hollow channels (red arrow) as indicated.</p>

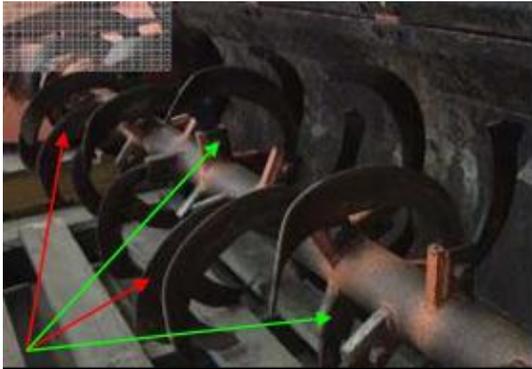
Description	Images
<p>The cutting blades (red arrows) on the rotary hoe. All blades must be removed to verify the internal cleanliness of the tynes (green arrows).</p>

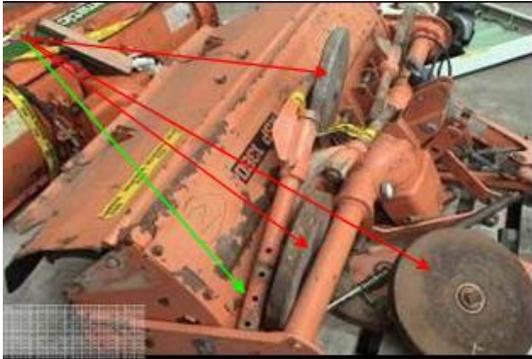
<p>All surfaces of the rotary wheels (red arrows) must be checked for cracks, splits or evidence of repair. These wheels are hollow and will require flushing to verify internal cleanliness if breached. Flush all hollow channels (green arrow) to verify cleanliness.</p>

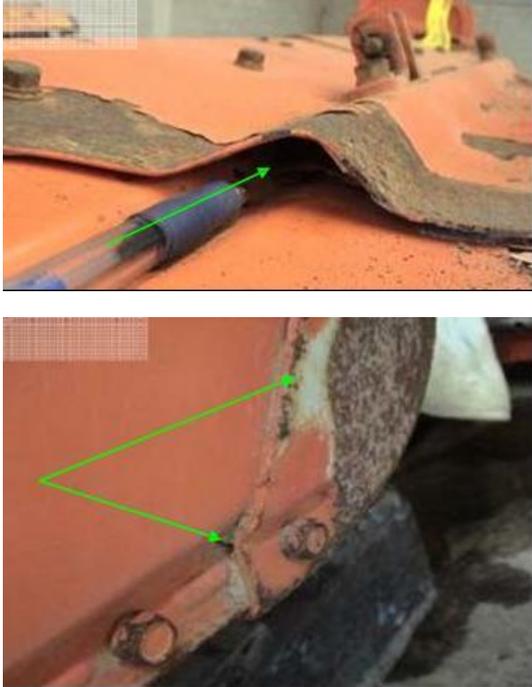
<p>Examples of the small cavities (green arrows) that are commonly found on rotary hoes. These areas must be cleaned and flushed to verify cleanliness.</p>

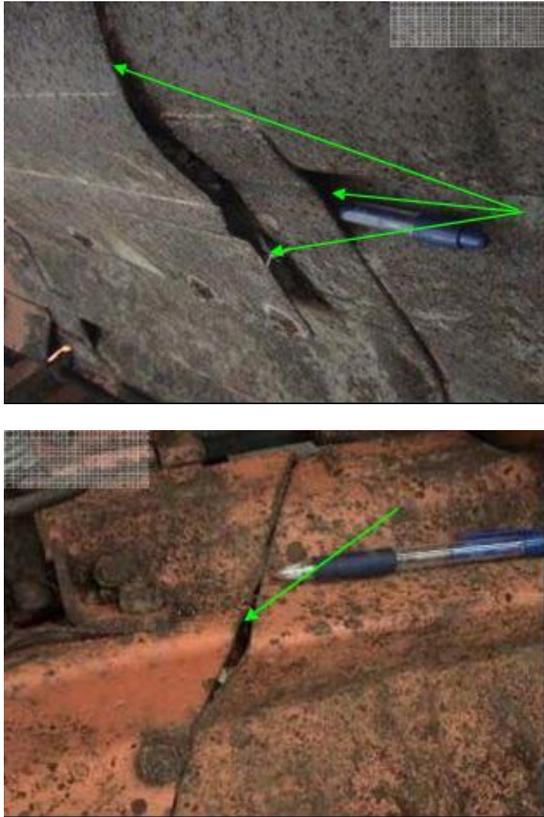
Description	Images
<p>Examples of the small cavities (green arrows) that are commonly found on rotary hoes. These areas must be cleaned and flushed to verify cleanliness.</p>

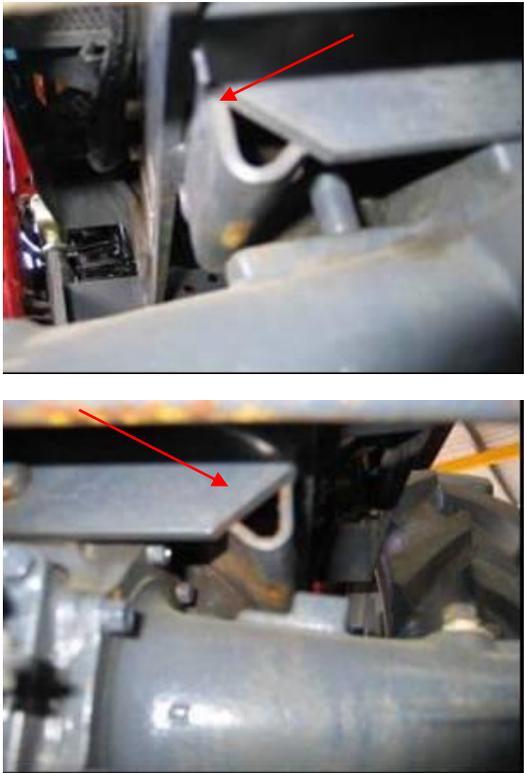
Description	Images
<p>Hollow channels like those highlighted (red arrows) must be verified internally clean.</p>

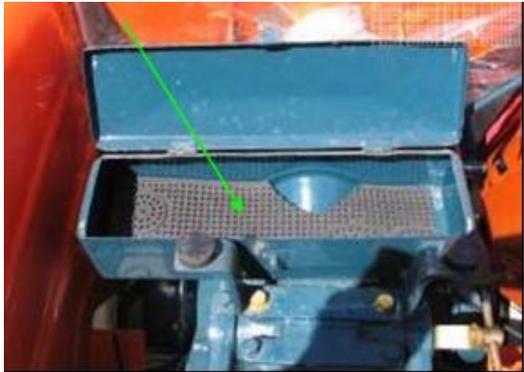
<p>Verify the internal cleanliness of the toolbox, located under or behind the seat.</p>

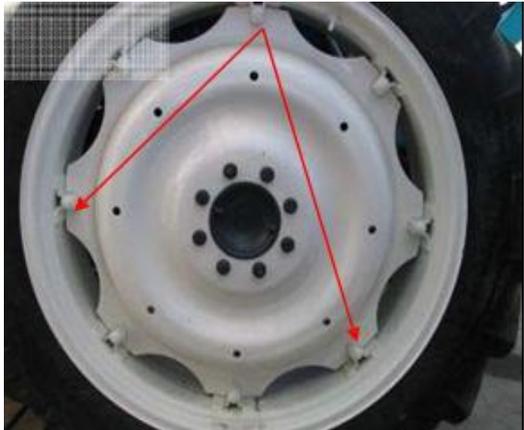
<p>Check all outer rims for small gussets (red arrows) that will require verification.</p>

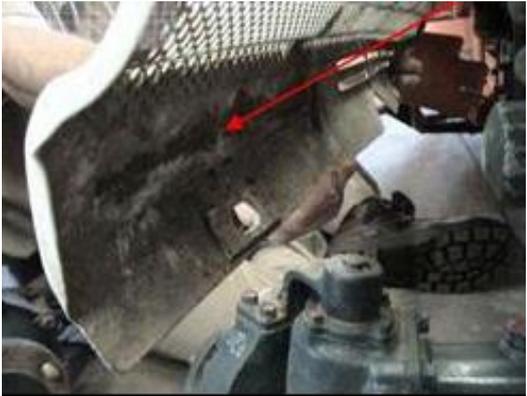
Description	Images
<p>All non-affixed panelling (red arrow) is removed for cleaning and inspection.</p>

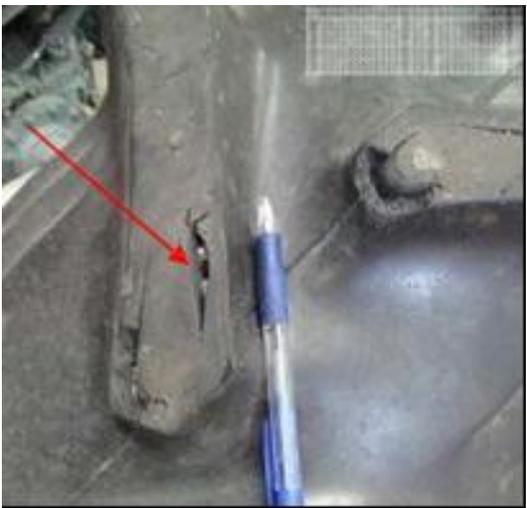
<p>All cracks and splits in tyres must be verified to ensure they are free of biosecurity risk material.</p>

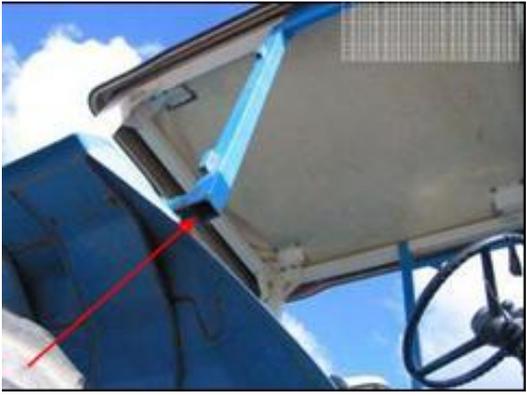
<p>If a cabin is present, check for hollow open-ended framework (red arrow) and flush to verify cleanliness.</p>

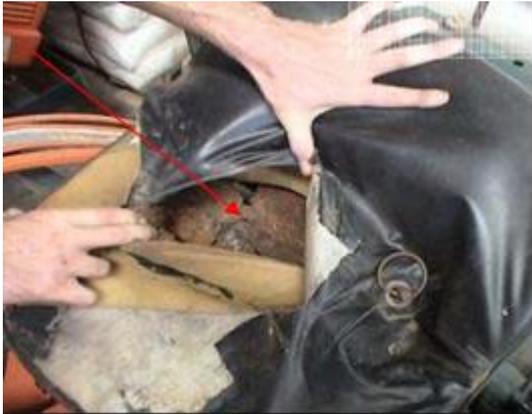
Description	Images
<p>The underside of the seats must be verified clean (red arrow).</p>

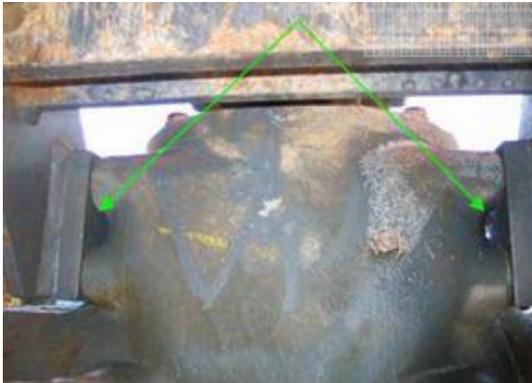
<p>The underside of the axles and differential may also have small recesses (green arrows) that require verification.</p>
