Australian Government
Department of Agriculture
and Water Resources

Machinery Cleaning Guide - Motor Grader

April 2016

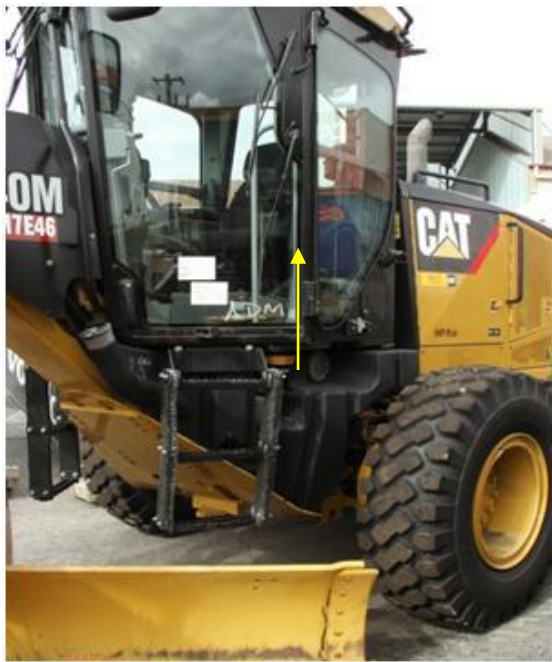
Description	Images
<p>A typical view of a grader cabin from the side. Cabin door rubbers can be contaminated and are therefore an area of concern. The yellow arrow highlights the hollow cabin framework, which requires flushing.</p>

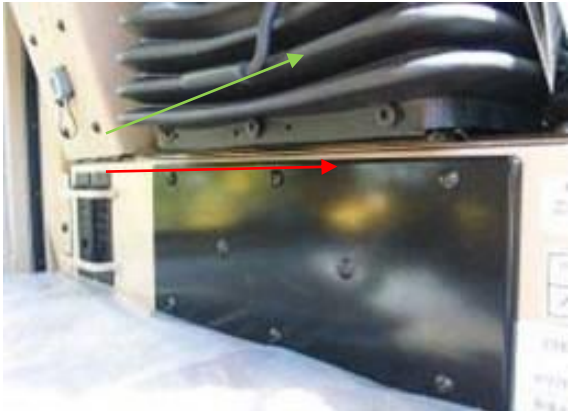
Description	Images
<p>Check below the seat on all models for box sections such as the one highlighted (red arrow). These will need to be checked internally for cleanliness and be accessible at the time of inspection. The rubber shroud under the seat (green arrow) must be externally and internally cleaned and inspected.</p>

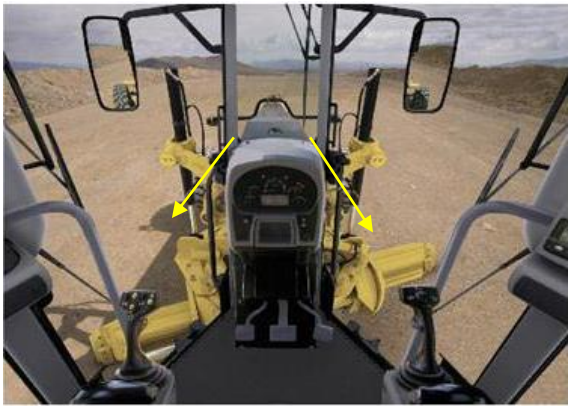
<p>All joystick control panels will need to be cleaned internally and be accessible at the time of inspection.</p>

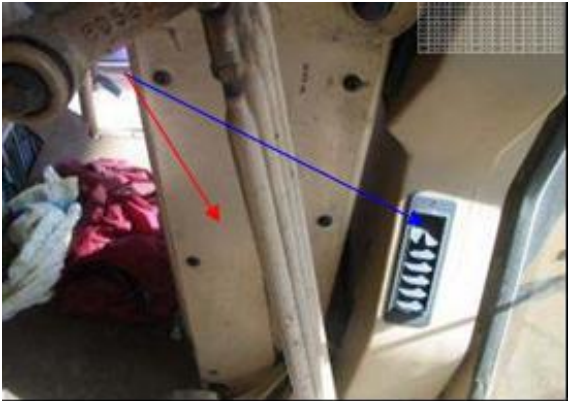
<p>The steering column (red arrow) will need to be internally cleaned and inspected, likewise the air-conditioning vents (blue arrow) can harbour internal biosecurity risk material.</p>

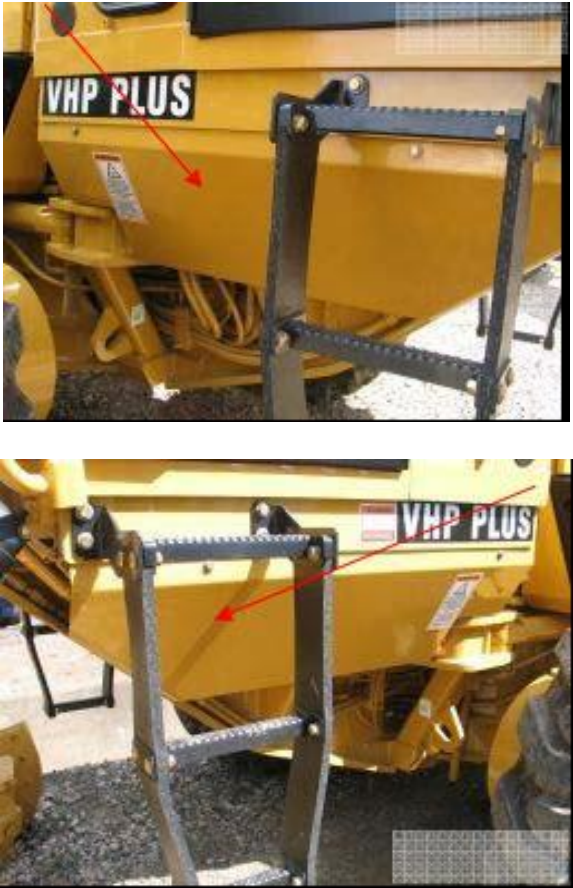
Description	Images
<p>The protective shrouds just below the cabin need to be removed to facilitate the cleaning and inspection process.</p>

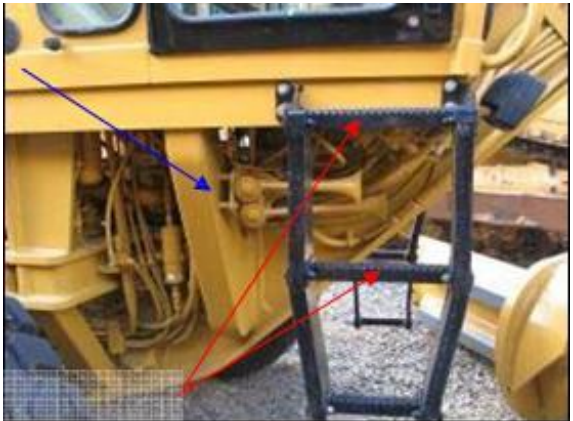
<p>Removing the non-affixed panels from below the cabin will facilitate the cleaning and inspection process (blue arrow). Check all ladder steps (red arrows) are clean.</p>

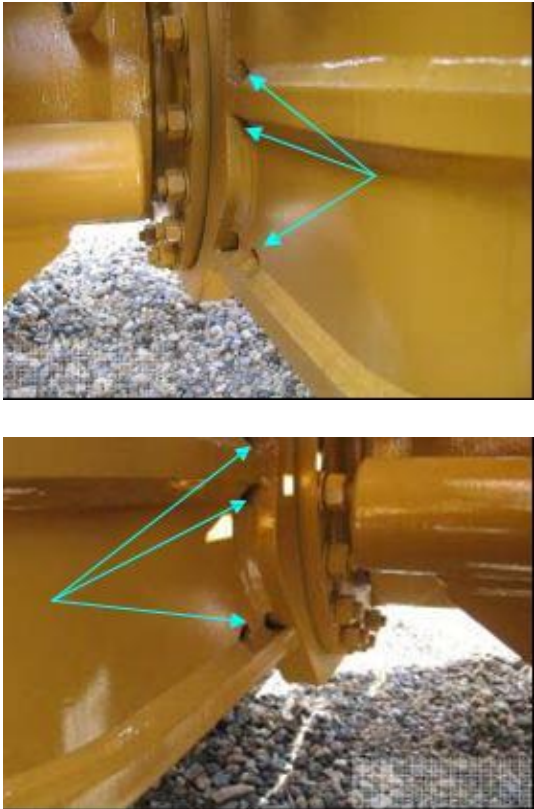
Description	Images
<p>Illustrates the drainage holes located behind a number of hydraulic hoses and pivot area, directly below the cabin.</p>

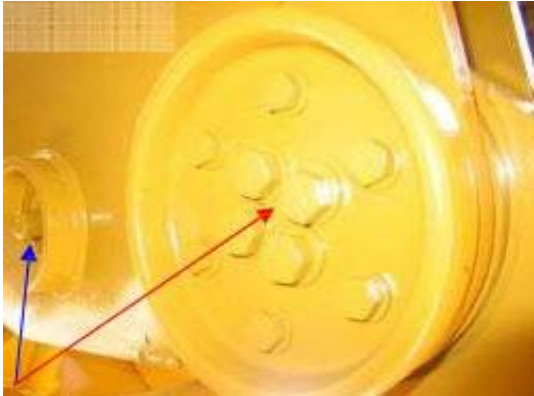
<p>The bottom pivot plate must be cleaned and free of all biosecurity risk material.</p>

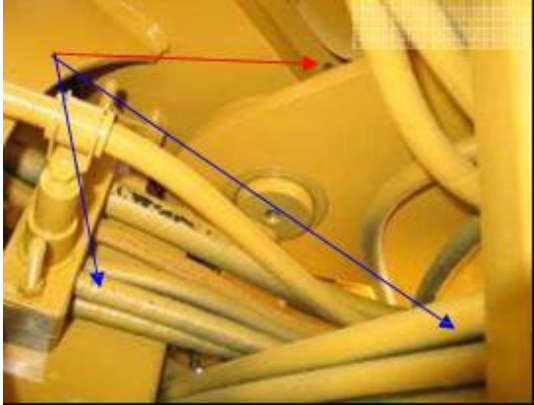
<p>The top pivot point below the cabin floor. This area must be thoroughly cleaned, including all hydraulic hoses (blue arrows) and ledges (red arrow).</p>

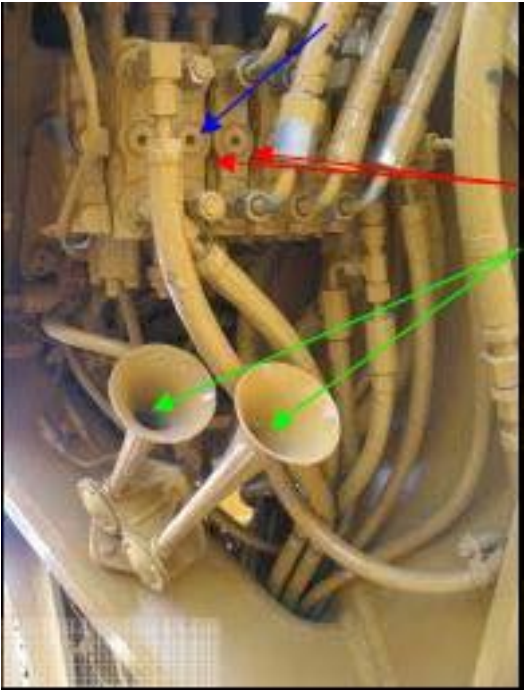
Description	Images
<p>A closer view of the hydraulic hoses under the cabin. Each hose must be thoroughly cleaned and inspected. Ensure in between each coupling (red arrow) and countersunk hole (blue arrow) is clean and free of biosecurity risk material. Wasp nests have been found inside horns (green arrow), internal verification is required.</p>

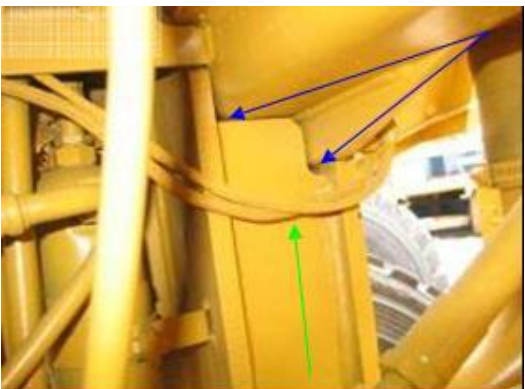
<p>The green arrow highlights one of the vertical support channels under the cabin. As this channel is not sealed (blue arrows), in this instance it will require flushing to verify cleanliness.</p>

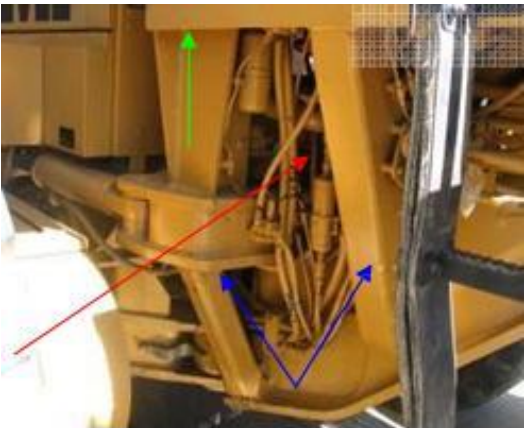
<p>Check under all cabin support rails for drainage holes or openings. As the green arrow highlights and the next illustration illustrates, not all holes are on the bottom of the channels. Check all surfaces of other support channels (blue arrows) for openings that will require flushing, if present. The myriad of hydraulic hoses in this area requires thorough cleaning and inspection.</p>

Description	Images
<p>The opening at the top of the channel (red arrow) as highlighted by the green arrow in the last illustration. These areas must be flushed to verify cleanliness.</p>

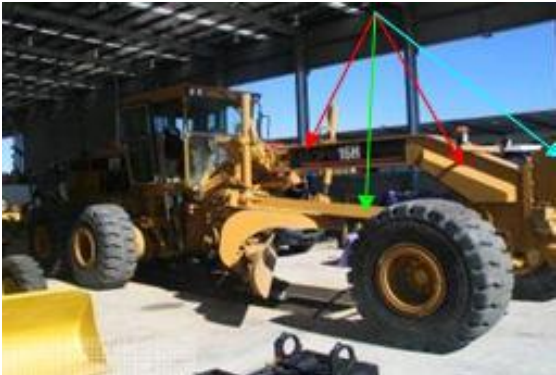
Description	Images
<p>The gooseneck (red arrows), circle arms (green arrow) and front end (aqua arrow) of the grader.</p>	<p>H Model</p>

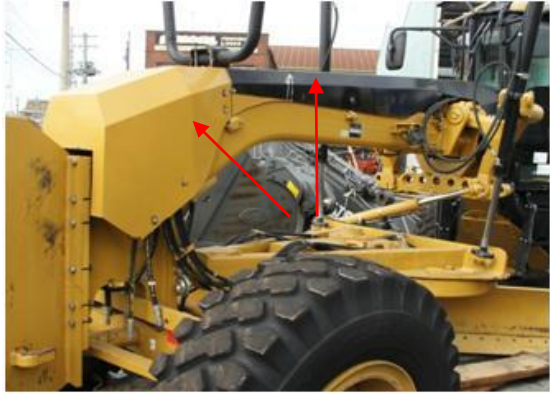
Description	Images
<p>All non-affixed panelling (red arrow) must be removed from along the gooseneck to facilitate cleaning and inspection.</p>

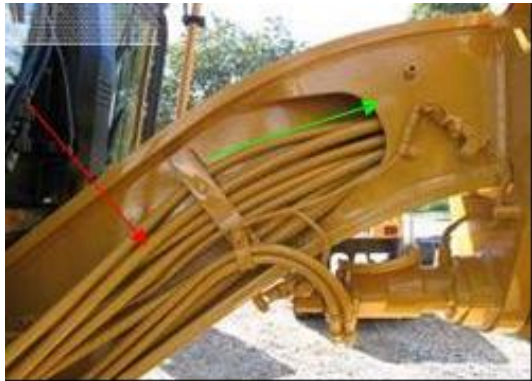
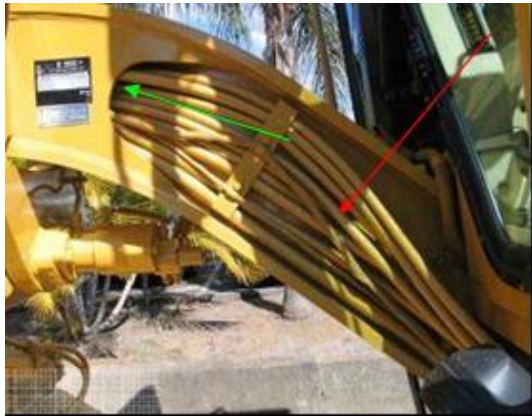
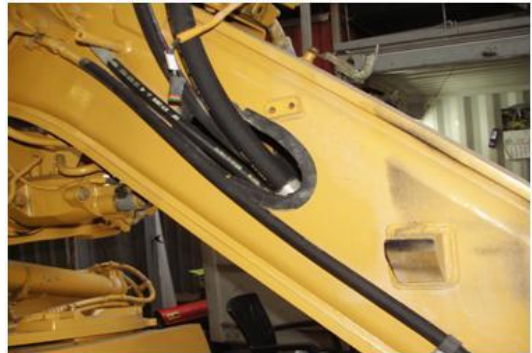
<p>The rear of the gooseneck, just in front of the cabin. All non-affixed panelling has been removed to allow cleaning of all hydraulic hoses and inspection. The hollow area highlighted by the direction of the green arrows is to be flushed to verify cleanliness.</p>

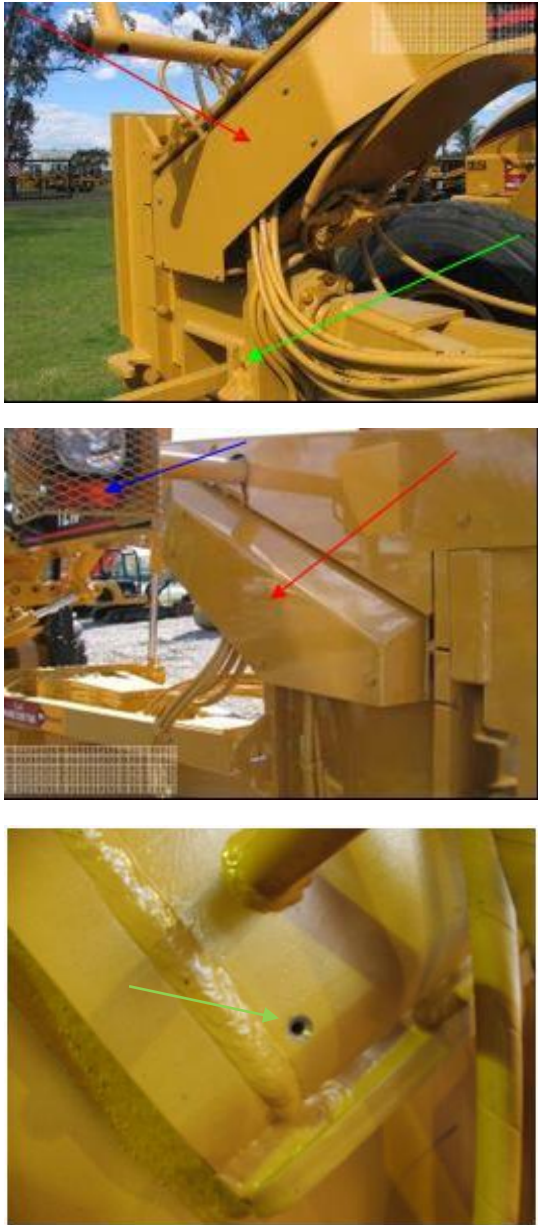
Description	Images
<p>On the front end or nose, a variety of non-affixed panelling can be found (red arrows). All must be removed to facilitate the cleaning and inspection process. The green arrow highlights the gooseneck drainage hole, which will be highlighted later. Check the internal of all light fittings (blue arrow) for cleanliness. The bottom image highlights further access at front of gooseneck provided by importer to confirm freedom of biosecurity risk material.</p>

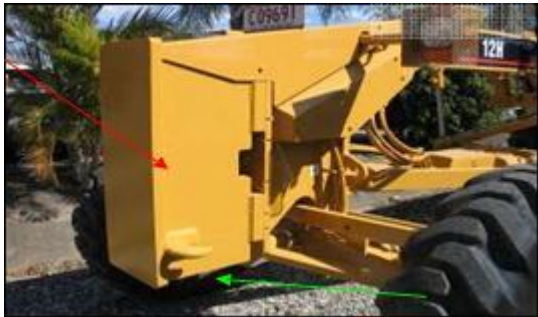
Description	Images
<p>The drainage hole (green arrow) at the front of the gooseneck as mentioned earlier.</p>

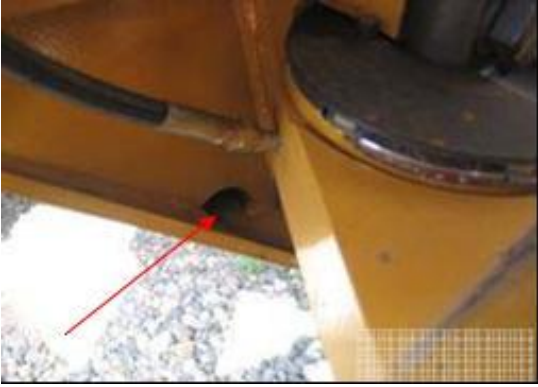
<p>A drainage hole (red arrow) at the bottom of the counterweight. This will require flushing to verify cleanliness.</p>

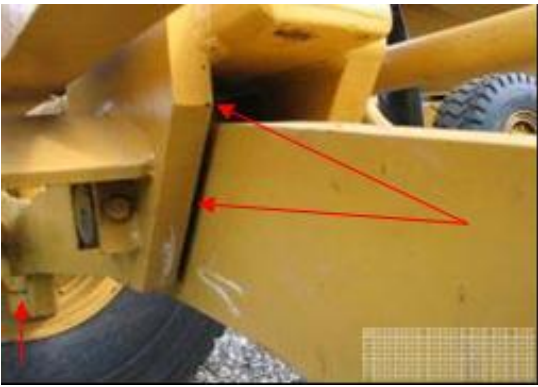
<p>This illustration highlights the pivot point between the two front axels. It may be necessary to flush this area (red arrows) to verify cleanliness. All contaminated grease must be removed.</p>

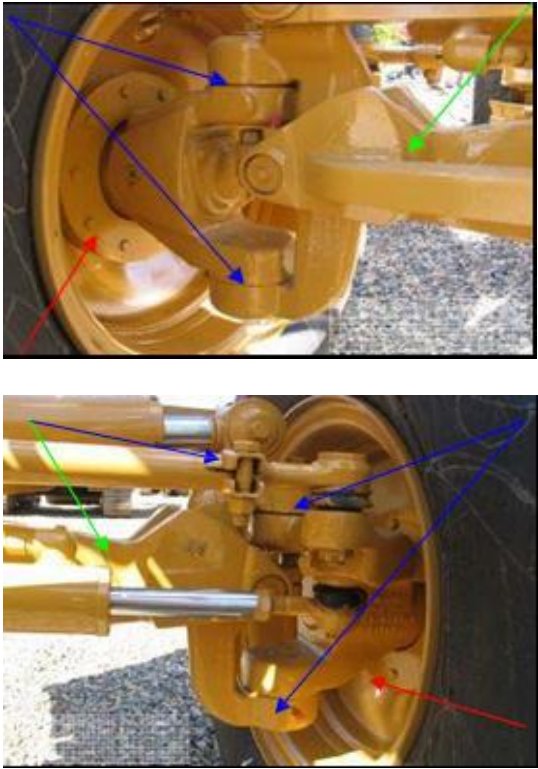
Description	Images
<p>The front rims (red arrows), axels (green arrows) and hydraulic rams and pivot points (blue arrows). All contaminated grease must be removed from these areas.</p>

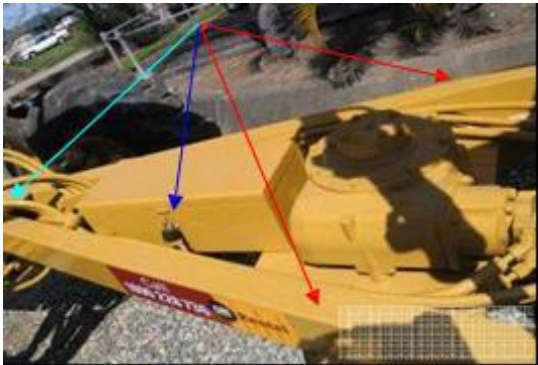
<p>The circle support arms (red arrows) under the gooseneck. Check these arms for cracks, splits and evidence of repair or drainage holes (aqua arrow) as illustrated next. Remove all contents of the toolbox (blue arrow) and clean internal surfaces.</p>

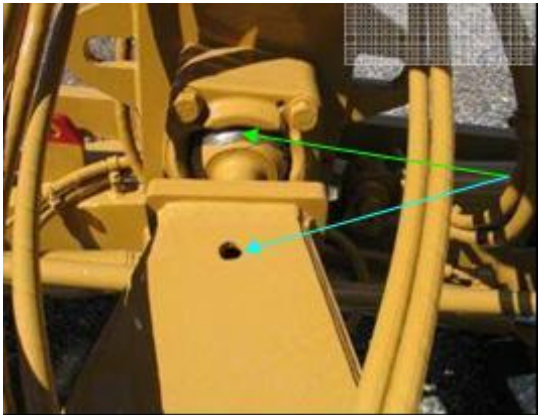
<p>The drainage hole (aqua arrow) at the point where the two arms meet at the front end. There may be further drainage holes on the underside. If these arms have openings as illustrated, they must be flushed to verify cleanliness.</p>

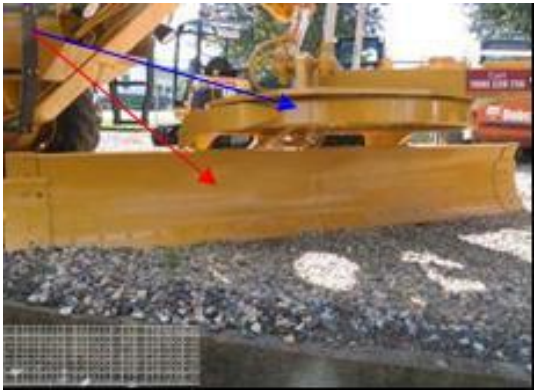
Description	Images
<p>A grader blade (red arrow) and circle above (blue arrow).</p>

<p>A photograph of a yellow motor grader blade. A red arrow points to the blade itself, and a blue arrow points to a circular component above it. The blade is positioned over a gravel surface.</p>
<p>All cutting teeth along the blade must be loosened off and flushed to verify cleanliness.</p>

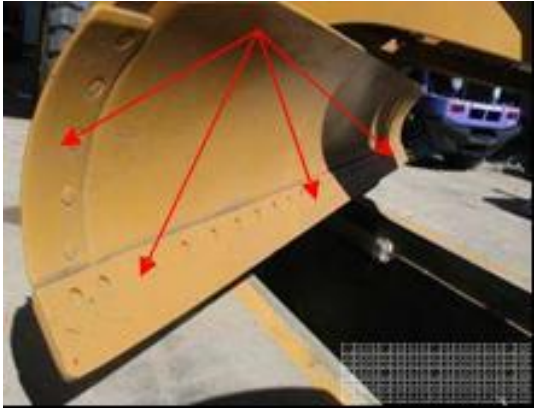
<p>A close-up photograph of a yellow grader blade. Red arrows point to several cutting teeth along the edge of the blade, indicating they need to be loosened and flushed.</p>
<p>All rear surfaces of the blade are to be cleaned and all cutting teeth loosened off and flushed.</p>

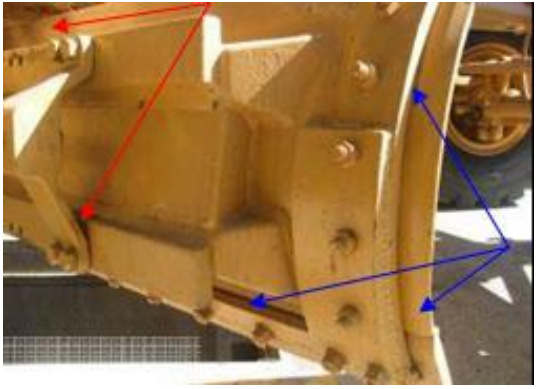
<p>A close-up photograph of the rear surface of a yellow grader blade. Red arrows point to the rear surfaces, and blue arrows point to the cutting teeth, indicating they need to be cleaned and loosened.</p>

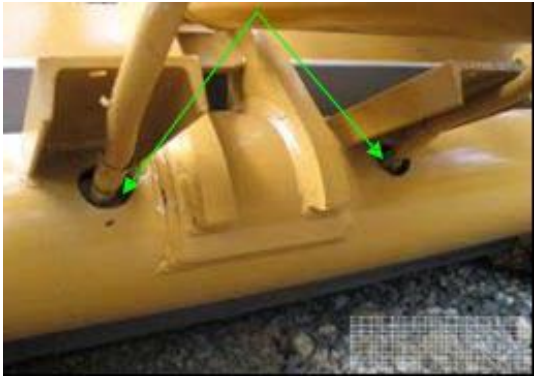
Description	Images
<p>On some models there may be openings (green arrows) where the hydraulic lines enter the rear of the blade. These areas must be flushed in the presence of the inspecting officer to verify cleanliness.</p>

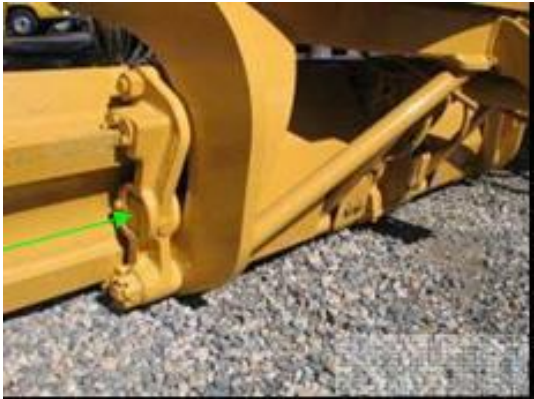
<p>As blades can be adjusted along a slide, flush through the small recesses (green arrow) to verify cleanliness.</p>

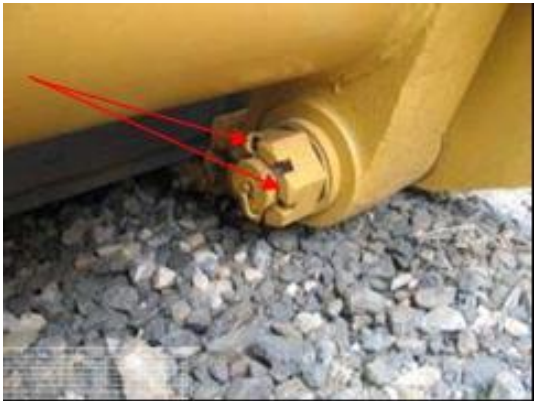
<p>Clean and inspect all countersunk recesses (red arrows) on the nuts.</p>

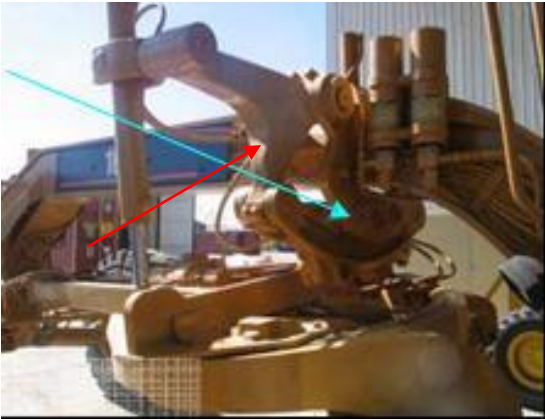
Description	Images
<p>Above the circle is the blade pitch adjuster. This configuration comprises of hydraulic rams, pivot points. Red arrow highlights hollow area that requires flushing.</p>

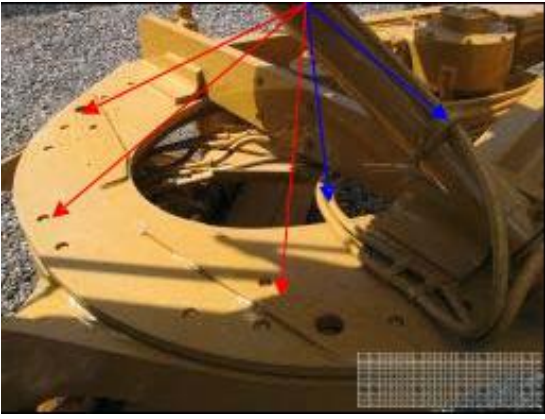
<p>All surfaces on the topside, including countersunk holes (red arrows) must be free of all biosecurity risk material. All hydraulic hoses (blue arrows) must be free of biosecurity risk material.</p>

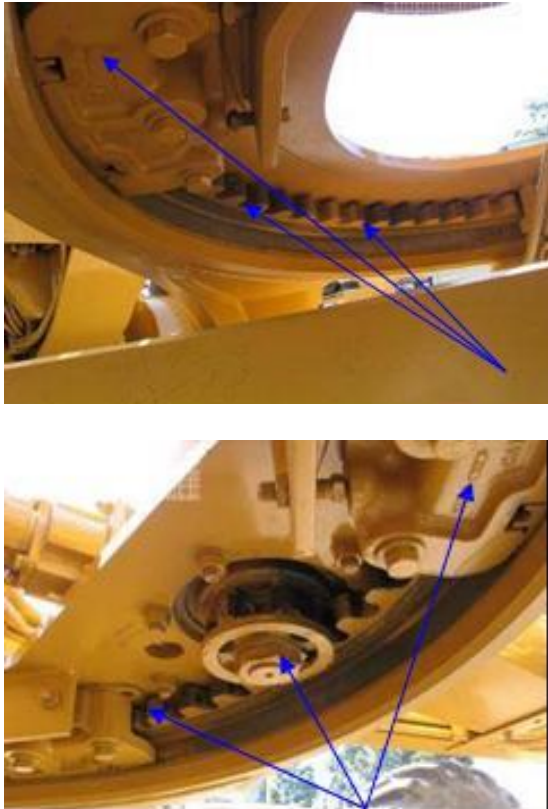
Description	Images
<p>The underside of the circle. All biosecurity risk material, including dirty grease must be removed from all surfaces, including the cogs.</p>

<p>The first photograph shows the underside of a yellow motor grader's circle, with blue arrows pointing to various components and cogs. The second photograph shows a close-up of the same area, with blue arrows pointing to specific components and cogs.</p>
<p>A close up of the blade pitch adjuster. This area must be free of all contaminated grease.</p>

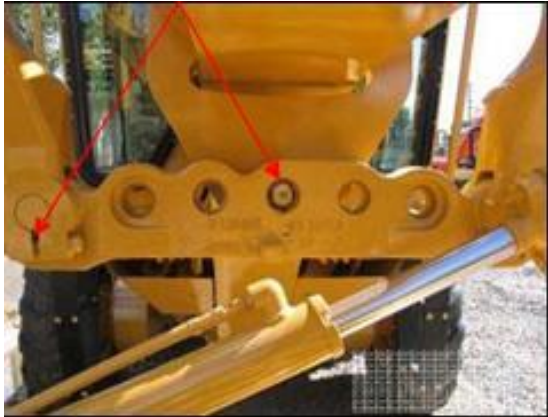
<p>The photograph shows a close-up of the blade pitch adjuster, with red arrows pointing to specific components.</p>

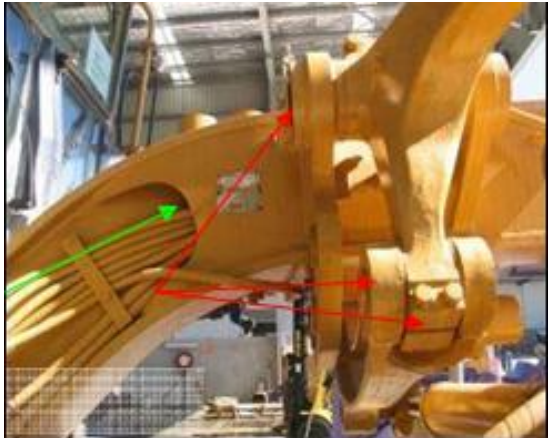
Description	Images
<p>Side view of the blade pitch adjuster. Green arrow highlights the hollow cavity in the gooseneck, which requires flushing to verify cleanliness. The red arrows highlight the pivot points where contaminated grease must be removed.</p>

<p>A photograph showing a side view of a yellow blade pitch adjuster. A green arrow points to a hollow cavity in the gooseneck. Several red arrows point to pivot points where contaminated grease must be removed.</p>

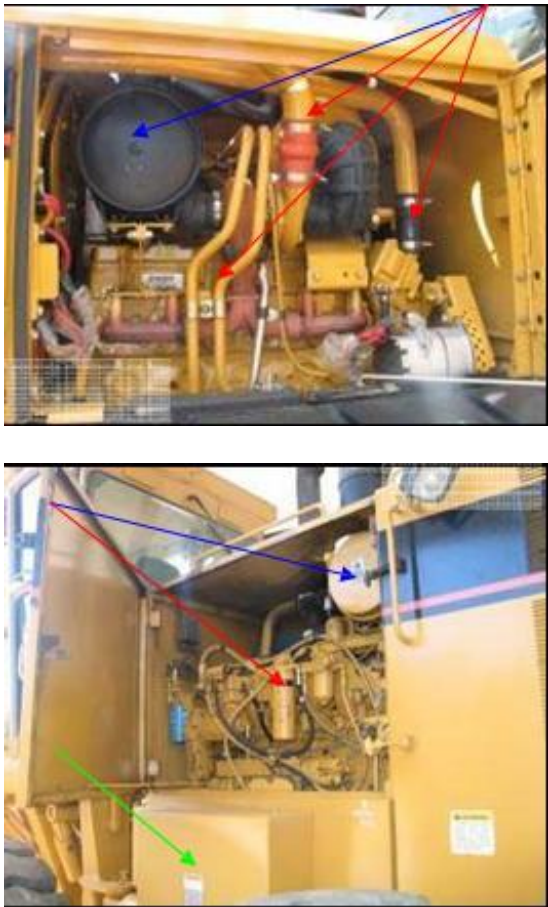
Description	Images
<p>The sides of the grader engine bay. All surfaces of the block, around all oil filters and hoses (red arrows) must be thoroughly cleaned and inspected. The air-filters (blue arrows) must be removed and verified clean. On some models, the battery box is mounted on the side (green arrow).</p>

<p>Two photographs showing the engine bay of a grader. The top photo shows the engine block with red arrows pointing to hoses and blue arrows pointing to air filters. The bottom photo shows the engine bay with red arrows pointing to hoses, blue arrows pointing to air filters, and a green arrow pointing to the battery box mounted on the side.</p>

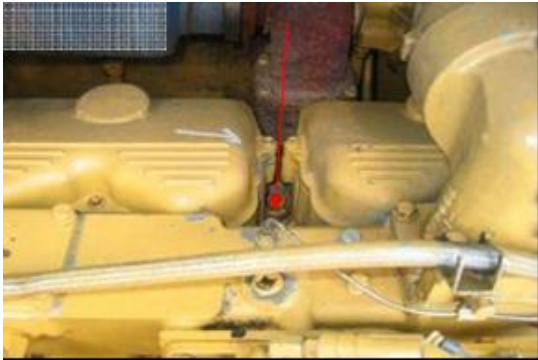
Description	Images
<p>All biosecurity risk material, including dirty grease must be removed from the engine block, including in between the tappet covers (red arrow).</p>

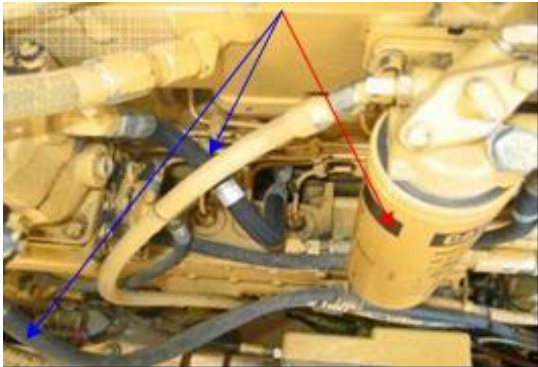
<p>The side of the block can have of a number of filters (red arrow) and hoses (blue arrows), all requiring thorough cleaning and inspection.</p>

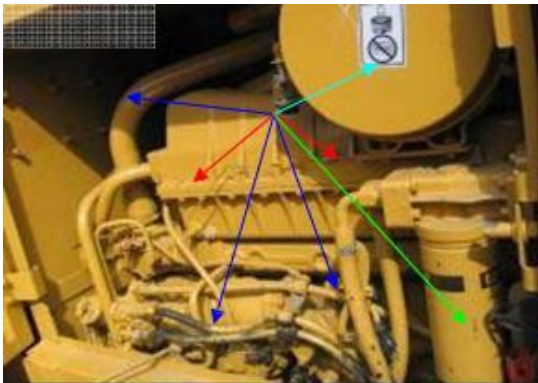
<p>Another example of the side of the engine block of a grader. All ledges (red arrows), hoses (blue arrows), filters (green arrow) and air-filters (aqua arrow) must be thoroughly cleaned and inspected.</p>

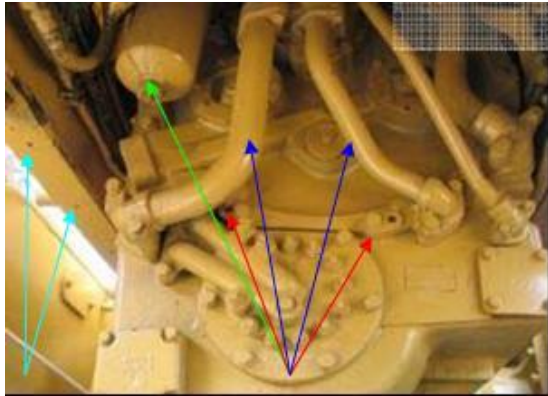
Description	Images
<p>The underside of the block, visible once the belly plates have been removed. All countersunk holes (red arrows), hoses (blue arrows) and filters (green arrow) must be thoroughly cleaned and inspected. The aqua arrows highlight the hollow chassis rails that will be illustrated later.</p>

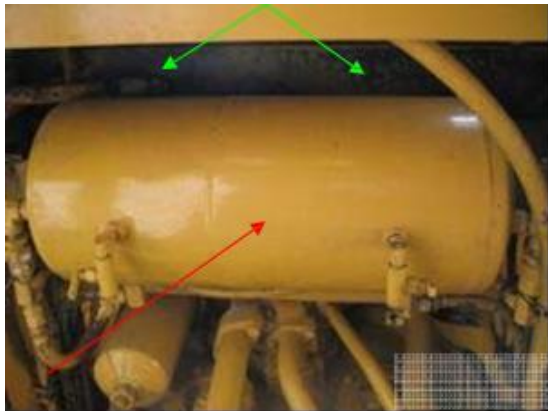
<p>An air tank (red arrow) can sometimes be found at the rear of the grader. Thorough cleaning, particularly the topside (green arrows) is essential.</p>

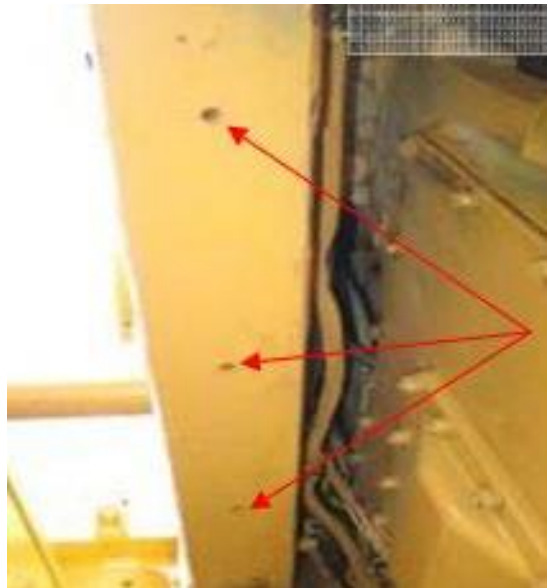
<p>Once the belly plates have been removed, the empty bolt holes (red arrows) allow flushing access to the chassis rails either side of the engine block. These rails must be flushed in the presence of the inspecting officer to verify cleanliness.</p>

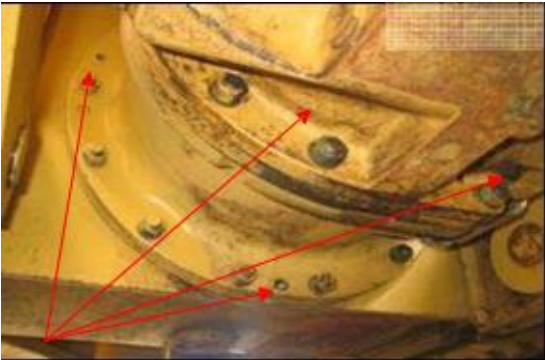
Description	Images
<p>The underside front of the block. All countersunk holes and recesses (red arrows) must be clean and free of biosecurity risk material.</p>

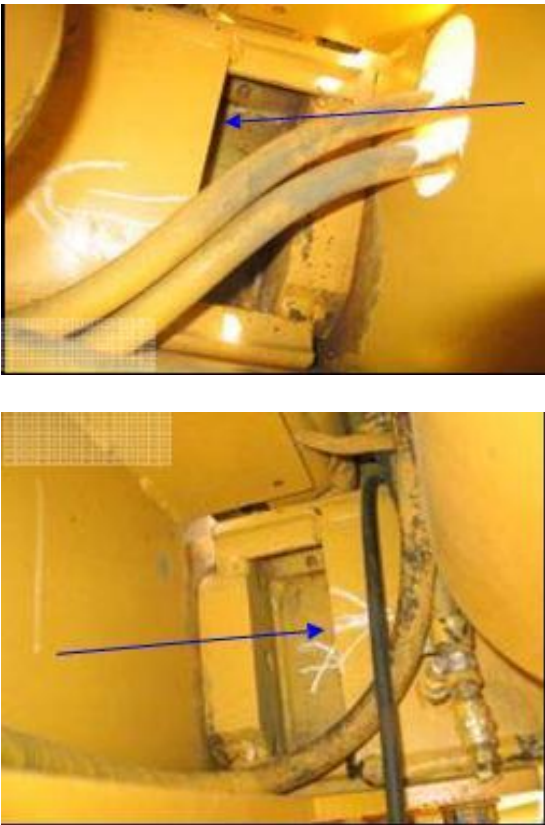
<p>Besides the belly plate bolt holes providing access to the hollow chassis rails, on some models, these may have open-ended channels as illustrated. To verify cleanliness, these channels must be flushed.</p>

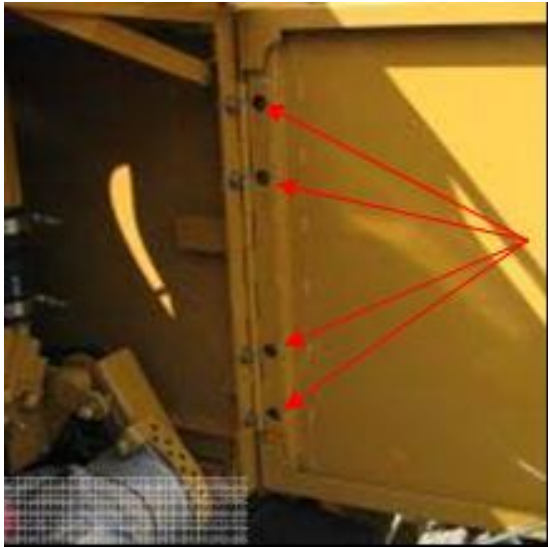
Description	Images
<p>Check all engine doors for hollow or open support channels (red arrows) that will require flushing to verify cleanliness.</p>

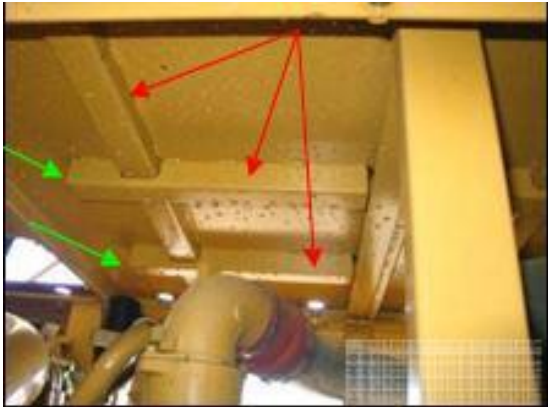
<p>Check all engine housing for hollow or open-ended support channels that will require flushing to verify cleanliness.</p>

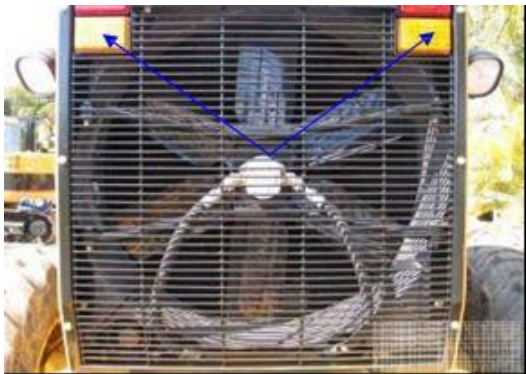
Description	Images
<p>The rear radiator grill on the back of the grader. This grill must be removed to allow cleaning and inspection access to the radiator core. All light fittings (blue arrows) must be verified internally clean.</p>

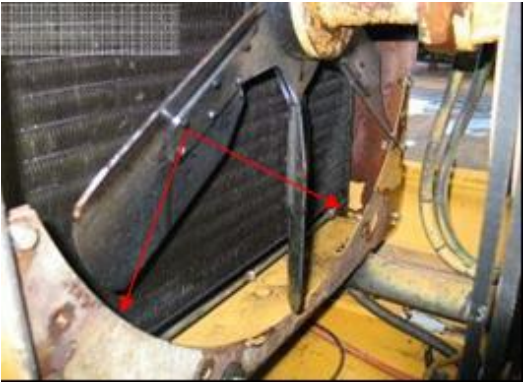
Description	Images
<p>The radiator grill removed, allowing cleaning and inspection access to the inside of the radiator shroud.</p>

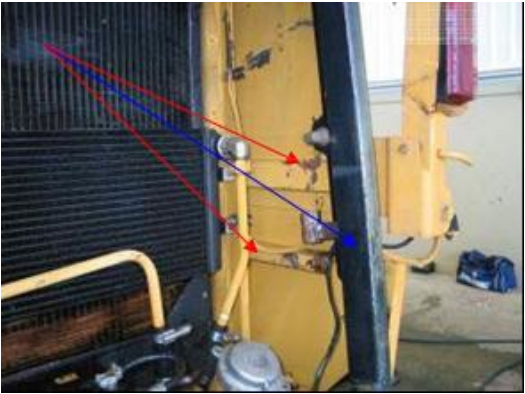
<p>This picture illustrates the right hand side of the engine cover near that radiator. The two red arrows highlight open-ended channels that will require flushing to verify cleanliness. Check the outside framework (blue arrow) for open ends or drainage holes. If present, flush to verify clean.</p>

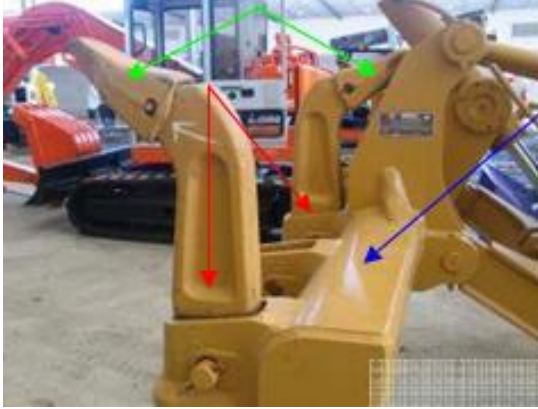
Description	Images
<p>The ripper cradle (red arrows) and tynes. All cutting teeth (green arrows) must be removed for internal cleaning and inspection.</p>	 
<p>All cutting teeth (green arrows) must be removed for cleaning and internal inspection. Flush through the tyne pockets (red arrows) to verify cleanliness. Check all surfaces of the cradle bar (blue arrow) for cracks, splits, evidence of repair or for drainage holes on the underside. Flush if drainage holes are present.</p>

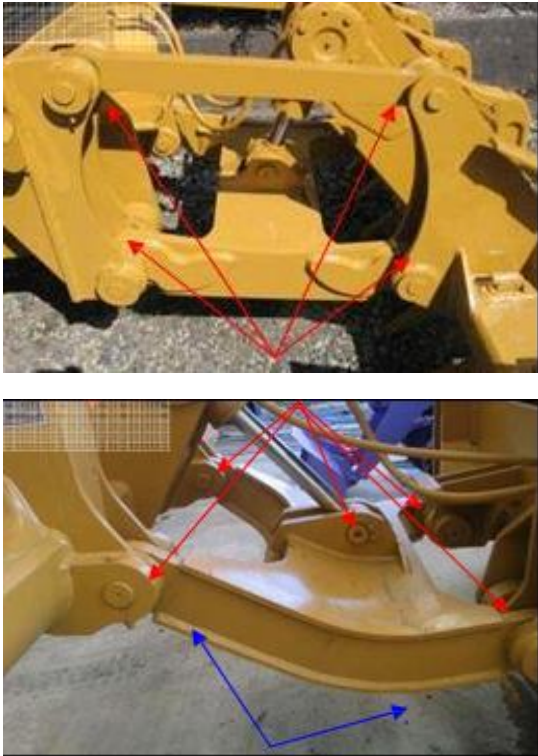
<p>Two examples of ripper cradles. All contaminated grease must be removed from all pivot points (red arrows) and check the ripper cradle surfaces for drainage holes (blue arrows), cracks, splits or any evidence of repair. If breached, it will have to be investigated and verified clean.</p>

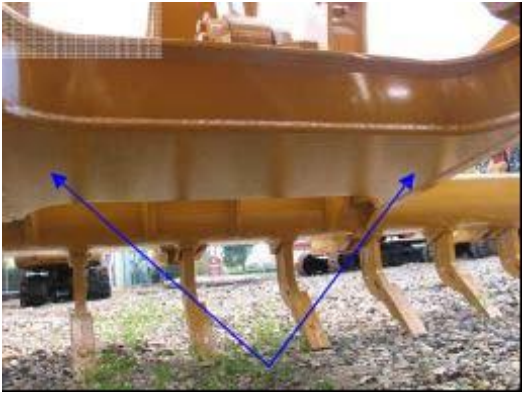
Description	Images
<p>The underside of the ripper cradle. On this model there are no drainage holes, however all surfaces and welding seams must be checked for breaches.</p>

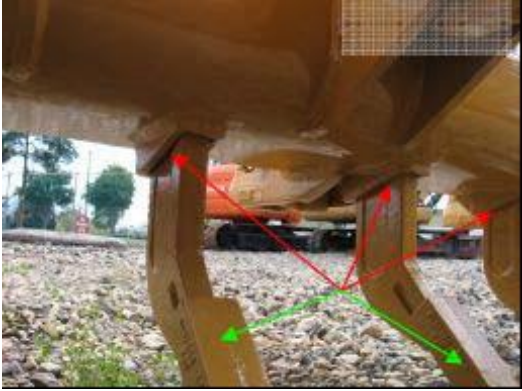
<p>All cutting teeth (green arrows) must be removed for cleaning and internal inspection. Flush through the tyne pockets (red arrows) to verify cleanliness.</p>

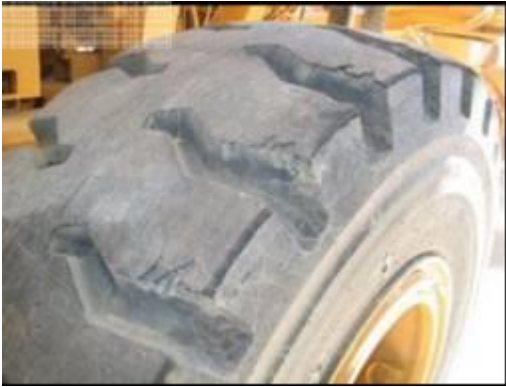
Description	Images
<p>Tyres in this condition can be easily cleaned and inspected.</p>

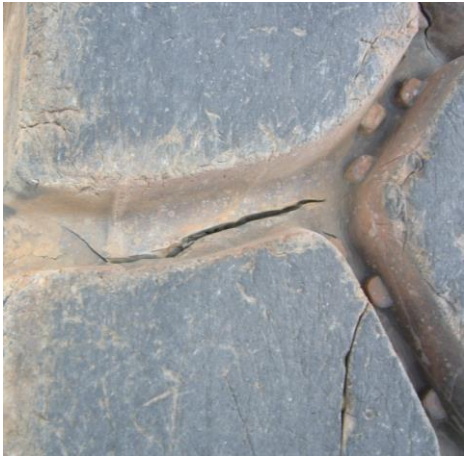
Description	Images
<p>All cracks and splits in tyres must be verified that all are free of biosecurity risk material.</p>

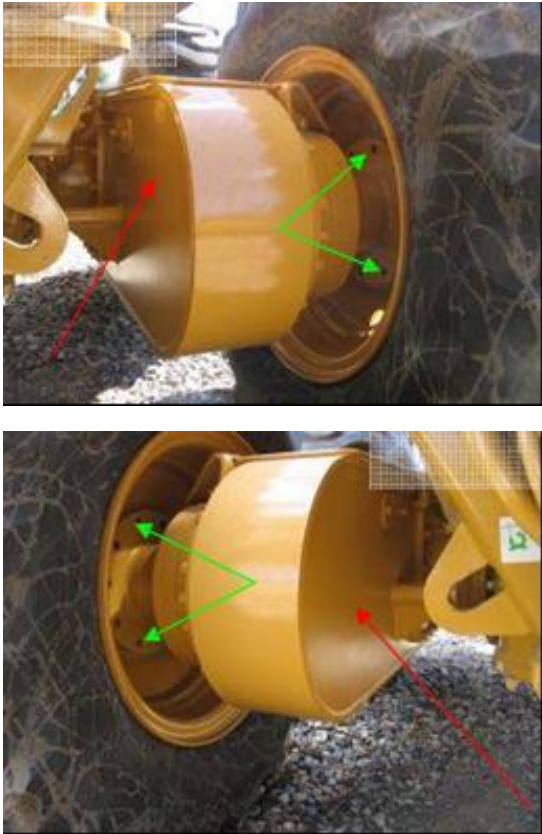
<p>The final drive motors are sealed inside these illustrated sections (red arrows) and filled with oil. All countersunk holes (green arrows) inside the rims must be clean and free of all biosecurity risk material.</p>

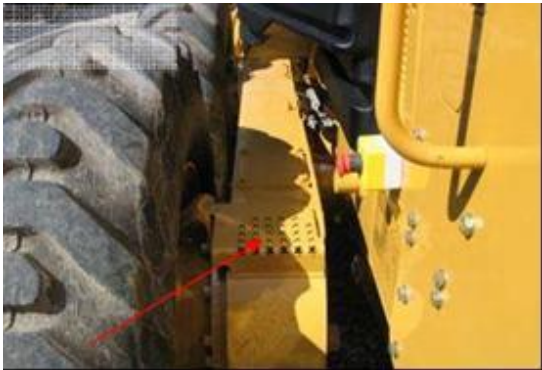
<p>Check under each footstep (red arrow) on the final drive motors is clean and free of biosecurity risk material.</p>

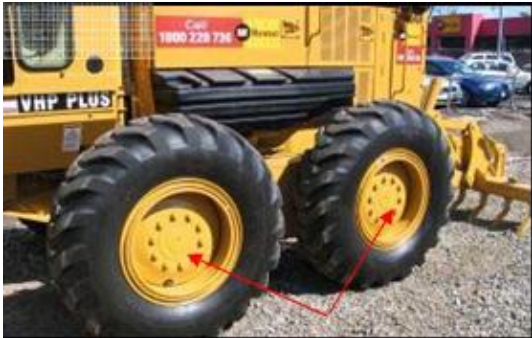
Description	Images
All outside rims must be cleaned and free of biosecurity risk material.

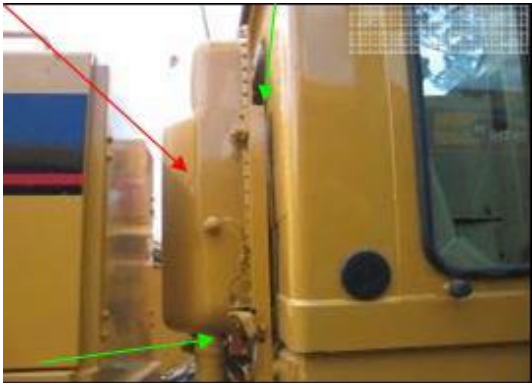
Description	Images
The oil tanks (red arrow) on graders are commonly located behind the cabin. All surfaces, particularly the backside and bottom (green arrows) are the hardest to access. The tank can be loosened off to allow access.

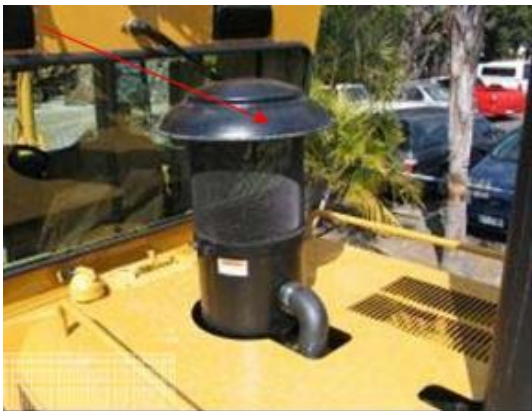
The top of the air-filter pre-cleaner must be removed for cleaning and inspection access.

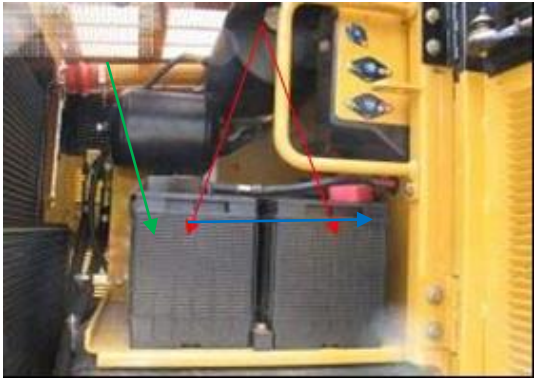
Description	Images
<p>All batteries (red arrows) must be loosened from tie-down points for cleaning and inspection. All hollow framework (blue arrow) is to be flushed to verify cleanliness. The green arrow (H models only) highlights the hollow cavity under the battery ledge and behind the fuel tank.</p>

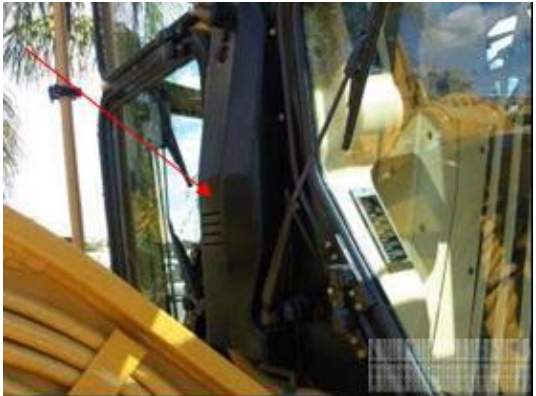
<p>The windscreen wiper housing (red arrow) will have to be removed to verify internal cleanliness.</p>

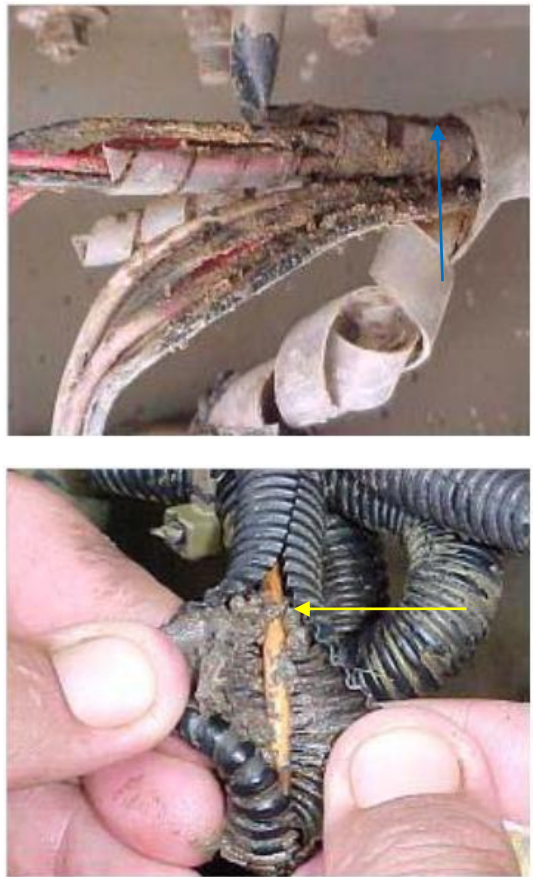
<p>Ensure that all looming (blue line) is free of contamination (see first image). Flushing these areas with the looming still in place rarely removes all contamination. All wiring (see second image yellow area) must be thoroughly inspected for internal contamination.</p>

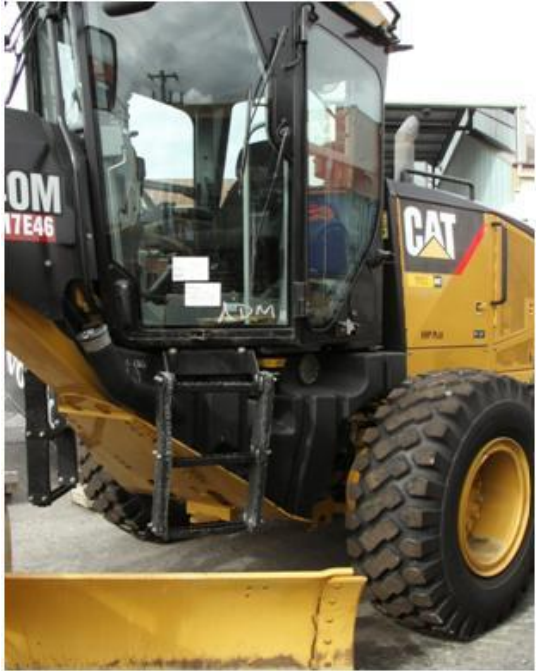
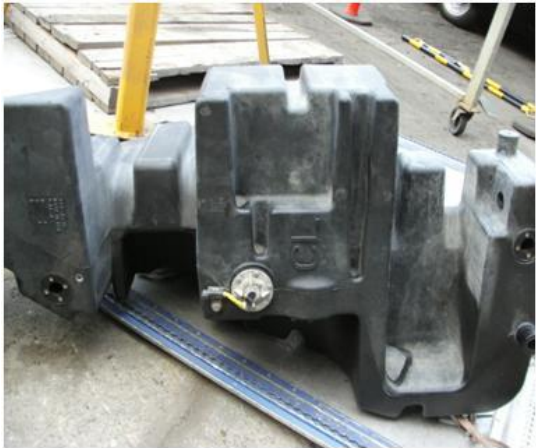
Description	Images
<p>This image highlights the fuel tank which has now been moved to under the cabin green arrow on M models. With the fuel tanks now under the cab on certain M models this has changed the whole set up of the cab supports, hydraulic hoses and cables. If the fuel tank is located under the cab, both fuel tanks must be loosened and may need to be removed on a case by case basis for access for cleaning of the cab supports (see below three images) and the cleaning of the internal side and underside of the fuel tanks.</p>

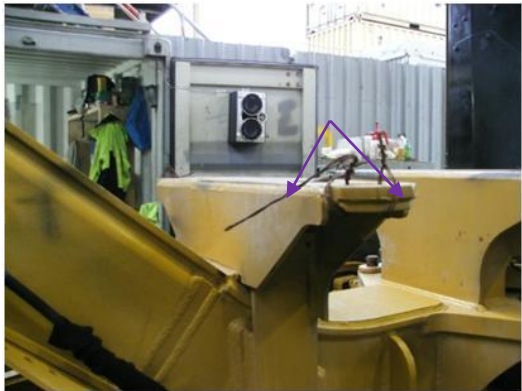
<p>This image shows the cabin and fuel tanks removed (common for containerized graders) giving access to the cabin supports (purple arrows). Note that there are no electrical cables or hydraulic hoses in this area.</p>

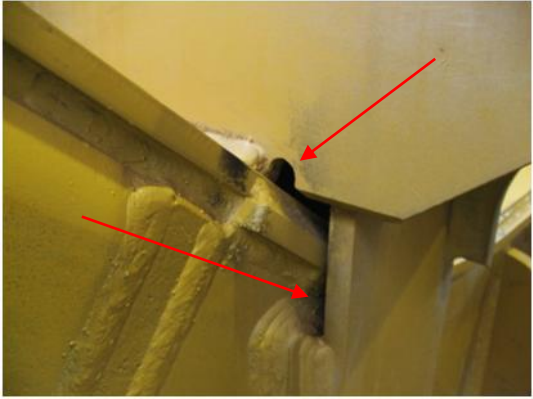
Description	Images
<p>Front cabin support highlights two flush areas (red arrows) which must be free from all biosecurity risk material.</p>
