Australian Government
Department of Agriculture
and Water Resources

Machinery Cleaning Guide - Scrapers

April 2016

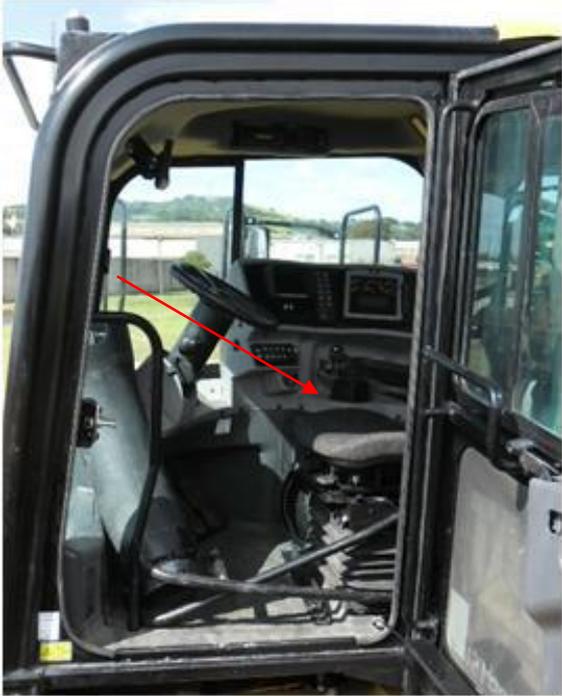
Description	Images
<p>Note that the seat will have to be removed as well as the rubber floor matting, allowing for cleaning and inspection. Inspection access will be required inside the joystick control panels (red arrow). The non-affixed panels inside the cabin have to be removed, allowing access to the air-conditioning, steering unit and some electrical controls. Check for drainage holes under the cabin framework. Any non-affixed floorpans are to be removed for cleaning and inspection.</p>

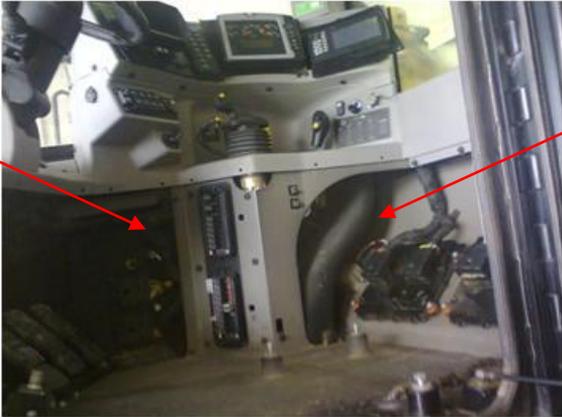
A photograph showing the interior of a machine cabin from an open door. A red arrow points to the joystick control panel located on the right side of the operator's seat. The cabin contains a steering wheel, a dashboard with a digital display, and various control levers.
<p>Close up shot of the joystick control panel. Note that access has to be provided to verify internal cleanliness in and around controls. Non affixed panels have been removed (red arrow). Also note that the seat and floor mats have been removed.</p>

A close-up photograph of the joystick control panel area. Two red arrows point to the gaps where non-affixed panels have been removed, providing access to the internal components like the air conditioning and steering unit. The seat and floor mats are also absent.

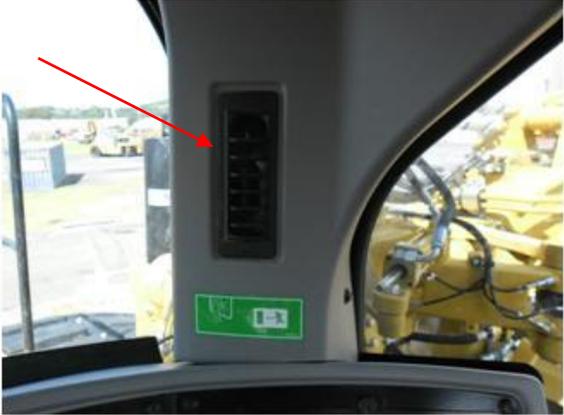
Description	Images
<p>A close up of the air-conditioning vents, which must be cleaned and accessible for inspection (red arrow).</p>

A close-up photograph of the interior of a yellow machine's cab. A red arrow points to a vertical air-conditioning vent located on the left side of the dashboard area. A green sticker is visible below the vent.
<p>The door rubbers (red arrows) are to be cleaned and inspected, as well as internal door linings (blue arrow).</p>

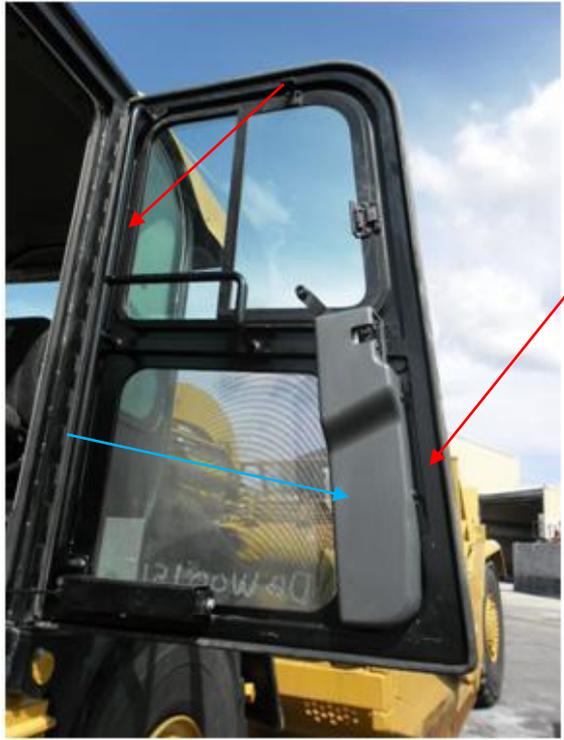
An exterior photograph of a yellow machine's door. Two red arrows point to the rubber seals at the top and bottom of the door frame. A blue arrow points to the internal door lining. The machine is parked outdoors under a blue sky with clouds.

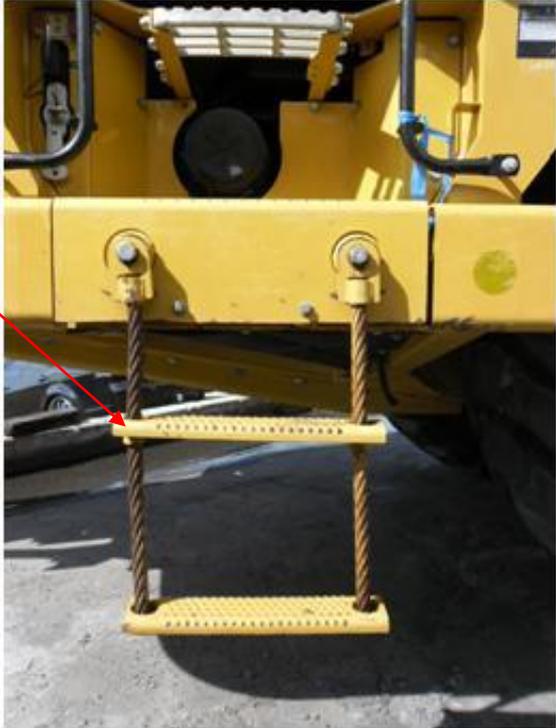
Description	Images
<p>Check the ladder to the cabin, particularly under the steps. On this model the ladder (red arrow) is made from wire bundles, which must be free of all biosecurity risk material (BRM).</p>

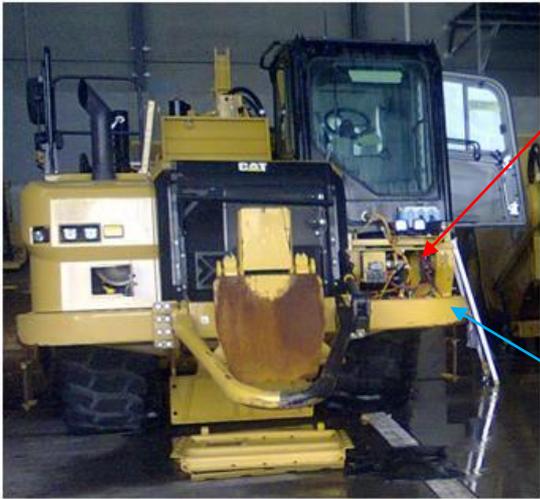
<p>The front end, highlighting the non-affixed panels removed from in front of the cabin, exposing the air-conditioning unit for inspection (red arrow). In newer models as photographed, removing these panels allows access to the first set of batteries located at the front of the machine as well as flush points located in the front bumper rail (blue arrow).</p>

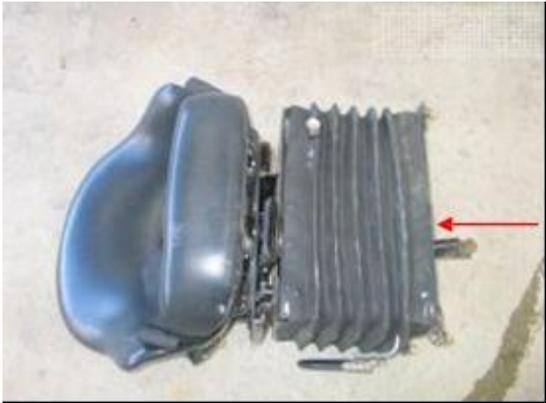
<p>Once the seat has been removed, the internal of the rubber shroud (red arrow) can be easily cleaned and inspected.</p>

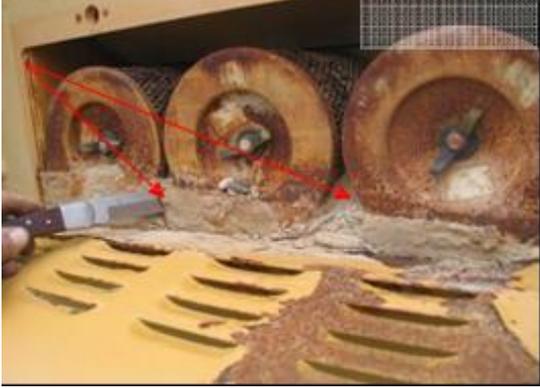
Description	Images
<p>Air-filters in front of the cabin(red arrow). This illustration highlights the amount of BRM that can be found in this area.</p>

A close-up photograph of three circular air filters mounted in a row. Red arrows point to the filters, highlighting the area where BRM (Biosecurity Risk Material) is likely to accumulate. The filters are surrounded by a mesh screen and are positioned above a yellow metal grate.

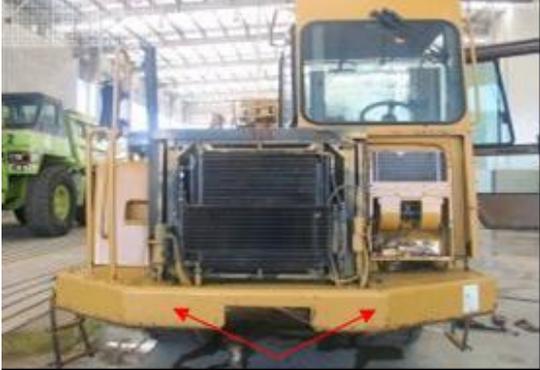
Description	Images
<p>Illustrates the amount of dismantling (a number of non-affixed panels) required to make the engine and front end accessible for cleaning and inspection. The front drawbar (red arrows) is usually hollow, which will be highlighted later.</p>

A photograph showing the front view of a yellow tractor in a workshop. Red arrows point to the front drawbar, which is a horizontal bar at the front of the tractor. The engine compartment is open, and various components are visible.
<p>All non-affixed engine covers (blue arrow) have been removed, allowing access for cleaning and inspection. The red arrow is highlighting the hollow drawbar.</p>

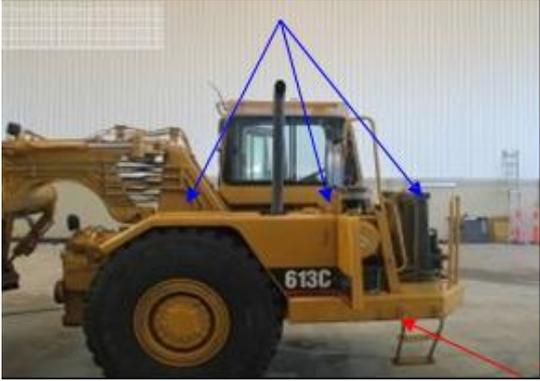
A photograph showing the side view of a yellow tractor. Blue arrows point to the engine covers, which have been removed. A red arrow points to the drawbar, which is highlighted as being hollow. The tractor is labeled '613C' on the side.

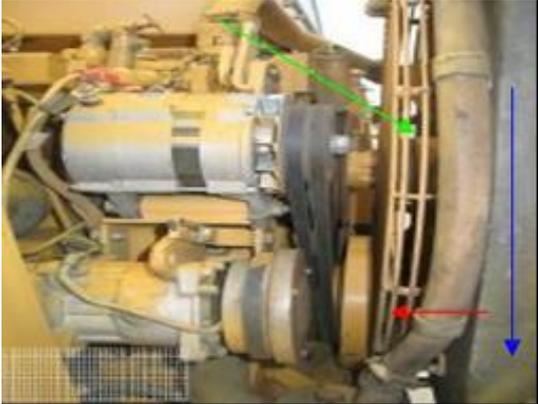
Description	Images
<p>The front of the block and the harmonic balance (flywheels). These can be concave and harbour BRM inside (red arrow). The internal radiator grill (green arrow) must be removed, allowing cleaning and inspection access inside the radiator shroud (blue arrow). Check all external surfaces of the block, including oil filters, starter motors and between tappet covers.</p>

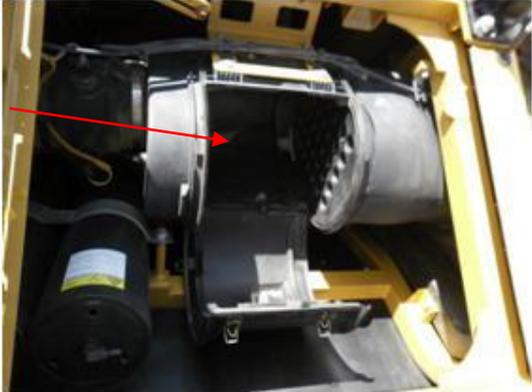
<p>The air-filter is to be removed from the housing (red arrow) and verified clean (usually performed with pressurized air).</p>

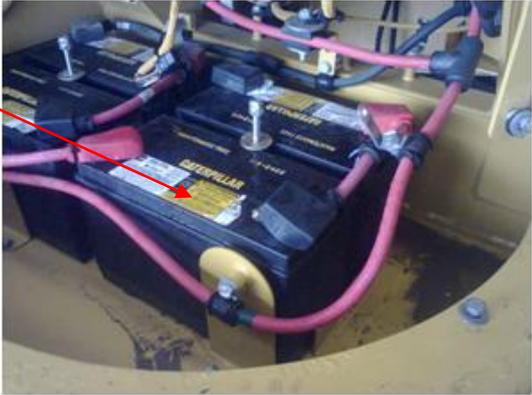
<p>The batteries (red arrow) are to be loosened from the tie-down points and inspected underneath. In newer scrapers the batteries are located under the front of the cab, removing the cover to allow access also allows access to the hollow sections of the front draw bar.</p>

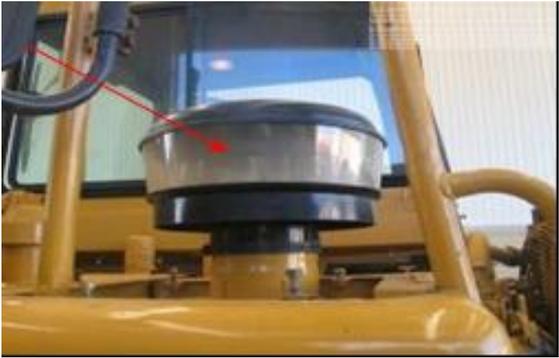
Description	Images
<p>The air-filter pre-cleaner or dust collector (red arrow). The cover must be removed to allow cleaning and inspection.</p>

<p>This photograph shows the air filter from a modern machine that has been removed to access all areas including the air-filter pre-cleaner or dust collector and air filter itself as they are now designed as a single unit.</p>

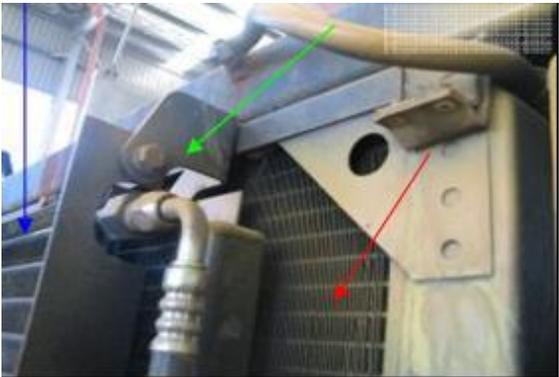
<p>All fins on the radiator (red arrow) and oil cooler (blue arrow) are to be flushed in order to verify cleanliness. Note the small gap between the oil cooler and radiator. On some models, the oil cooler can be unbolted (green arrow), allowing better access for cleaning the fins and inspection.</p>

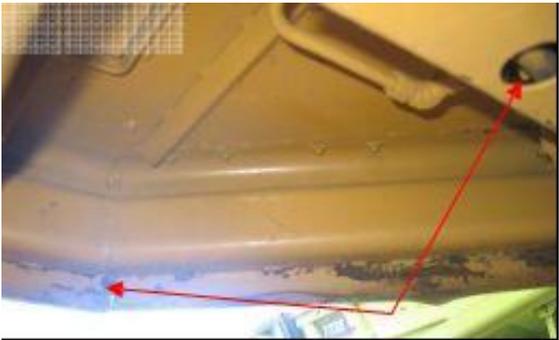
<p>The front drawbar as seen from the underside. These support channels can be hollow, as seen above and can be flushed via the drainage holes (red arrows).</p>

Description	Images
<p>Different models contain different compartments within the front draw bar, these are accessed from under the machine or removing the non-affixed panels, to the front and side of the machine (red arrow).</p>

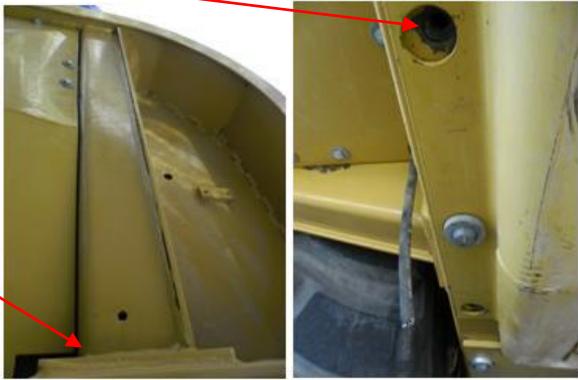
<p>There are other hollow support structures (red arrows) under the front end that will require flushing to verify cleanliness.</p>

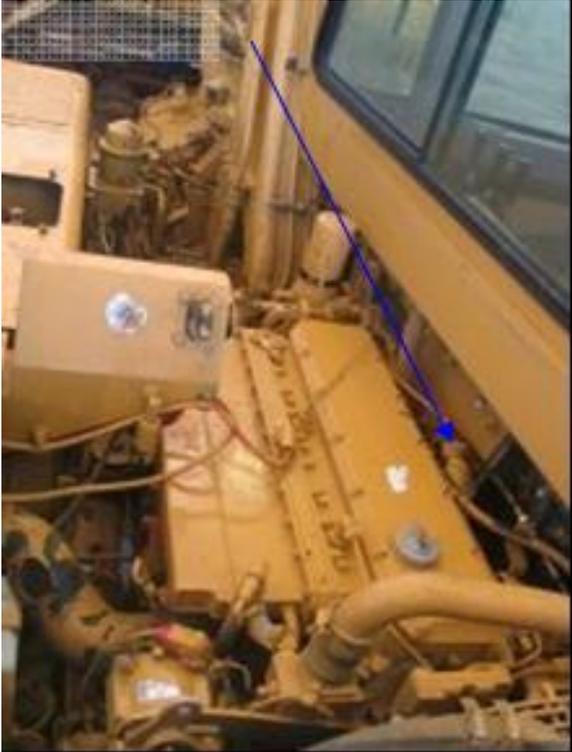
<p>The topside of the block is highly visible for cleaning and inspection once all non-affixed engine covers and panels have been removed. The area between the cabin and the block (blue arrow) is very confined and the use of inspection mirrors is recommended. Flushing to verify areas that cannot be seen or felt will be required.</p>

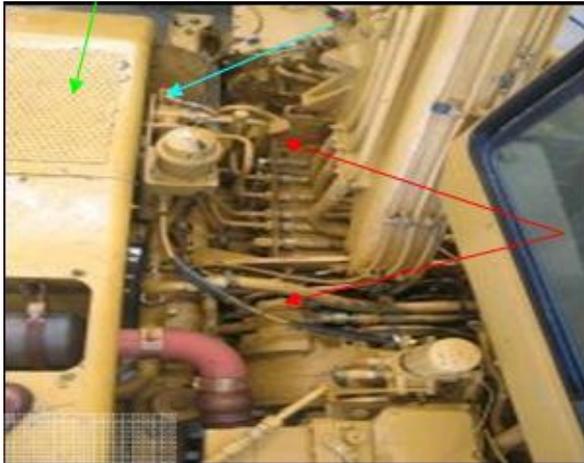
Description	Images
<p>The rear of the block, below the gooseneck. This area is also characterised by numerous hydraulic and electrical hoses and cables (red arrows), all requiring thorough cleaning and inspection. All checker plates (green arrow) are to be flushed to verify cleanliness. Flushing to verify areas that cannot be seen or felt will be required. The aqua arrow highlights the access point to the hollow chassis rail that is highlighted next.</p>

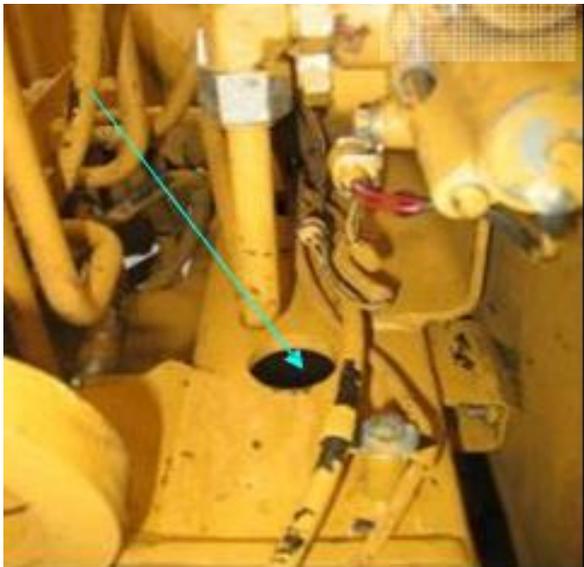
<p>The two chassis rails either side of the engine block are hollow (aqua arrow). On most models there will be access points or drainage holes. The one illustrated in this picture is located on the topside of the chassis rail, towards the rear.</p>

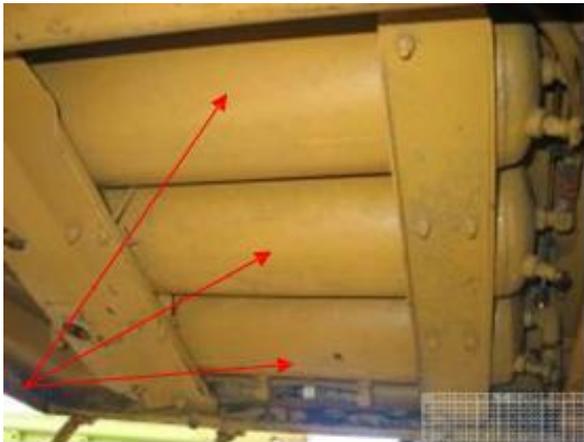
<p>The air tanks that can be located under the front end (red arrows). The topside of these can be difficult to access and may require dismantling for cleaning and inspection.</p>

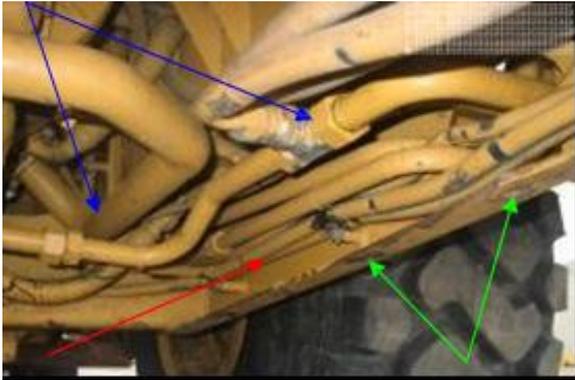
Description	Images
<p>The underside of the front end and hollow chassis rail (red arrow). The belly plates have been removed, allowing access for flushing both channels via the vacant belly plate bolt-holes (green arrows). All hydraulic hoses require thorough cleaning and inspection (blue arrows - especially the non-visible surfaces).</p>

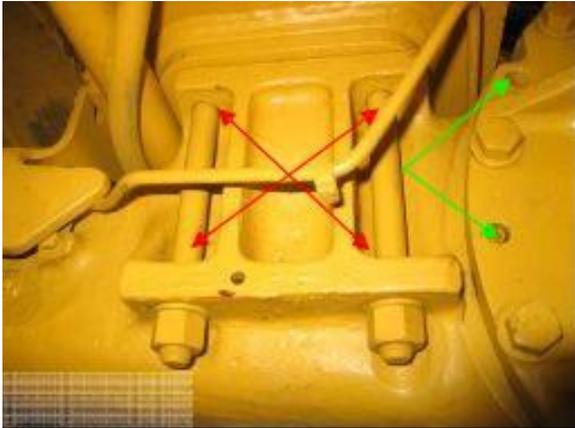
<p>Each axle on either side of the differential has supports (red arrows) for the housing above. Each of these areas requires thorough cleaning and inspection. Check all countersunk recesses (green arrows).</p>

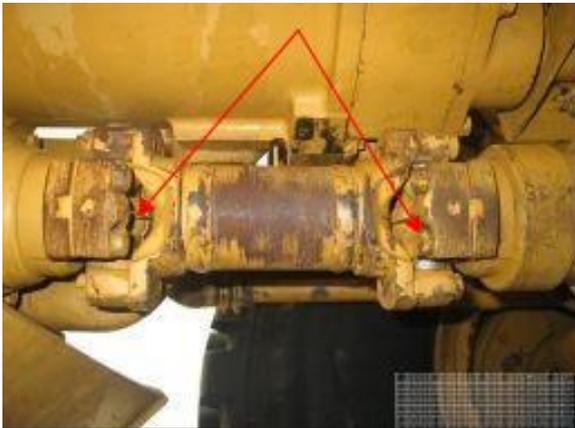
<p>All universal joints must be free of contaminated grease.</p>

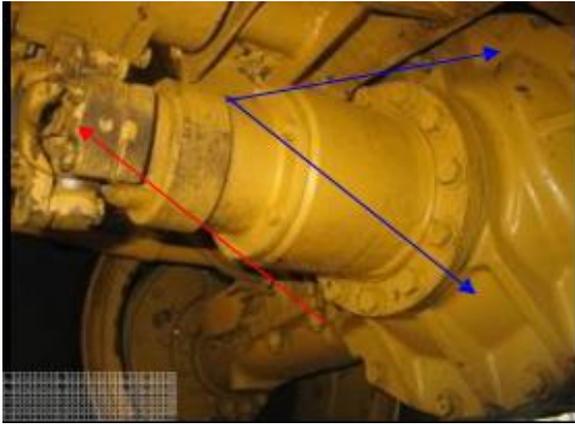
Description	Images
<p>All universal joints must be free of contaminated grease (red arrow). The bell housing (blue arrow) has many nooks, ledges, countersunk holes and hydraulic hoses, all of which require careful cleaning and inspection.</p>

A close-up photograph of a yellow universal joint and bell housing. A red arrow points to a joint area, and a blue arrow points to the bell housing. The image shows various mechanical components, including bolts and hydraulic hoses.
<p>All non-affixed internal wheel rims (red arrows) must be removed for cleaning and inspection.</p>

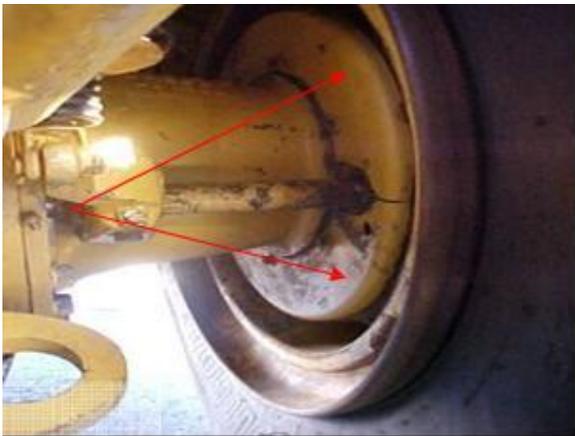
A close-up photograph of a wheel rim. Two red arrows point to non-affixed internal components, likely brake shoes or pads, which need to be removed for cleaning and inspection.
<p>Thoroughly inspect all internal wheel rim surfaces. A mirror is recommended to inspect the backside of the brake drum (blue arrow).</p>

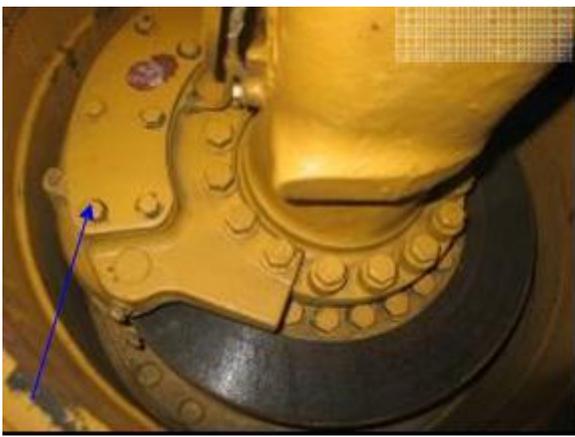
A close-up photograph of a brake drum. A blue arrow points to the backside of the brake drum, which should be inspected thoroughly. The image shows the internal surfaces and components of the brake drum.

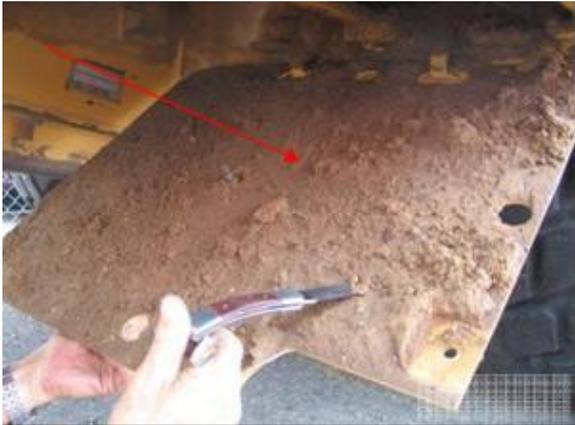
Description	Images
<p>A non-affixed panel removed from under the cabin floor (red arrow). This illustration highlights the amount of BRM that can be found in these areas.</p>

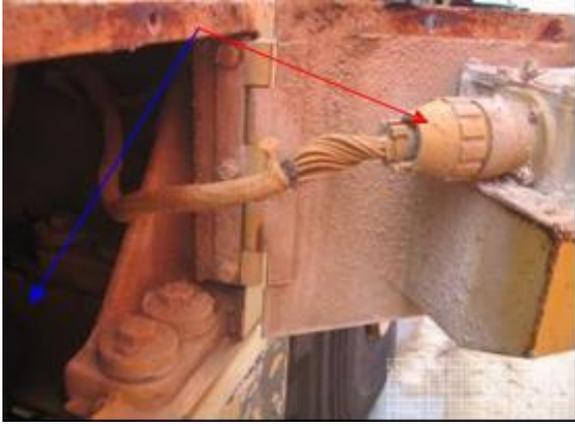
<p>A small door below the cabin, which also provides access to the BRM seen in the last illustration (red and blue arrow).</p>

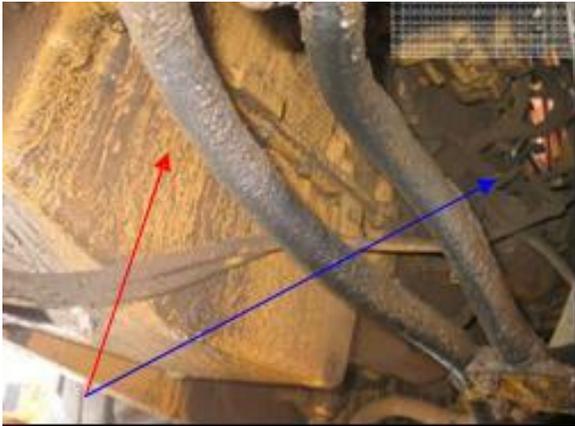
<p>The side of the sump (red arrow), which can only be accessed once all belly plates have been removed. Note the amount of BRM (blue arrow) that can be seen in the surrounding area. This whole area must be thoroughly cleaned and inspected.</p>

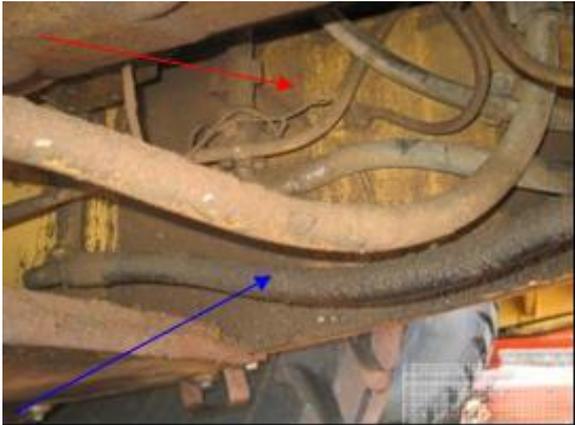
Description	Images
<p>The inside chassis rails (red arrow), visible once the belly plates have been removed. All hydraulic hoses (blue arrow) must be thoroughly cleaned and inspected.</p>

A photograph showing the underside of a vehicle chassis. A red arrow points to a horizontal metal rail, and a blue arrow points to a hydraulic hose. The area is cluttered with various mechanical parts and hoses.
<p>Another view of how contaminated the underside of the engine block and sump can be (red arrow). All belly plates and non-affixed panels must be removed for cleaning and inspection.</p>

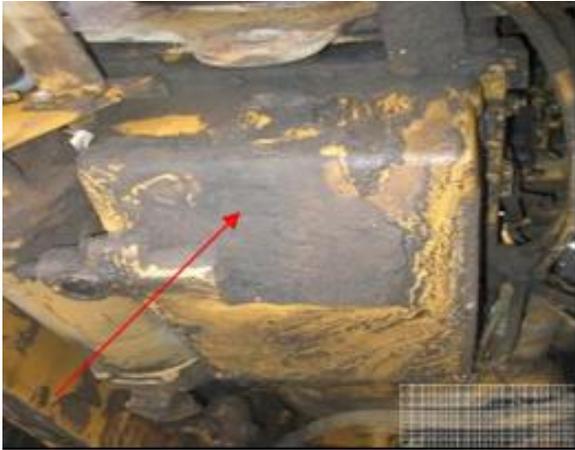
A close-up photograph of the underside of an engine block and sump. A red arrow points to a heavily contaminated, dark, and greasy surface. The surrounding area shows various mechanical components.
<p>BRM seen around hydraulic hoses (blue arrows). All surfaces of these hoses must be thoroughly cleaned, including the removal of contaminated grease.</p>

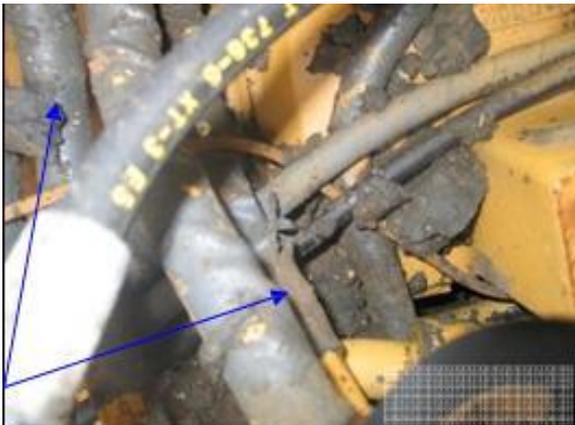
A close-up photograph of hydraulic hoses. Two blue arrows point to areas where BRM (Biosafety Residue Material) is visible on the hoses. The hoses are surrounded by other mechanical parts and grease.

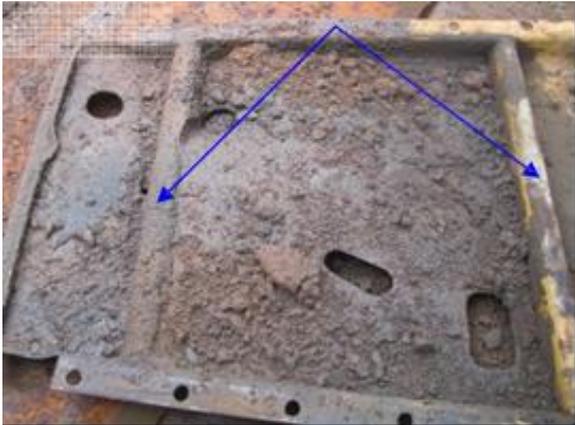
Description	Images
<p>Belly plates must be removed and thoroughly cleaned. Check for openings along the framework (blue arrows). If open, these will require flushing to verify cleanliness.</p>

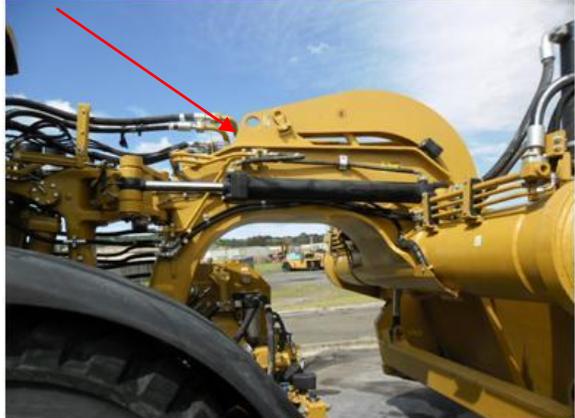
Description	Images
<p>The gooseneck found on all scrapers. Check all surfaces of the gooseneck for any openings or drainage holes. On some models the opening may be topside (red arrow). All hydraulic hoses and lines must be thoroughly cleaned and inspected. Remove all contaminated grease from pivot points and rams.</p>

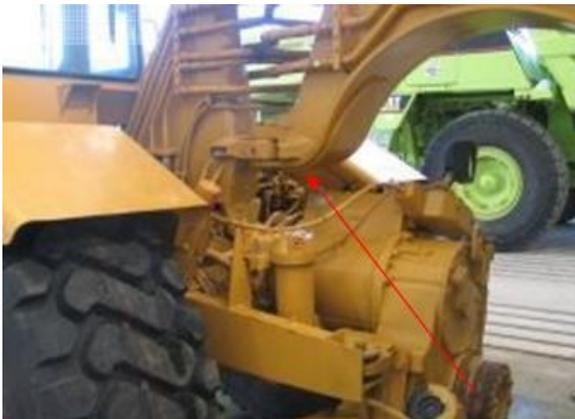
<p>Check all surfaces of the gooseneck for any openings or drainage holes. On some models the opening may be at the bottom (red arrow).</p>

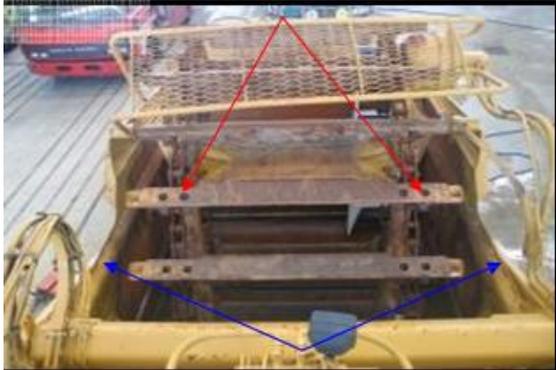
Description	Images
<p>The elevator as seen from the gooseneck. This area consists of a series of blades (red arrows) on a chain, used to push the load to the rear of the bowl. The blue arrows highlight the side of the bowl, which will be highlighted later.</p>

<p>A photograph showing the elevator mechanism from a rear perspective. Red arrows point to the blades on the chain, and blue arrows point to the sides of the bowl.</p>
<p>The elevator blades (red arrows) are hollow and need to be flushed via the entrance holes (blue arrows) to verify cleanliness.</p>

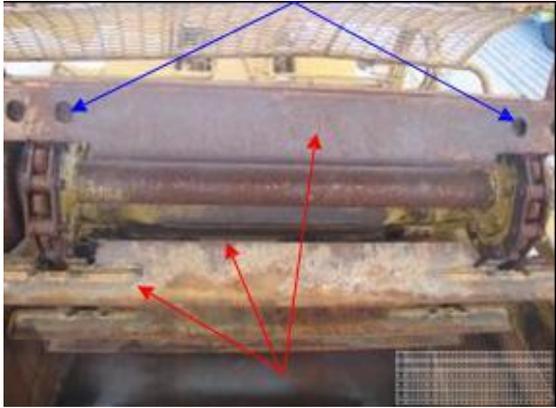
<p>A close-up photograph of the elevator blades. Red arrows point to the blades, and blue arrows point to the entrance holes used for flushing.</p>
<p>Another view of the Elevator blades, highlighting the flushing entrance holes (red arrows).</p>

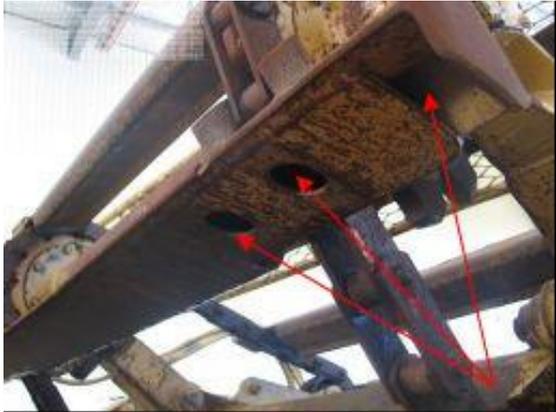
<p>A close-up photograph of the elevator blades, focusing on the flushing entrance holes. Red arrows point to these holes.</p>

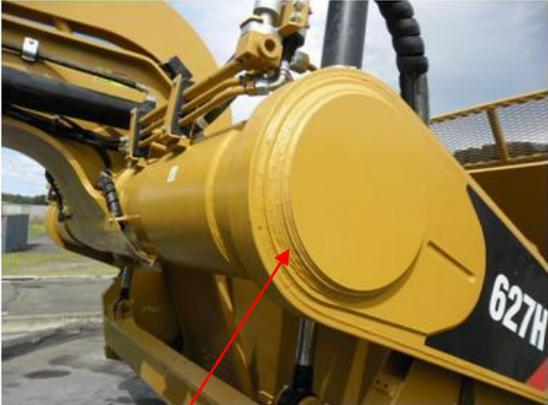
Description	Images
<p>An illustration of the cylinder, located just behind the gooseneck (red arrow). This area is hollow and can harbour significant amounts of BRM. Generally a sealed unit as illustrated however check for cracks, splits or evidence of repair. On this model the ends are completely welded, sealing the unit, but on other models this plate may only be spot-welded. If only spot-welded, flush inside to verify cleanliness.</p>

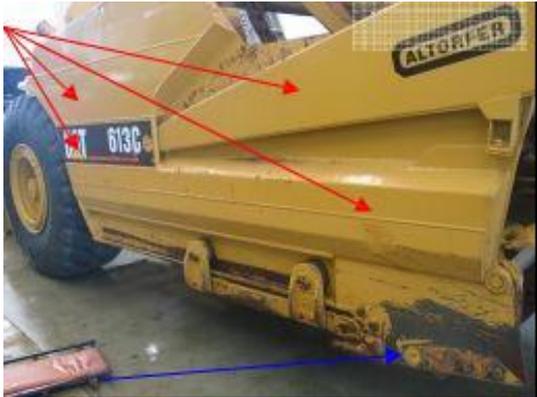
Description	Images
<p>An illustration of the side of a typical scraper bowl. The sides, rear and underside of most scraper bowls are hollow structures and can potentially harbour hundreds of litres of BRM. The red arrows highlight that there may be separate compartments and the blue arrow shows where the wear plates have been removed.</p>

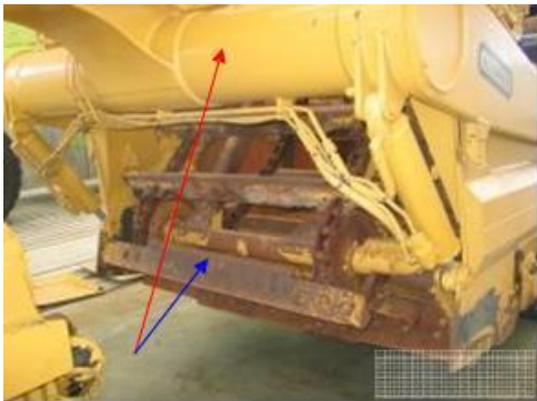
<p>The front of the scraper bowl (blue arrow), also showing the elevator and cylinder (red arrow).</p>

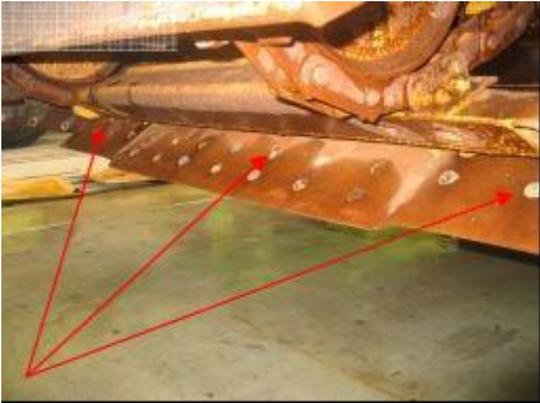
Description	Images
<p>All cutting teeth (red arrows) along the front of the bowl are to be loosened and flushed behind to verify cleanliness.</p>

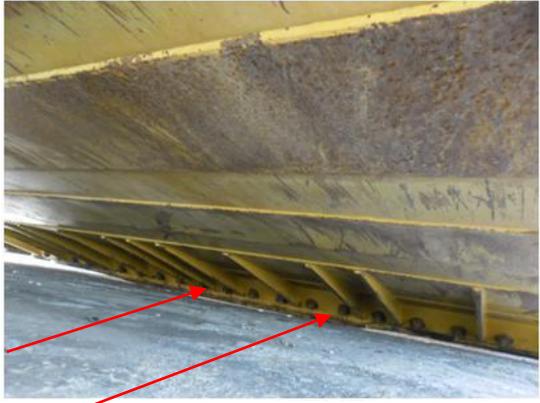
<p>The underside of the cutting teeth. Ensure around each bolt head (red arrows) is clean as well as looking for any cracks, splits or evidence of repair on the underside. The bowl will have to be supported by chocks at the time of inspection.</p>

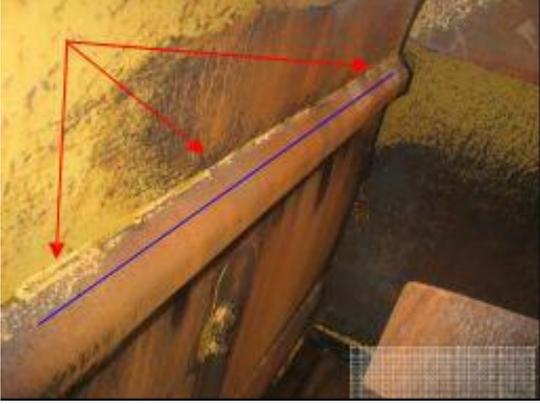
<p>The internal wall of the scraper bowl may have protective plates, covering the hydraulic hoses as they run from front to back. This area is hollow and may only be spot welded (as highlighted by the red arrows), or open-ended and will require flushing to verify cleanliness. The blue line indicates the hollow channel.</p>

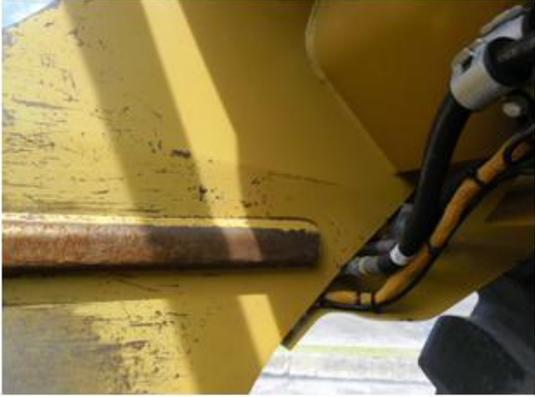
Description	Images
<p>Another example of a protective plate, covering the hydraulic hoses.</p>

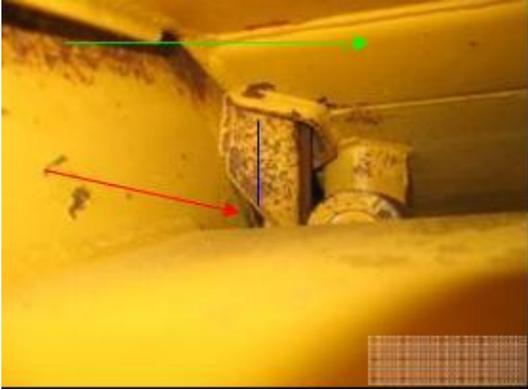
<p>The ends of the protective covers, which were highlighted in the last few illustrations. In this picture the open-end (red arrow) can be seen behind the rear of the bowl (green arrow) and this channel (blue line) will require flushing to verify cleanliness.</p>

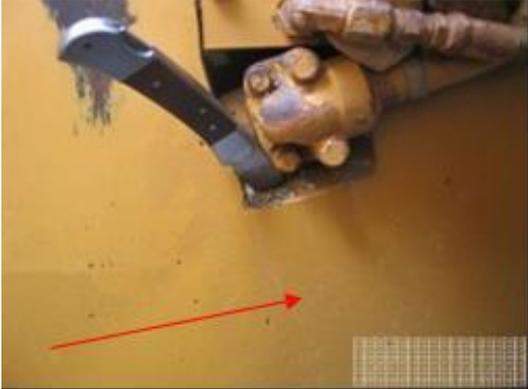
<p>This illustration highlights the exit of the hydraulic hoses from the inside of the bowl, just behind the rear. This is a natural opening on some models, allowing hundreds of litres of BRM to enter the sides. The knife is supported by the amount of BRM inside (the red arrow highlights the area full of BRM).</p>

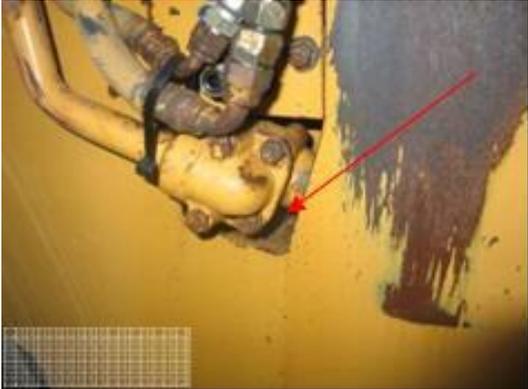
<p>On some models these natural openings can be found on each side of the bowl, behind the rear face. This side is also full of contaminants (red arrow).</p>

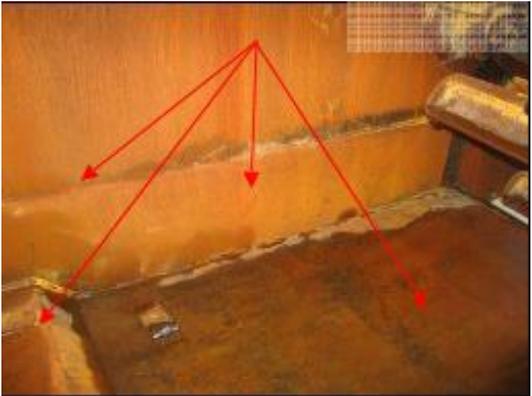
Description	Images
<p>The inside face of a typical scraper bowl. Check all surfaces carefully for any cracks, splits or evidence of repair. If detected, these areas will need to be investigated to be verified clean (red arrows).</p>

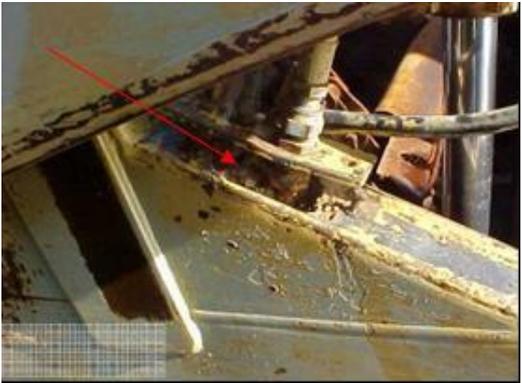
<p>This illustrates the hydraulic lines entering the sides of the bowl at the front end. Several bolts have been removed, allowing access for inspection. This area has been illustrated to show that these sides can be full of BRM.</p>

<p>A close view of where the hydraulics enter the side of the bowl. Once again, several bolts (green arrows) have been removed to allow for cleaning and inspection. This area has been illustrated to show that these sides can be full of BRM (red arrows).</p>

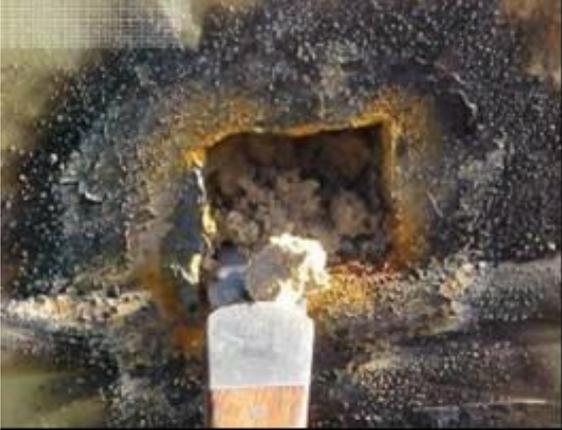
<p>Another illustration to highlight an area where repairs were detected. The area was examined and the inside of the bowl was contaminated.</p>

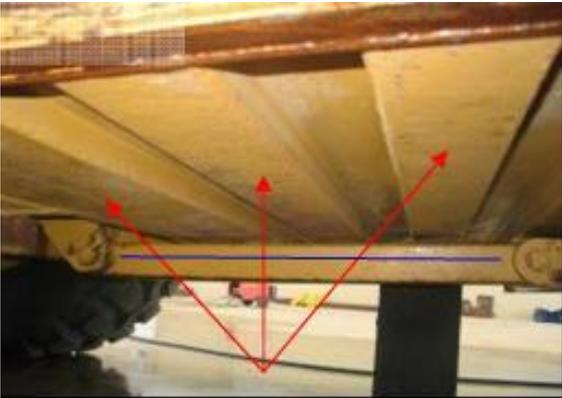
<p>The underside of the scraper bowl, showing individual gussets that can each harbour BRM (red arrows). Check all surfaces for cracks, splits or evidence of repair. The beam highlighted by the blue line may also be hollow and require flushing.</p>

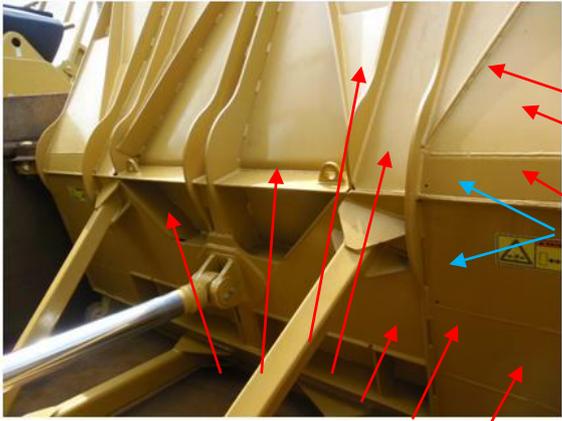
<p>More modern models have a number of hollow sections in the back of the ejector of the scraper bowl (red arrows). Some of these areas have flush holes that are easily accessible. Whilst other compartments are spot welded. Care should be taken to inspect for damage and that access has been granted to all hollow (blue arrows)</p>

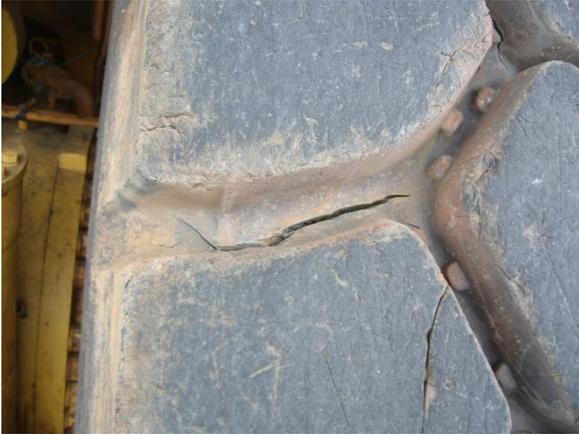
Description	Images
<p>All cracks and splits in tyres must be verified to ensure that all are free of BRM.</p>

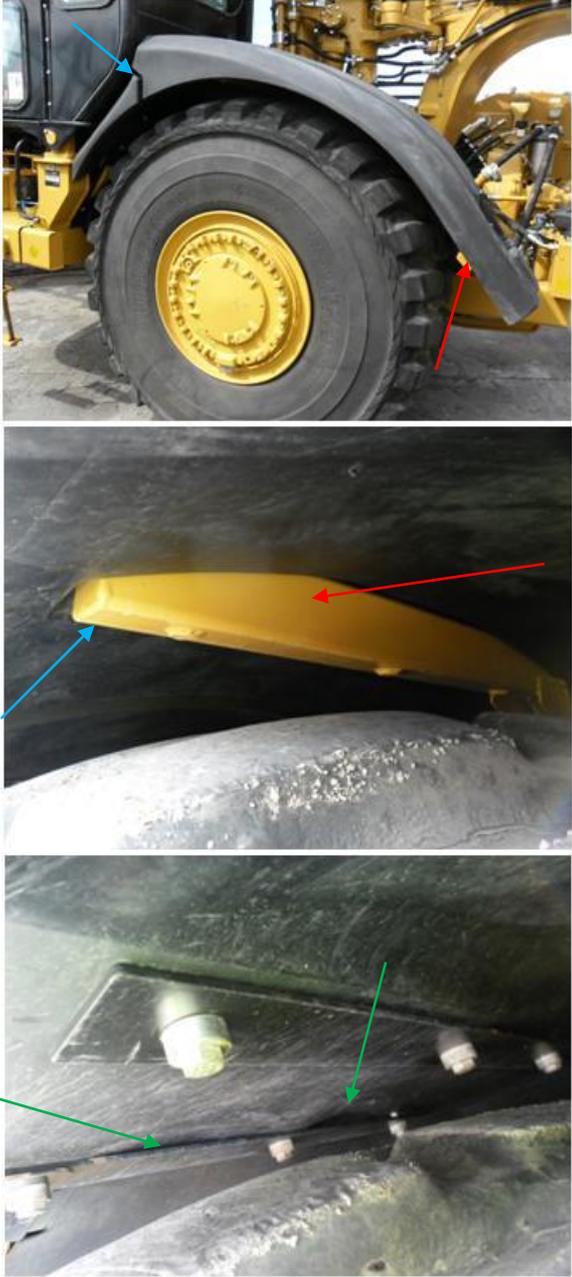
Description	Images
<p>Newer models now have plastic wheel guards over the front wheels. These guards are held in place with hollow metal support rails (red arrow). The plastic guards should be loosened off to allow access between the plastic and metal supports where BRM is easily caught up as the plastic is warped and damaged (green arrows). Also bends are formed in the plastic from manufacture where the supports are housed allowing little to no access for cleaning (blue arrow). Care should be taken to ensure the plastic guards are not damaged or breached, allowing risk material to build up inside.</p>

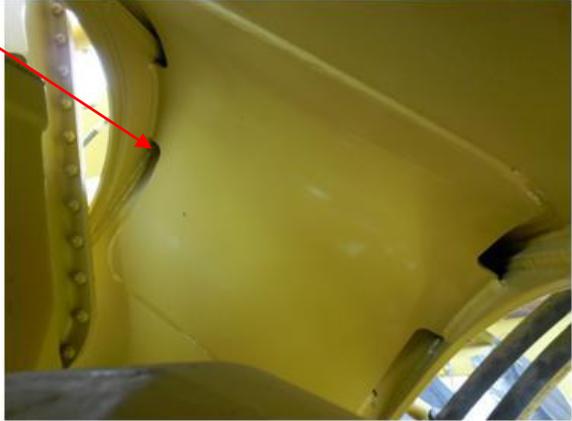
<p>The metal guards over the rear wheels of the newer models have a hollow section inside the guard which can harbor large amounts of BRM (red arrow).</p>

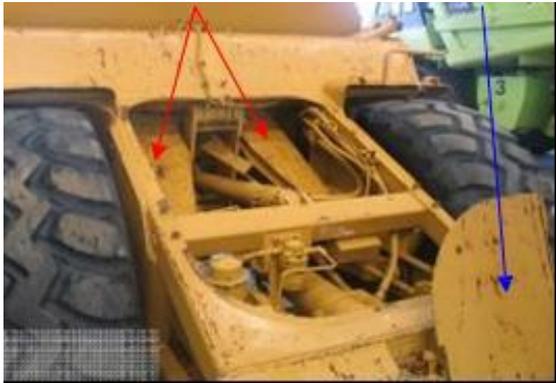
Description	Images
<p>The rear end of the scraper with all non-affixed panels removed, allowing access for cleaning and inspection. The red arrows highlight the rails under the rear, which will be seen later (red arrow).</p>

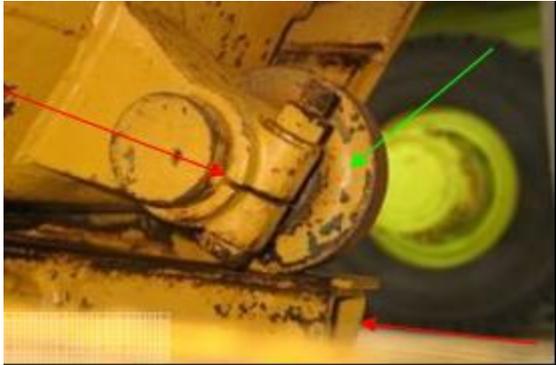
<p>At the back of the bowl and under the rear, check the small bowl pulley wheels (green arrow) and flush small recesses (red arrow).</p>

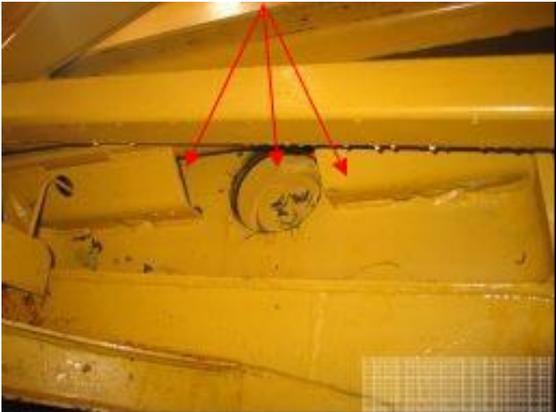
<p>Hollow cavities (red arrows) such as these are common under the rear of scrapers. All must be accessible at inspection.</p>

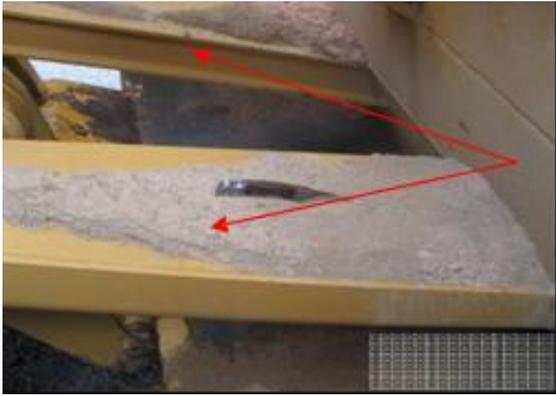
Description	Images
<p>The rails (red arrows) as seen under the rear of the scraper, behind the bowl. These areas can hold significant amounts of BRM.</p>

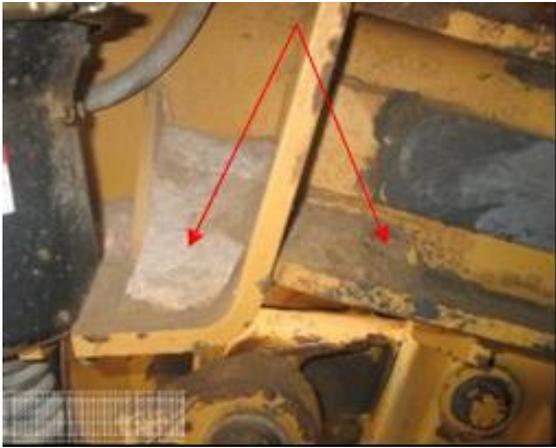
<p>An example of the different nooks and ledges that can be found under the rear of the scraper, harbouring BRM.</p>

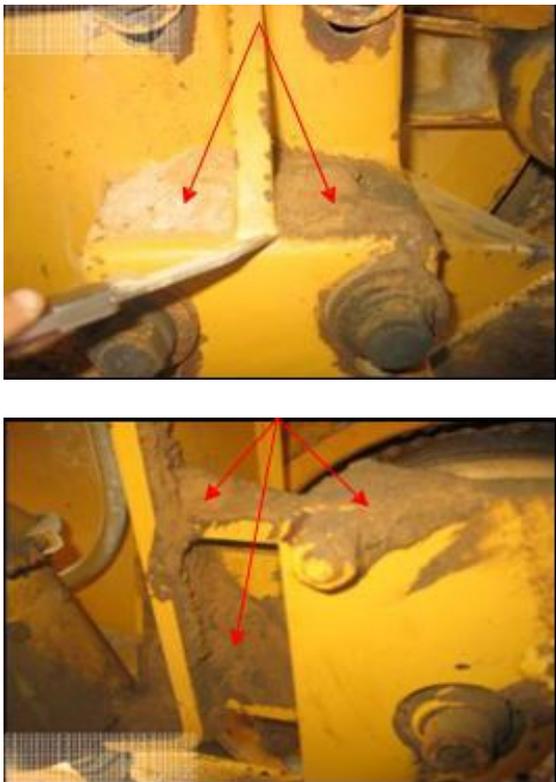
<p>More examples of the different nooks and ledges that can be found under the rear of the scraper, harbouring BRM.</p>

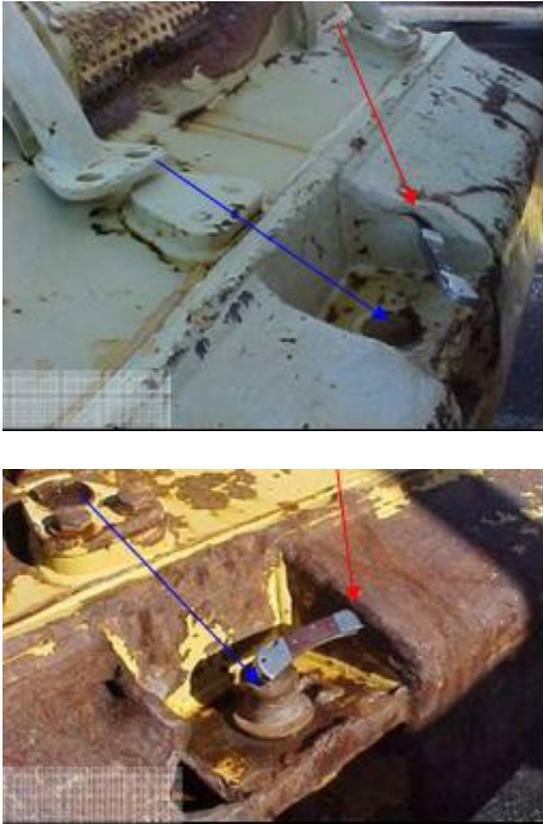
Description	Images
<p>Examples of the rear drawbars on scrapers. In each, a crack in the drawbar (red arrows) can be seen, which will require further investigation in order to verify the internal cleanliness. Remove the pins (blue arrows), as sometimes the access point to these areas maybe via this entrance (or drainage holes below).</p>

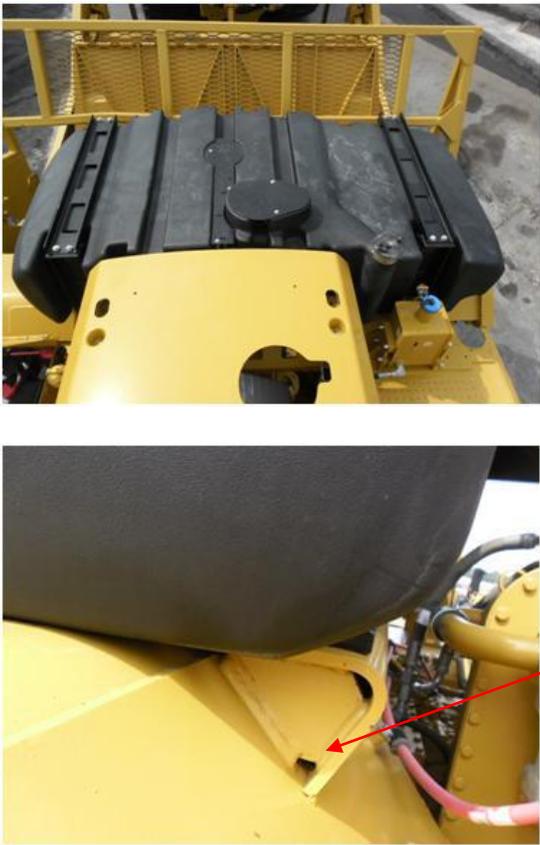
<p>Modern models now have a plastic fuel tank mounted to the rear of the scraper. Care is required to verify no risk material has lodged under the fuel tank as the fuel tank has been moulded to fit in place access is difficult. The fuel tank also sits on hollow sections that require flushing (red arrow).</p>

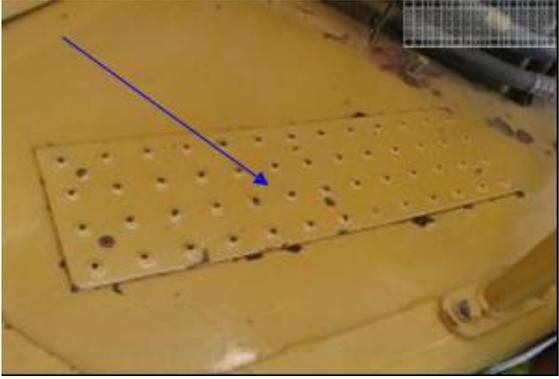
Description	Images
<p>All non-slip checker plates must be flushed to verify cleanliness underneath.</p>

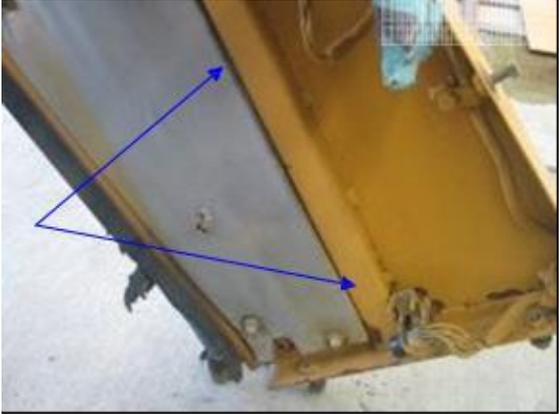
<p>Check all engine covers for hollow support framework and flush to verify cleanliness if required (blue arrows).</p>

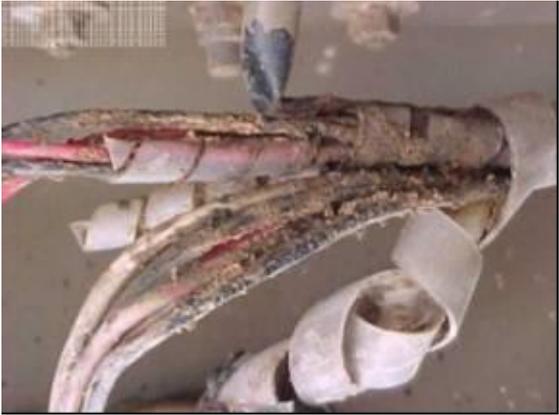
<p>Check all wiring harnesses for internal cleanliness.</p>
