Australian Government
Department of Agriculture
and Water Resources

Machinery Cleaning Guide - Scrapers

April 2016

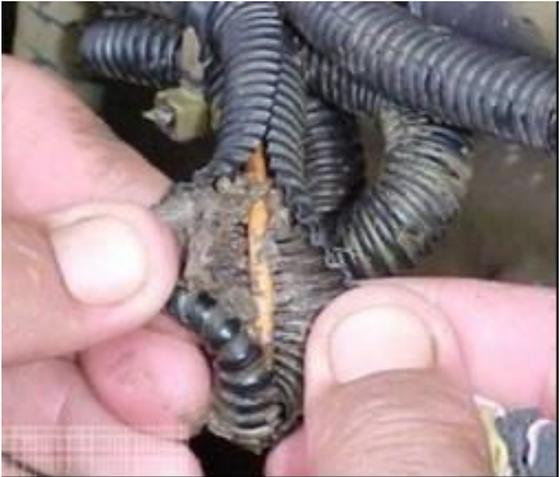
Description	Images
Check all looming around hydraulic hoses for internal cleanliness.
