Australian Government
Department of Agriculture
and Water Resources

Machinery Cleaning Guide - Komatsu Dozers

April 2016

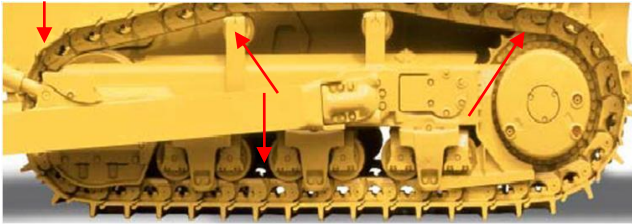
Description	Images
<p>The tracks on the dozer need to be rotated to ensure no biosecurity risk material is located behind the cogs, wheels (red arrows) and track pads.</p>

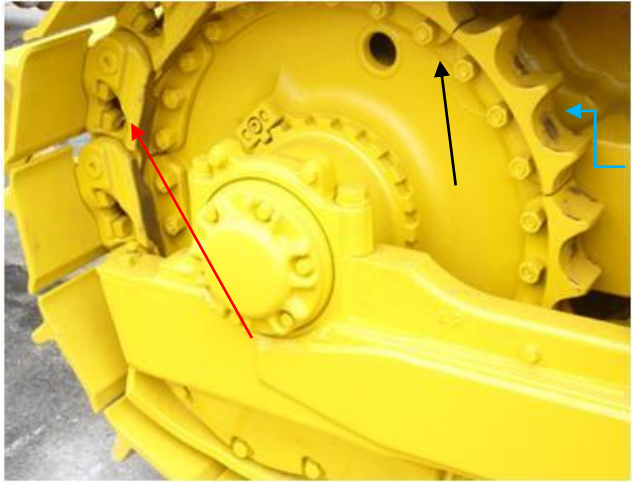
<p>Track links (red arrow) need to be inspected and flushed to ensure cleanliness on all sections through the track. The final drive sprocket end capping needs to be flushed (black arrow), visual inspection and flush if required behind the sprocket and bolt heads (blue arrow).</p>

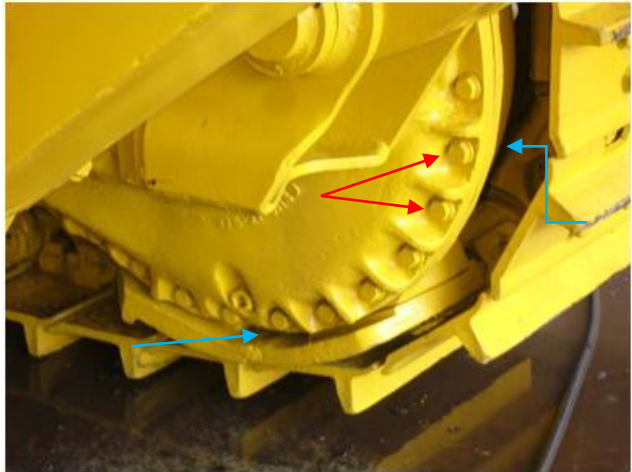
<p>A visual inspection must be carried out on bolt heads (red arrow) and also flushing will be required behind the final drive and sprocket (blue arrows).</p>

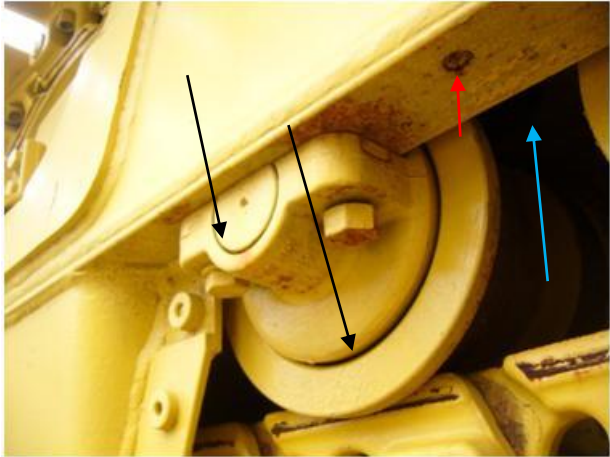
Description	Images
<p>The underside of the track frame usually has drainage holes (red arrow) along the entire length of the frame, which need to be flushed. Each of the individual track rollers and mounting points need to be flushed and rotated (black arrows). Most track frames are concave; some may also have structural supports in the hollow section as well and will require thorough flushing along cavity to ensure cleanliness (blue arrow).</p>

<p>A close-up photograph of the underside of a yellow track frame. A red arrow points to a small drainage hole on the top edge of the frame. Two black arrows point to track rollers and their mounting points. A blue arrow points into a hollow cavity within the frame structure.</p>
<p>The inside front track support plate needs to be flushed (red arrow) and the cover plate below needs a thorough inspection inside as well as outside and flush (black arrows). The hollow cavity below the track frame (blue arrows) will require flushing via the slight opening around the bolts.</p>

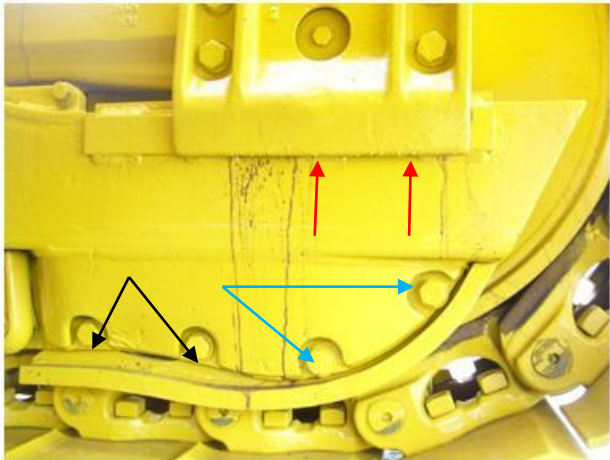
<p>A close-up photograph of the inside front track support plate and cover plate. A red arrow points to the support plate. Two black arrows point to the cover plate. A blue arrow points to a hollow cavity below the track frame, indicating where flushing is required.</p>

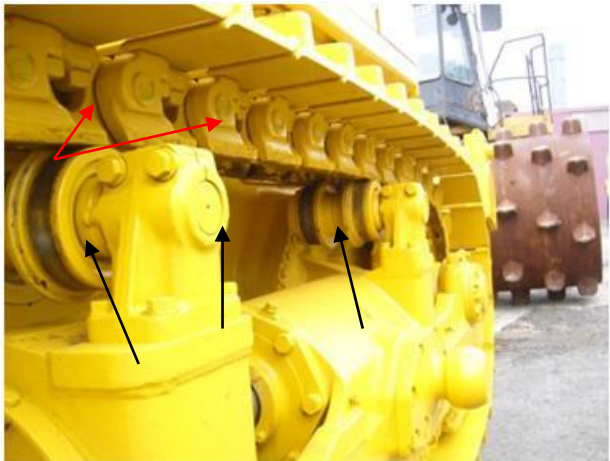
<p>The individual track links (red arrows) need to be inspected and flushed if required. Easier to do when rotating the tracks when moving the machine off the pad. Also flush the inside track carrier rollers and supports (black arrows) on all sides.</p>

<p>A side-view photograph of the track system. A red arrow points to an individual track link. Two black arrows point to the inside track carrier rollers and supports.</p>

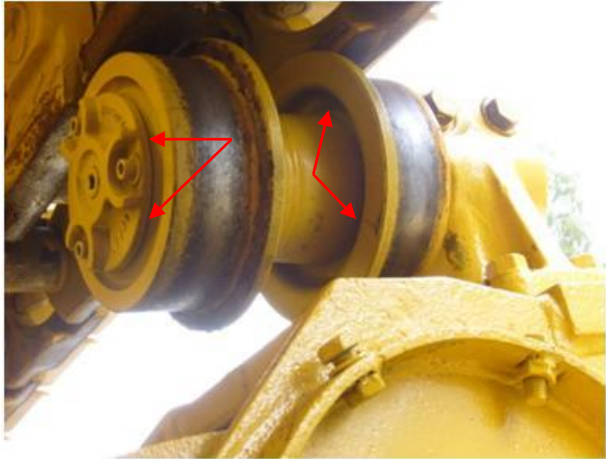
Description	Images
<p>The track carrier rollers mounted on the track frame must be inspected and flushed (red arrows) on all sides.</p>

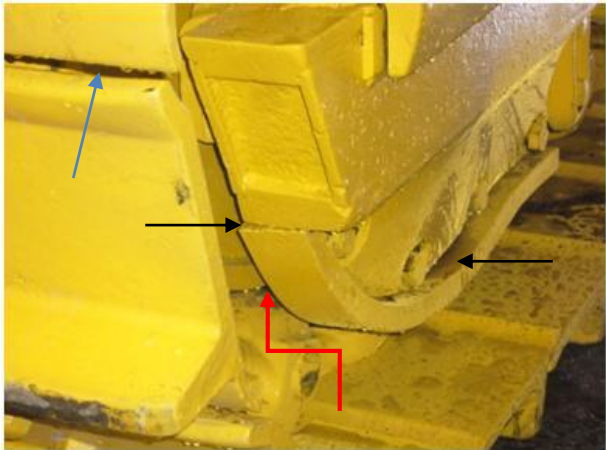
<p>All track frame components with gap plates that have a seam (black arrows) must be flushed. Also a visual inspection followed up with flushing on all sides is required on the inside of the track rock guard/guide support (red arrow). Each individual track plate (blue arrow) must be inspected and cleaned if required during the rotation of the tracks.</p>

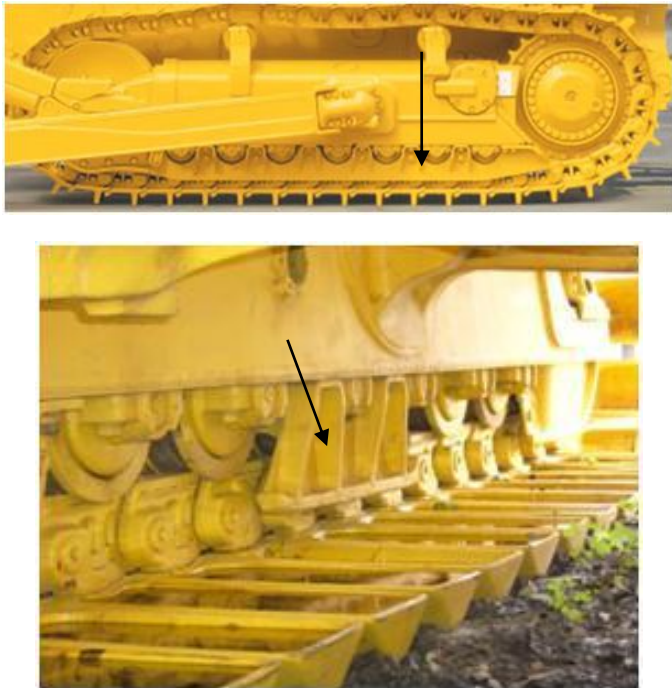
<p>On some models the rock guards (black arrows) must be removed prior to re-inspection. You must ensure that the rock guards on the inside of the track are removed as well.</p>

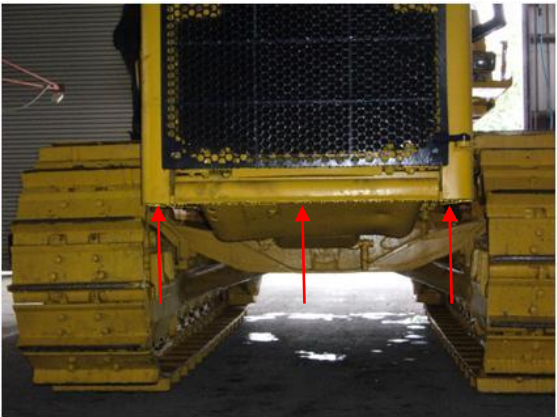
<p>A close-up photograph of the underside of the engine bay of a yellow Komatsu dozer. Three red arrows point to specific areas on the structural frame, indicating channels that need to be inspected and flushed if required.</p>

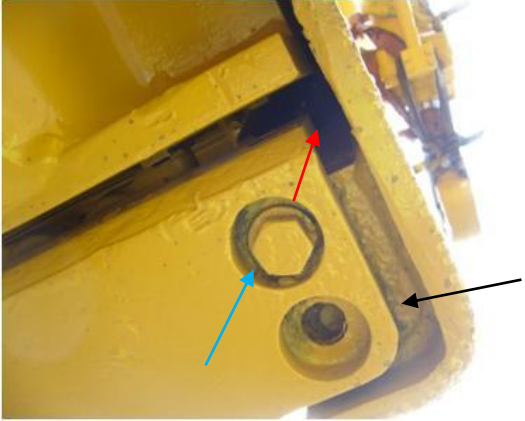
<p>Below the front nose structure frame is a noticable channel/hollow area (red arrow) running up the side of the frame. Flushing of the support brace (black arrow) is required as well as a visual inspection of any bolts (blue arrow).</p>

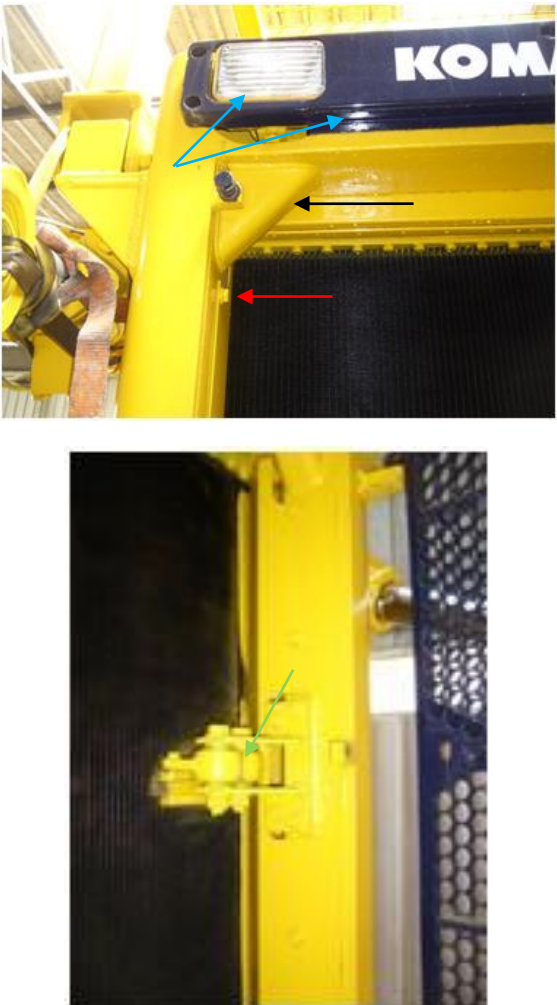
Description	Images
<p>The frame side structure is hollow and requires flushing, some models may require bolts to be removed (red arrow). On this model there is a plate and lights across the top that requires flushing (blue arrow). Some models have support structures (black arrow) around the radiator that require a visual inspection. The hinge swing brackets will also require flushing (green arrow).</p>

<p>The top photograph shows the side of a yellow Komatsu dozer. A blue arrow points to a light assembly on the top plate. A black arrow points to a support structure around the radiator. A red arrow points to a bolt on the frame side structure. The bottom photograph is a close-up of a hinge swing bracket, with a green arrow pointing to it.</p>

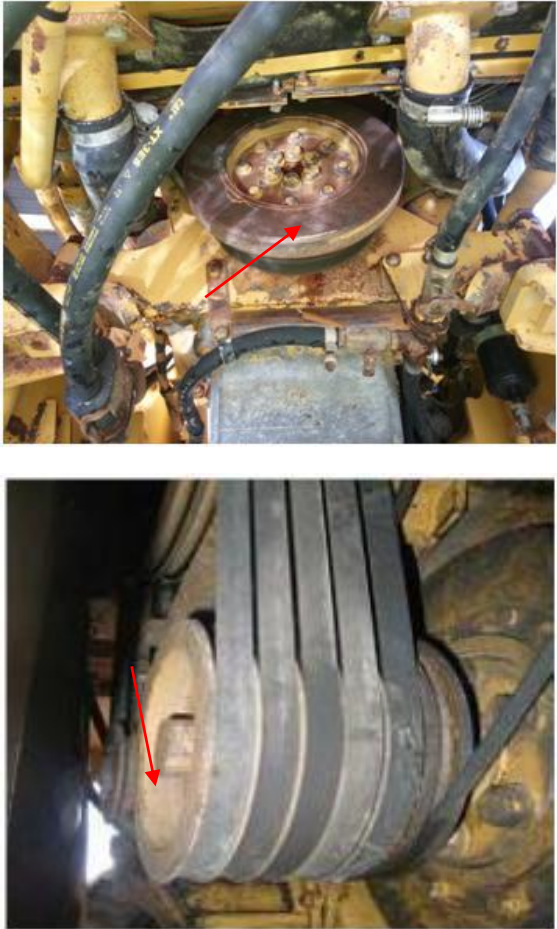
Description	Images
<p>Harmonic Balancers are found at the front of the engine block. These areas are generally hollow and can harbour contamination. Also check pulleys and all parts associated with the engine for biosecurity risk material.</p>

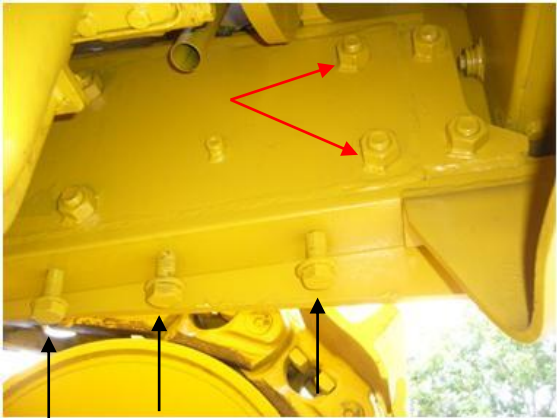
<p>This picture shows that on some models there are bolts along the underside chassis rail. These have to be removed and flushed. On some machines there might be plugs, cork or silicon in place of the bolts, they still have to be removed and flushed. Visual inspection is required on all bolt heads and nuts (red arrows).</p>

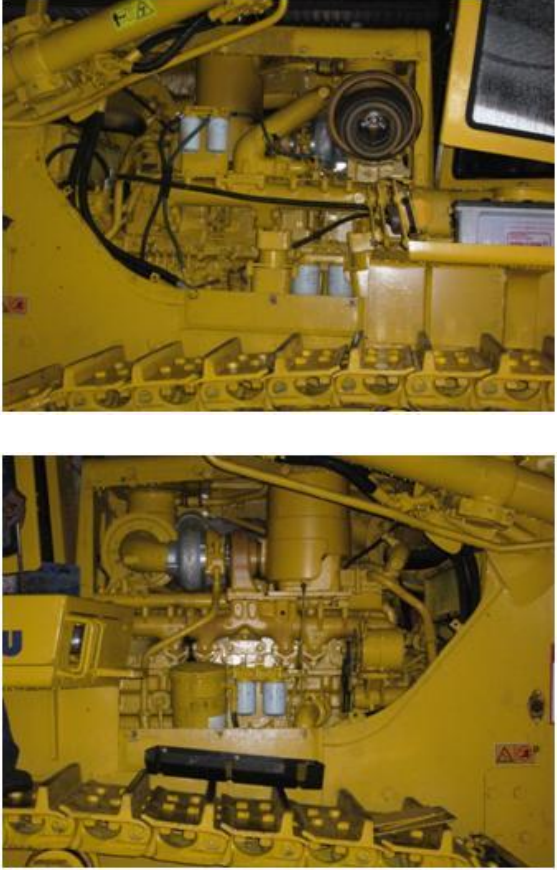
Description	Images
<p>These pictures show a typical engine bay. All non-affixed panels must be removed and cleaned as required. Specific areas of concern are the engine block, between cylinder heads, air filter, hydraulics, bolts and inside the chassis rails.</p>

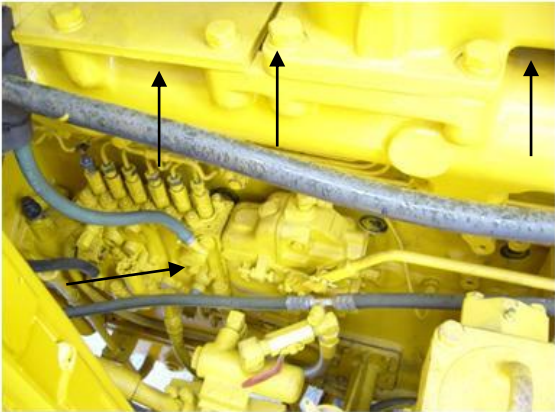
<p>Always visually check all areas of the engine block including any attachments (black arrows). All hoses must be rotated to ensure all sides are clean. Seams between cover plates are common and must be flushed.</p>

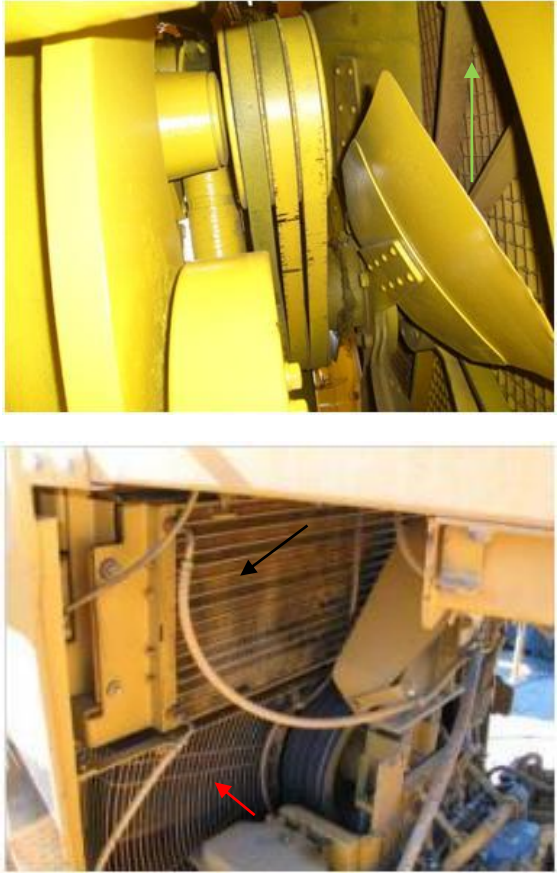
Description	Images
<p>Some models could have a radiator grill (red arrow), as shown below, and must be removed for access. The radiator shroud (green arrow) has to be flushed, specifically towards the corners top and bottom. Any oil coolers (black arrow) present must be flushed in the presence of the officer.</p>

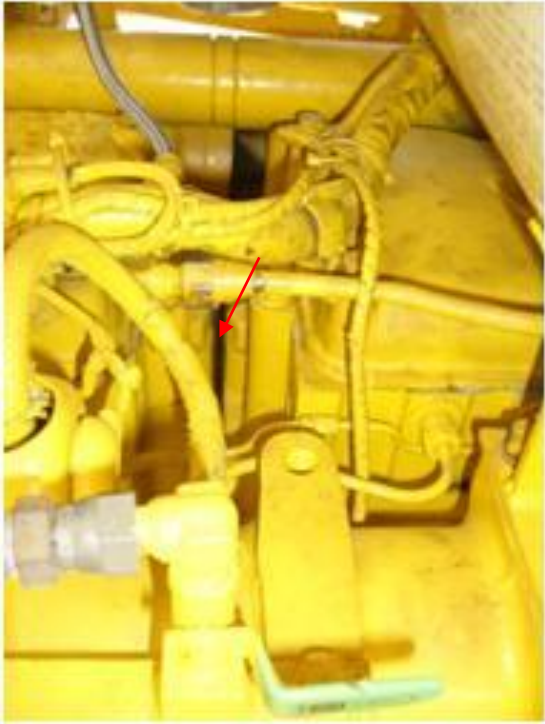
<p>The topside of a typical dozer block. Check between each tappet cover (red arrow) and along the centre of the block. Best to flush these areas after visual inspection to ensure all contamination has been removed. All ancillary items must be six sided inspected, specific attention must be made to all hoses, bolts and clamps.</p>

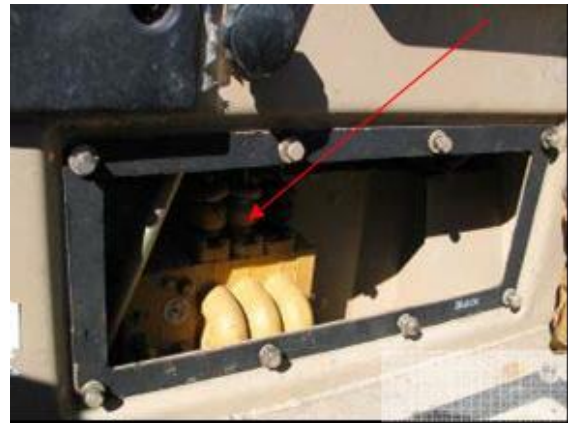
These pictures illustrate the various compartments found under the seat and around the seat. All non-affixed panels have been removed, allowing access for cleaning and inspection. These areas sometimes have ledges inside which can harbor biosecurity risk material and need to be thoroughly inspected. Care must be taken when inspecting electronics in this area.

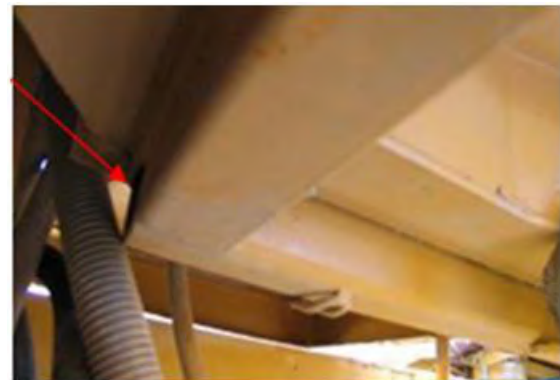
Some models have structural box channels below the floor pan, as shown below. All box channels must be identified and checked for openings/drainage holes and flushed to ensure there is no biosecurity risk material.

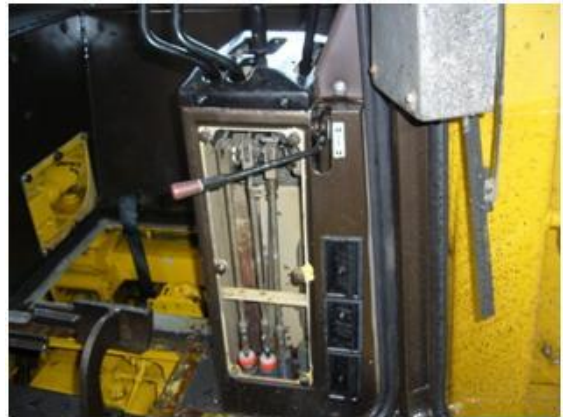
It is vital that all removable panels be removed and thoroughly inspected for biosecurity risk material. Particular attention must be paid to the air-conditioning vents and filter.

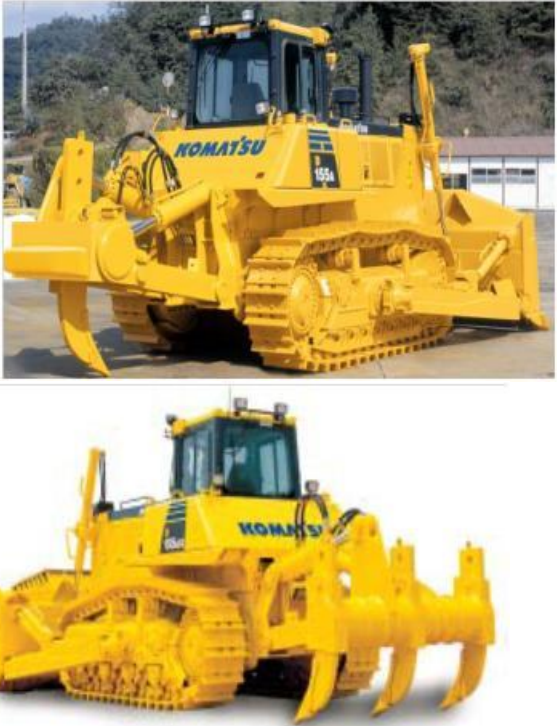
Description	Images
<p>Images of two different ripper versions that are commonly imported. The inspection regime is virtually the same as detailed in the below pictures.</p>

<p>The top image shows a yellow Komatsu bulldozer with a rear-mounted ripper, viewed from the side. The bottom image shows a similar yellow Komatsu bulldozer with a rear-mounted ripper, viewed from the front.</p>
<p>The first part of the inspection of the rear end should include the fuel tanks, including cover plates (black arrows) and accompanying valves, hydraulic pipes and hoses and any lights.</p>

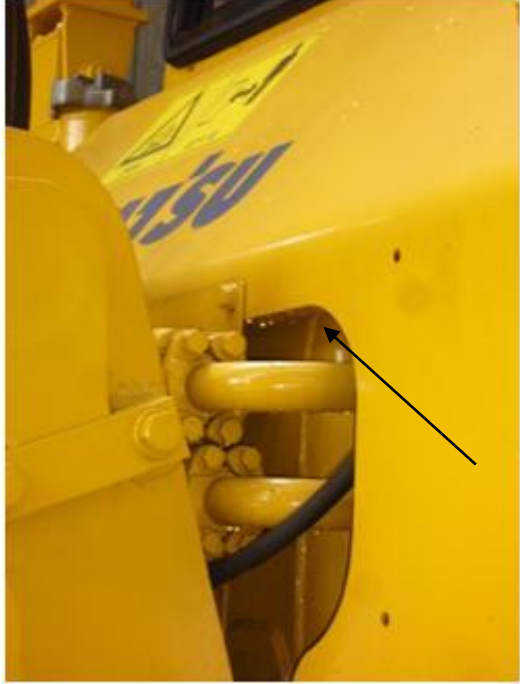
<p>A close-up photograph of the rear end of a yellow Komatsu bulldozer. The image shows the fuel tanks, cover plates, and hydraulic pipes. A black arrow points to a specific cover plate on the right side of the fuel tank.</p>

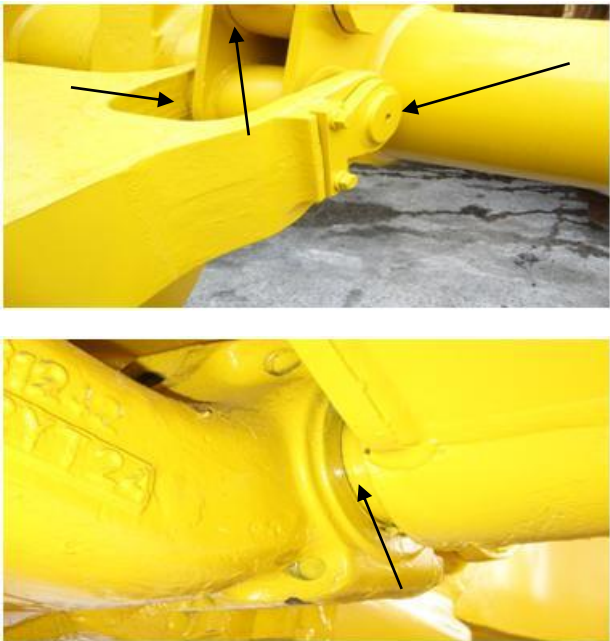
<p>All the pivot points from the ripper cradle must be visually inspected and flushed to ensure cleanliness.</p>

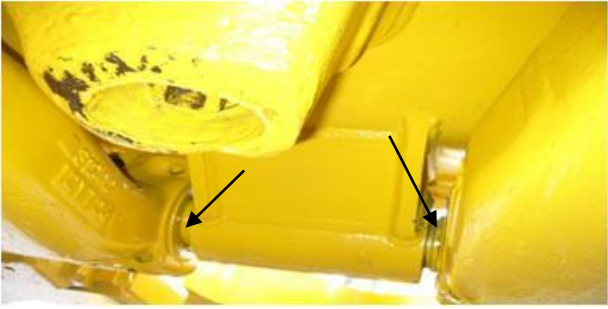
<p>The middle of the ripper cradle is hollow and may not have any drainage holes. If no holes are located check carefully for cracks, splits or evidence of repairs. If there are any cracks/ seams or signs of repair then access will need to be provided to verify cleanliness.</p>

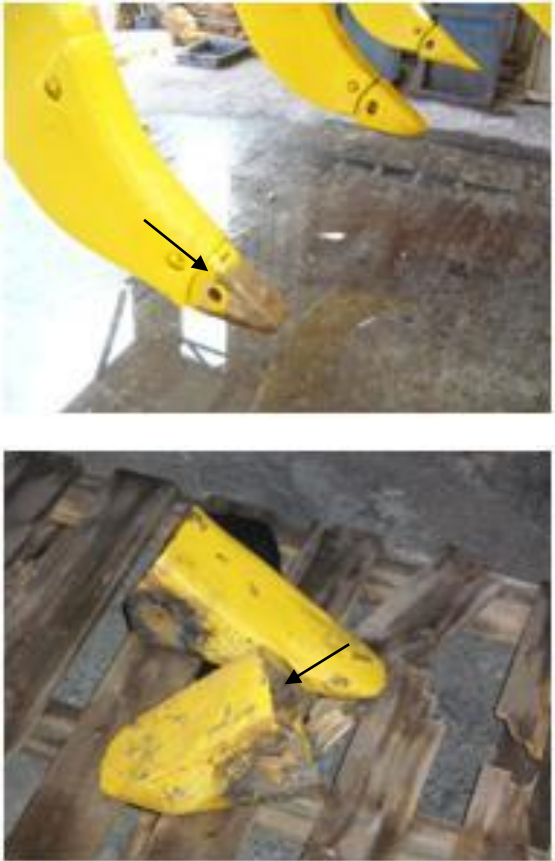
<p>All boots and wear plates must be removed for cleaning. It is not sufficient to just flush the boots; they must be physically inspected after removal.</p>

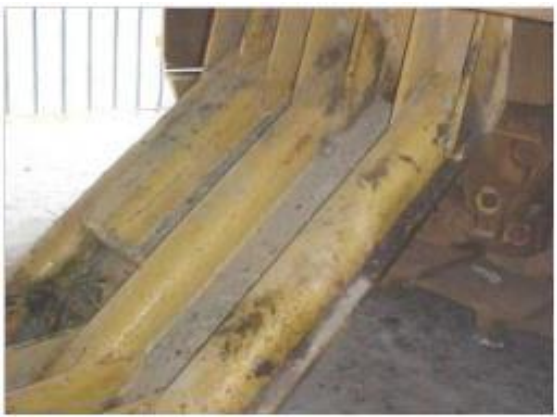
Description	Images
<p>Most belly pans have hollow structural framework that might have drainage holes that require flushing. Check for cracks, splits or signs of repair.</p>

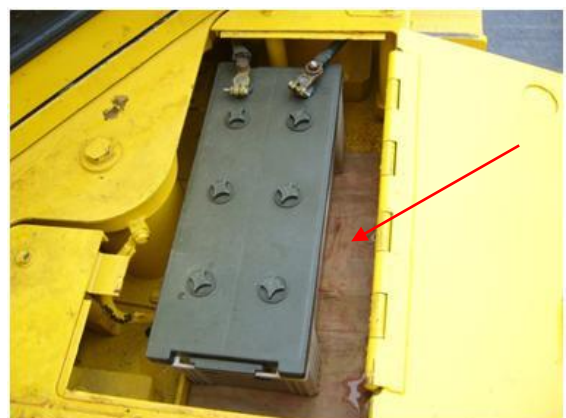
These pictures identify compartments along the side of the machine that require opening and full inspection. Thoroughly inspect all pipes, clamps, brackets and any hidden support channels for biosecurity risk material. Battery must be loosened and flushed underneath.

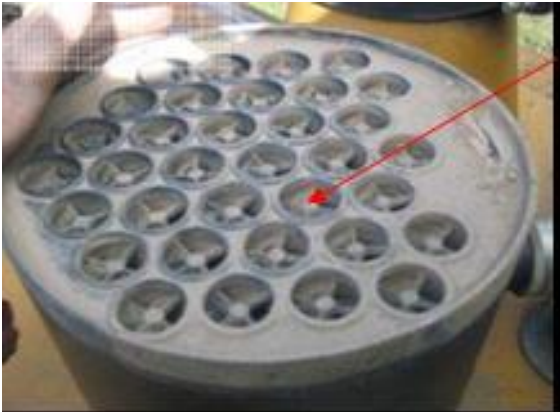
Description	Images
<p>All pre-cleaners and air filters must be dismantled and thoroughly inspected</p> <p>If the air filter can't be air cleaned then an ATT must be obtained for destruction.</p>

A photograph of a circular air filter assembly, likely from a Komatsu Dozer. It features a grid of small, circular individual filters. A red arrow points to one of these filters, indicating it for inspection or cleaning.
<p>This picture illustrates a different version of the tracks that may be presented. It highlights the need to rotate the tracks prior to completion.</p>

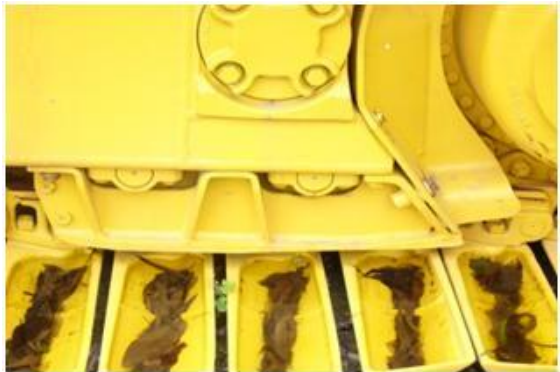
A photograph showing a close-up of yellow track links from a Komatsu Dozer. The links are arranged in a row, and the image highlights the need to rotate them for proper alignment and function.
